Taylor Mill Creek		co-0904-r-016	Sedimentation Risk Index 44																																																																		
<u>Common:</u> 6.8mi SE of Andalusia <u>Drainage:</u> Yellow River <i>GPS:</i> 31.278513547, -86.372965993 <u>Land owner:</u> C&R Wratchford -US, J&R Pate LE -DS		<u>County:</u> Covington <u>State:</u> Alabama <u>PLSS (T-R-S):</u> 4N-17E-29/32 <u>Parcel No.:</u> 16; 5 <u>Road Name:</u> Ellis Griggs Rd

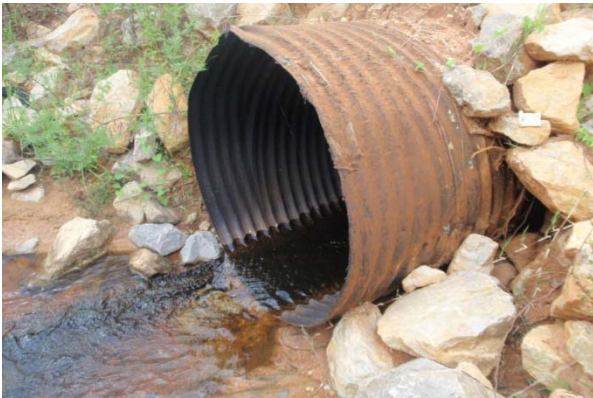
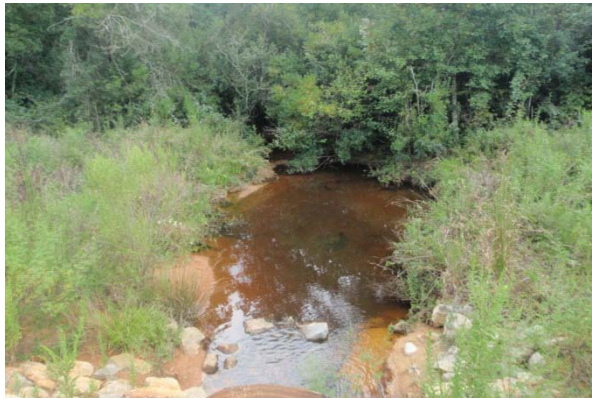
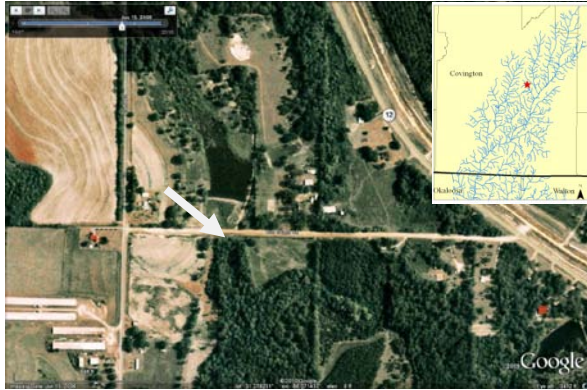
Risk Factor	Ranking	Score																																																																			
US Channel Morph	C	5																																																																			
DS Channel Morph	C	5																																																																			
DS Bank Alteration	MINOR/PARTIAL	3																																																																			
Upstream Skew Angle	<5°	5																																																																			
Crossing fill condition	Fair/Rip Rap	3																																																																			
Inlet/Outlet Condition	Sed Islands/Scouring	3																																																																			
Road Approach Material	All Sand/Clay	3																																																																			
Potential Eroded Volume Mean	<21 y ³	5																																																																			
Approach Slope Mean	>4%	1

Soil K Factor	<0.20	5																																																																			
Upstream Rt Outlet	Vegetated	1																																																																			
Upstream Lt Outlet	Vegetated	1																																																																			
Upstream Rt Ditch	Vegetated	1																																																																			
Upstream Lt Ditch	Vegetated	1																																																																			
Downstream Rt Outlet	Bare soil	0																																																																			
Downstream Lt Outlet	Bare soil	0																																																																			
Downstream Rt Ditch	Bare soil	0																																																																			
Downstream Lt Ditch	Bare soil	0																																																																			
Outlet Total	Partially Improved Outlet System	3

Ditches Total	Partially Improved Drainage System	3																																																																			
SRI Total	Medium Risk	44																																																																			
Additional Site Features <u>Crossing Type and Quantity:</u> Culvert, 1 <u>Crossing Materials:</u> Metal <u>Soil Types:</u> BoC,CdB,DmB,FuB,MBA <u>Rt Approach Prism Fill:</u> 0.1in <u>Lt Approach Prism Fill:</u> 0.25in		<table border="1"> <thead> <tr> <th>Feature</th> <th>Within Range</th> <th>Descriptive Field</th> </tr> </thead> <tbody> <tr> <td>303(d)</td> <td>No</td> <td>N/A</td> </tr> <tr> <td>Wetland Species</td> <td>No</td> <td>N/A</td> </tr> <tr> <td>Rare and Imperiled</td> <td>No</td> <td>N/A</td> </tr> <tr> <td>Land Use/Cover</td> <td>Yes</td> <td>N/A/ SUCCESSIONAL SHRUB, SCRUB (CLEAR CUT)</td> </tr> <tr> <td>Candidate Mussels</td> <td>No</td> <td>N/A</td> </tr> <tr> <td>Sturgeon C.H.</td> <td>No</td> <td>N/A</td> </tr> </tbody> </table>		Feature	Within Range	Descriptive Field	303(d)	No	N/A	Wetland Species	No	N/A	Rare and Imperiled	No	N/A	Land Use/Cover	Yes	N/A/ SUCCESSIONAL SHRUB, SCRUB (CLEAR CUT)	Candidate Mussels	No	N/A	Sturgeon C.H.	No	N/A
