Unnamed tributary		co-1104-r-001	Sedimentation Risk Index 48																																																																		
<u>Common:</u> 2.5mi SW of Friendship <u>Drainage:</u> Lightwood Knot <u>GPS:</u> 31.380717333, -86.238880743 <u>Land owner:</u> Edward & Janie Clark		<u>County:</u> Covington <u>State:</u> Alabama <u>PLSS (T-R-S):</u> 5N-18E-27 <u>Parcel No.:</u> 3 <u>Road Name:</u> Old Boggy Rd

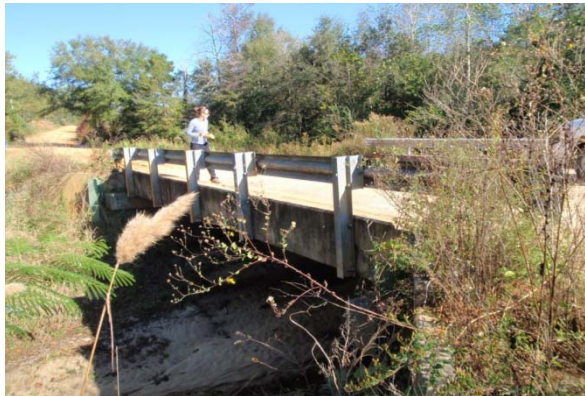
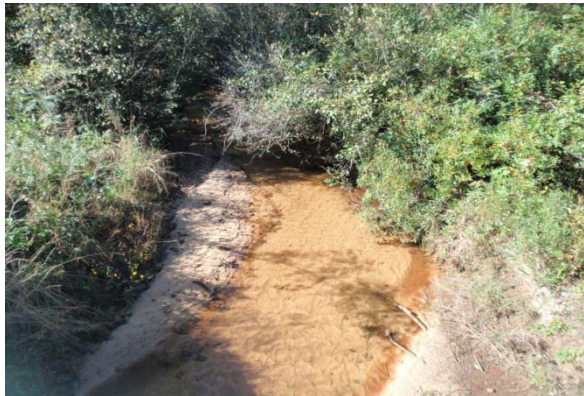
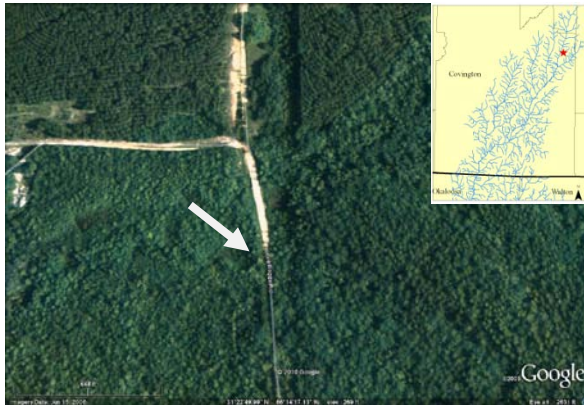
Crossing Structure: DS		DS																																																																			
<table border="1"> <thead> <tr> <th>Risk Factor</th> <th>Ranking</th> <th>Score</th> </tr> </thead> <tbody> <tr><td>US Channel Morph</td><td>DA</td><td>3</td></tr> <tr><td>DS Channel Morph</td><td>C</td><td>5</td></tr> <tr><td>DS Bank Alteration</td><td>MINOR/PARTIAL</td><td>3</td></tr> <tr><td>Upstream Skew Angle</td><td><5°</td><td>5</td></tr> <tr><td>Crossing fill condition</td><td>Good/Vegetated</td><td>5</td></tr> <tr><td>Inlet/Outlet Condition</td><td>No Impairment</td><td>5</td></tr> <tr><td>Road Approach Material</td><td>All Sand/Clay</td><td>3</td></tr> <tr><td>Potential Eroded Volume Mean</td><td>21-40 y³</td><td>3</td></tr> <tr><td>Approach Slope Mean</td><td>2.1-4%</td><td>3</td></tr> <tr><td>Soil K Factor</td><td><0.20</td><td>5</td></tr> <tr><td>Upstream Rt Outlet</td><td>Vegetated</td><td>1</td></tr> <tr><td>Upstream Lt Outlet</td><td>Vegetated</td><td>1</td></tr> <tr><td>Upstream Rt Ditch</td><td>Bare soil</td><td>0</td></tr> <tr><td>Upstream Lt Ditch</td><td>Vegetated</td><td>1</td></tr> <tr><td>Downstream Rt Outlet</td><td>Vegetated</td><td>1</td></tr> <tr><td>Downstream Lt Outlet</td><td>Vegetated</td><td>1</td></tr> <tr><td>Downstream Rt Ditch</td><td>Vegetated</td><td>1</td></tr> <tr><td>Downstream Lt Ditch</td><td>Bare soil</td><td>0</td></tr> <tr><td>Outlet Total</td><td>Improved Outlet System</td><td>5</td></tr> <tr><td>Ditches Total</td><td>Partially Improved Drainage System</td><td>3</td></tr> <tr><td>SRI Total</td><td>Low Risk</td><td>48</td></tr> </tbody> </table>		Risk Factor	Ranking	Score	US Channel Morph	DA	3	DS Channel Morph	C	5	DS Bank Alteration	MINOR/PARTIAL	3	Upstream Skew Angle	<5°	5	Crossing fill condition	Good/Vegetated	5	Inlet/Outlet Condition	No Impairment	5	Road Approach Material	All Sand/Clay	3	Potential Eroded Volume Mean	21-40 y ³	3	Approach Slope Mean	2.1-4%	3	Soil K Factor	<0.20	5	Upstream Rt Outlet	Vegetated	1	Upstream Lt Outlet	Vegetated	1	Upstream Rt Ditch	Bare soil	0	Upstream Lt Ditch	Vegetated	1	Downstream Rt Outlet	Vegetated	1	Downstream Lt Outlet	Vegetated	1	Downstream Rt Ditch	Vegetated	1	Downstream Lt Ditch	Bare soil	0	Outlet Total	Improved Outlet System	5	Ditches Total	Partially Improved Drainage System	3	SRI Total	Low Risk	48

Notes: Road is primary sediment source.
