Titi Creek		ok-1022-001		Severity Score 4	
<u>Common:</u> 7.7mi SE of Crestview <u>Drainage:</u> Shoal River <u>GPS:</u> 30.698776532, -86.462921107 <u>Land owner:</u> USA- Eglin AFB		<u>County:</u> Okaloosa <u>PLSS(T-R-S):</u> 2N-22W-1 <u>Parcel No.:</u> 1		<u>State:</u> Florida

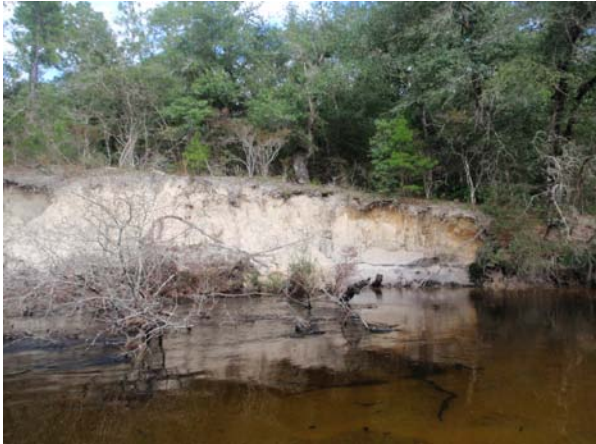
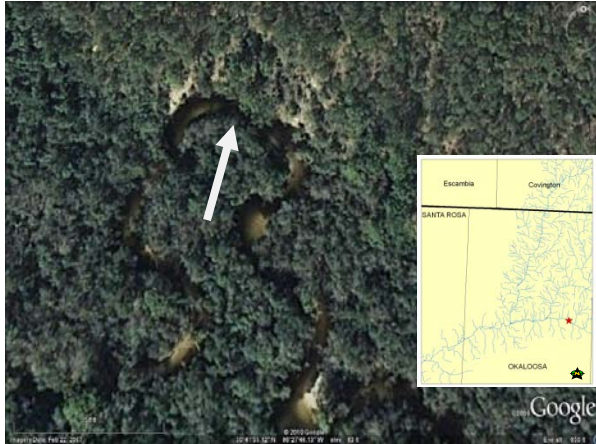
RB					
<b>Risk Factor</b>	<b>Ranking</b>	<b>Score</b>	<b>Feature</b>	<b>Within Range</b>	<b>Descriptive Field</b>
Channel Stability	Fair	1	303(d)	No	N/A
Channel Alteration	None	0	Wetland Species	No	N/A
Bank Erosion	Active	1	Rare and Imperiled	No	N/A
BEHI	Moderate	0.5	Land Use/Cover	Yes	INSTITUTIONAL/ STREAMS AND WATERWAYS
Local NPSP	No Evidence	0	Candidate Mussels	No	N/A
Shoring Structures	Not Present	0	Sturgeon C.H.	No	N/A
Pipe Discharge	Not Present	0			
Water Odors	Not Present	0			
Fish Passage Barrier	Not Present	0			
RB: Riparian Buffer	0-29 ft	0.75			
LB: Riparian Buffer	100+ ft	0			
RB: Floodplain Access	None	0.75

LB: Floodplain Access	Full	0			
<b>River Threat Index:</b>		<b>4</b>	<b>Additional Site Features</b> <u>Stream Channel Woody Material:</u> Numerous <u>Impoundments:</u> Woody Material Jams <u>Substrate Composition:</u> Coarse Sand <u>Bank Material:</u> Coarse Sand

Notes: Uncommon feature for Titi Creek. 270ft reach
