Unnamed tributary		co-0901-r-019	Sedimentation Risk Index 56																																																																		
<u>Common:</u> 10.4mi NW of Florala <u>Drainage:</u> Yellow River <i>GPS:</i> 31.141652044, -86.378701811 <u>Land owner:</u> T. Ivey Powell & Sons Inc		<u>County:</u> Covington <u>State:</u> Alabama <u>PLSS (T-R-S):</u> 2N-17E-7 <u>Parcel No.:</u> 1 <u>Road Name:</u> Cravey Bridge Rd

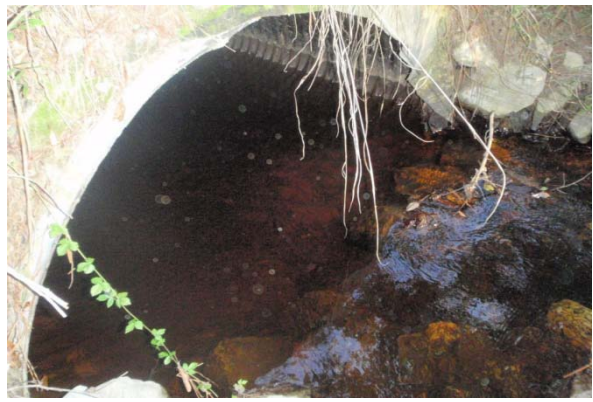
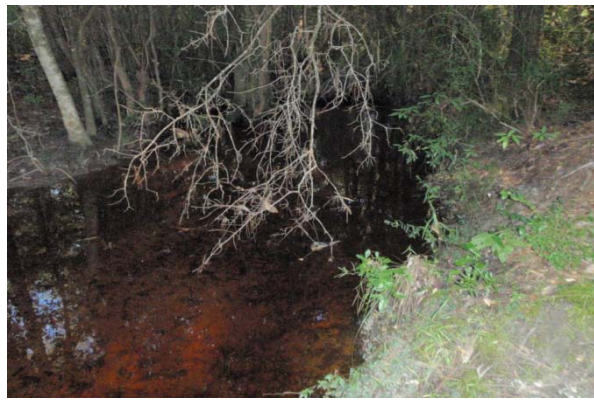
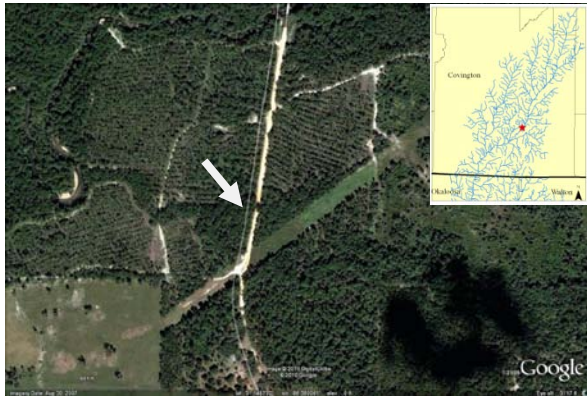
Crossing Structure: DS		US																																																																			
<table border="1"> <thead> <tr> <th>Risk Factor</th> <th>Ranking</th> <th>Score</th> </tr> </thead> <tbody> <tr><td>US Channel Morph</td><td>C</td><td>5</td></tr> <tr><td>DS Channel Morph</td><td>C</td><td>5</td></tr> <tr><td>DS Bank Alteration</td><td>NATURAL</td><td>5</td></tr> <tr><td>Upstream Skew Angle</td><td><5°</td><td>5</td></tr> <tr><td>Crossing fill condition</td><td>Fair/Rip Rap</td><td>3</td></tr> <tr><td>Inlet/Outlet Condition</td><td>No Impairment</td><td>5</td></tr> <tr><td>Road Approach Material</td><td>All Sand/Clay</td><td>3</td></tr> <tr><td>Potential Eroded Volume Mean</td><td><21 y³</td><td>5</td></tr> <tr><td>Approach Slope Mean</td><td><2%</td><td>5</td></tr> <tr><td>Soil K Factor</td><td><0.20</td><td>5</td></tr> <tr><td>Upstream Rt Outlet</td><td>Vegetated</td><td>1</td></tr> <tr><td>Upstream Lt Outlet</td><td>Vegetated</td><td>1</td></tr> <tr><td>Upstream Rt Ditch</td><td>Vegetated</td><td>1</td></tr> <tr><td>Upstream Lt Ditch</td><td>Vegetated</td><td>1</td></tr> <tr><td>Downstream Rt Outlet</td><td>Vegetated</td><td>1</td></tr> <tr><td>Downstream Lt Outlet</td><td>Vegetated</td><td>1</td></tr> <tr><td>Downstream Rt Ditch</td><td>Vegetated</td><td>1</td></tr> <tr><td>Downstream Lt Ditch</td><td>Vegetated</td><td>1</td></tr> <tr><td>Outlet Total</td><td>Improved Outlet System</td><td>5</td></tr> <tr><td>Ditches Total</td><td>Improved Drainage System</td><td>5</td></tr> <tr><td>SRI Total</td><td>Low Risk</td><td>56</td></tr> </tbody> </table>		Risk Factor	Ranking	Score	US Channel Morph	C	5	DS Channel Morph	C	5	DS Bank Alteration	NATURAL	5	Upstream Skew Angle	<5°	5	Crossing fill condition	Fair/Rip Rap	3	Inlet/Outlet Condition	No Impairment	5	Road Approach Material	All Sand/Clay	3	Potential Eroded Volume Mean	<21 y ³	5	Approach Slope Mean	<2%	5	Soil K Factor	<0.20	5	Upstream Rt Outlet	Vegetated	1	Upstream Lt Outlet	Vegetated	1	Upstream Rt Ditch	Vegetated	1	Upstream Lt Ditch	Vegetated	1	Downstream Rt Outlet	Vegetated	1	Downstream Lt Outlet	Vegetated	1	Downstream Rt Ditch	Vegetated	1	Downstream Lt Ditch	Vegetated	1	Outlet Total	Improved Outlet System	5	Ditches Total	Improved Drainage System	5	SRI Total	Low Risk	56

Notes: Rip rap in stream bed. Close proximity to YR main stem.
