Gopher Creek		ok-0318-r-001		Sedimentation Risk Index 36	
<u>Common:</u> 5.9mi SW of Crestview <u>Drainage:</u> Shoal River <u>GPS:</u> 30.681847, -86.606008 <u>Land owner:</u> US Government- Eglin AFB		<u>County:</u> Okaloosa <u>PLSS (T-R-S):</u> 2N-24-11 <u>Parcel No.:</u> 1 <u>Road Name:</u> Rattlesnake Hill Rd		<u>State:</u> Florida

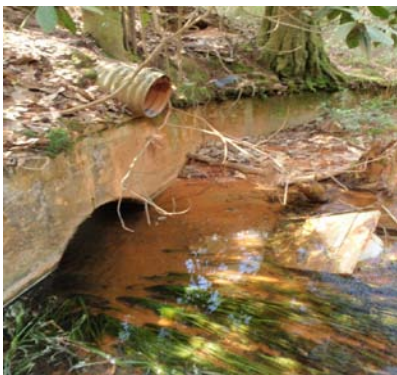
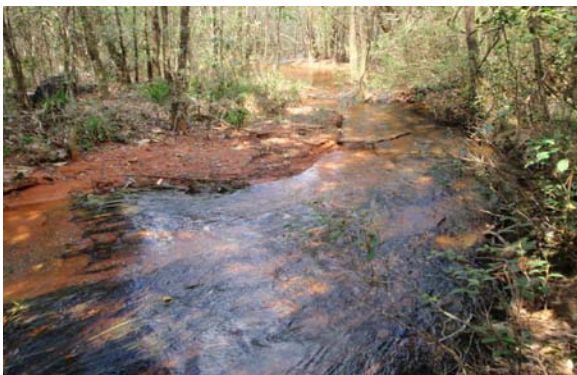
Crossing Structure: DS		DS			
Risk Factor	Ranking	Score			
US Channel Morph	E	5			
DS Channel Morph	DA	3			
DS Bank Alteration	MINOR/PARTIAL	3			
Upstream Skew Angle	<5°	5			
Crossing fill condition	Good/Vegetated	5			
Inlet/Outlet Condition	Sed Islands/Scouring	3			
Road Approach Material	All Sand/Clay	3			
Potential Eroded Volume Mean	>40 y ³	1			
Approach Slope Mean	>4%	1			
Soil K Factor	<0.20	5			
Upstream Rt Outlet	Bare soil	0			
Upstream Lt Outlet	Bare soil	0			
Upstream Rt Ditch	Bare soil	0			
Upstream Lt Ditch	Bare soil	0			
Downstream Rt Outlet	Bare soil	0

Downstream Lt Outlet	Bare soil	0			
Downstream Rt Ditch	Bare soil	0			
Downstream Lt Ditch	Bare soil	0			
Outlet Total	Unimproved Outlet System	1			
Ditches Total	Unimproved Drainage System	1			
SRI Total	High Risk	36			
Additional Site Features <u>Crossing Type and Quantity:</u> Culvert, 1 <u>Crossing Materials:</u> Reinforced Concrete <u>Soil Types:</u> 12,13,14,25 <u>Lt Approach Prism Fill:</u> 0.5in <u>Rt Approach Prism Fill:</u> 1.0in
