Battle Creek		wa-0707-r-001	Sedimentation Risk Index 42																																																																		
<u>Common:</u> 2.3mi NE of Mossy Head <u>Drainage:</u> Shoal River <i>GPS:</i> 30.767306, -86.288072 <u>Land owner:</u> Anthony & Deborah Farrantello-DS, Marie Berry-US		<u>County:</u> Walton <i>State:</i> Florida <u>PLSS(T-R-S):</u> 3N-20-07 <u>Parcel No.:</u> 21.0011;020.0010 <u>Road Name:</u> Unpaved road off Squire Way

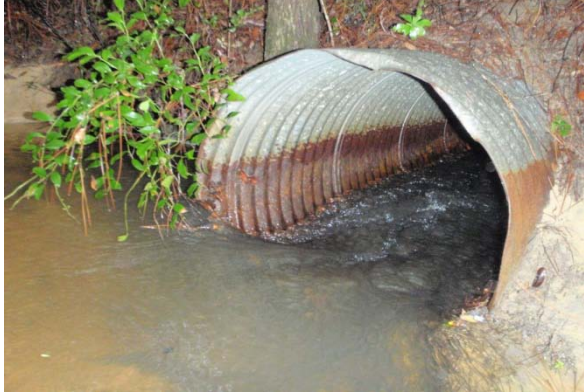
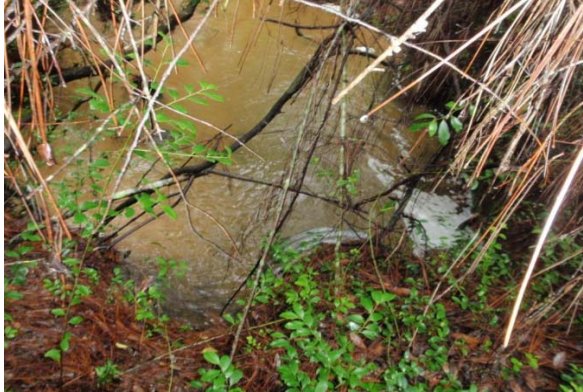
Risk Factor	Ranking	Score																																																																			
US Channel Morph	DA	3																																																																			
DS Channel Morph	DA	3																																																																			
DS Bank Alteration	NATURAL	5																																																																			
Upstream Skew Angle	5-30°	3																																																																			
Crossing fill condition	Good/Vegetated	5																																																																			
Inlet/Outlet Condition	Sed Islands/Scouring	3																																																																			
Road Approach Material	All Native Soil	1																																																																			
Potential Eroded Volume Mean	<21 y ³	5																																																																			
Approach Slope Mean	>4%	1

Soil K Factor	<0.20	5																																																																			
Upstream Rt Outlet	Vegetated	1																																																																			
Upstream Lt Outlet	Vegetated	1																																																																			
Upstream Rt Ditch	Vegetated	1																																																																			
Upstream Lt Ditch	Bare soil	0																																																																			
Downstream Rt Outlet	Vegetated	1																																																																			
Downstream Lt Outlet	Vegetated	1																																																																			
Downstream Rt Ditch	Vegetated	1																																																																			
Downstream Lt Ditch	Vegetated	1																																																																			
Outlet Total	Improved Outlet System	5

Ditches Total	Partially Improved Drainage System	3																																																																			
SRI Total	Medium Risk	42																																																																			
Additional Site Features <u>Crossing Type and Quantity:</u> Culvert, 1 <u>Crossing Materials:</u> Metal <u>Soil Types:</u> 6,17,18,31,32,33,34 <u>Rt Approach Prism Fill:</u> 9.0in <u>Lt Approach Prism Fill:</u> 3.5in		<table border="1"> <thead> <tr> <th>Feature</th> <th>Within Range</th> <th>Descriptive Field</th> </tr> </thead> <tbody> <tr> <td>303(d)</td> <td>No</td> <td>N/A</td> </tr> <tr> <td>Wetland Species</td> <td>Yes</td> <td>1-3 FOCAL SPECIES IN UPLAND AREAS</td> </tr> <tr> <td>Rare and Imperiled</td> <td>No</td> <td>N/A</td> </tr> <tr> <td>Land Use/Cover</td> <td>Yes</td> <td>VACANT RESIDENTIAL/HYDRIC PINE FLATWOODS</td> </tr> <tr> <td>Candidate Mussels</td> <td>No</td> <td>N/A</td> </tr> <tr> <td>Sturgeon C.H.</td> <td>No</td> <td>N/A</td> </tr> </tbody> </table>		Feature	Within Range	Descriptive Field	303(d)	No	N/A	Wetland Species	Yes	1-3 FOCAL SPECIES IN UPLAND AREAS	Rare and Imperiled	No	N/A	Land Use/Cover	Yes	VACANT RESIDENTIAL/HYDRIC PINE FLATWOODS	Candidate Mussels	No	N/A	Sturgeon C.H.	No	N/A
