Pond Creek		ok-0710-r-002		Sedimentation Risk Index 50																																																																			
<u>Common:</u> 6.1mi NW of Mossy Head <u>Drainage:</u> Shoal River <u>GPS:</u> 30.793986, -86.399002 <u>Land owner:</u> Rick & Susan Goff		<u>County:</u> Okaloosa <u>PLSS(T-R-S):</u> 4N-22-36 <u>Parcel No.:</u> 3.001 <u>Road Name:</u> Pond Creek Rd		<u>State:</u> Florida

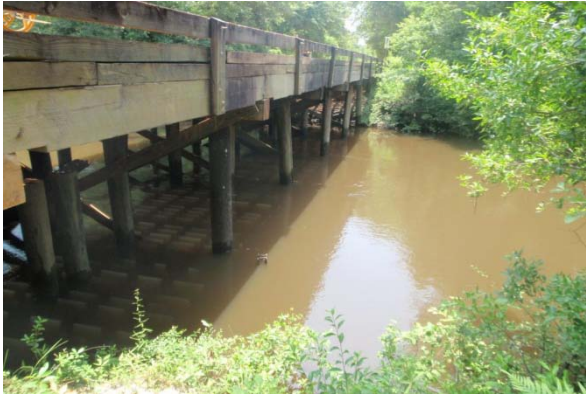
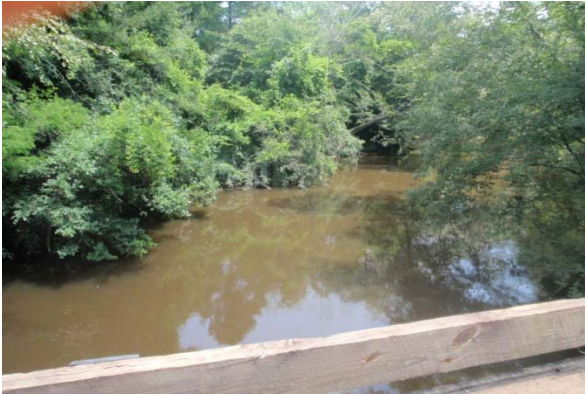
Crossing Structure: DS		US																																																																					
<table border="1"> <thead> <tr> <th>Risk Factor</th> <th>Ranking</th> <th>Score</th> </tr> </thead> <tbody> <tr><td>US Channel Morph</td><td>C</td><td>5</td></tr> <tr><td>DS Channel Morph</td><td>C</td><td>5</td></tr> <tr><td>DS Bank Alteration</td><td>NATURAL</td><td>5</td></tr> <tr><td>Upstream Skew Angle</td><td><5°</td><td>5</td></tr> <tr><td>Crossing fill condition</td><td>Good/Vegetated</td><td>5</td></tr> <tr><td>Inlet/Outlet Condition</td><td>No Impairment</td><td>5</td></tr> <tr><td>Road Approach Material</td><td>All Sand/Clay</td><td>3</td></tr> <tr><td>Potential Eroded Volume Mean</td><td><21 y³</td><td>5</td></tr> <tr><td>Approach Slope Mean</td><td>2.1-4%</td><td>3</td></tr> <tr><td>Soil K Factor</td><td><0.20</td><td>5</td></tr> <tr><td>Upstream Rt Outlet</td><td>Bare soil</td><td>0</td></tr> <tr><td>Upstream Lt Outlet</td><td>Vegetated</td><td>1</td></tr> <tr><td>Upstream Rt Ditch</td><td>Bare soil</td><td>0</td></tr> <tr><td>Upstream Lt Ditch</td><td>Bare soil</td><td>0</td></tr> <tr><td>Downstream Rt Outlet</td><td>Vegetated</td><td>1</td></tr> <tr><td>Downstream Lt Outlet</td><td>Vegetated</td><td>1</td></tr> <tr><td>Downstream Rt Ditch</td><td>Bare soil</td><td>0</td></tr> <tr><td>Downstream Lt Ditch</td><td>Bare soil</td><td>0</td></tr> <tr><td>Outlet Total</td><td>Partially Improved Outlet System</td><td>3</td></tr> <tr><td>Ditches Total</td><td>Unimproved Drainage System</td><td>1</td></tr> <tr><td>SRI Total</td><td>Low Risk</td><td>50</td></tr> </tbody> </table>		Risk Factor	Ranking	Score	US Channel Morph	C	5	DS Channel Morph	C	5	DS Bank Alteration	NATURAL	5	Upstream Skew Angle	<5°	5	Crossing fill condition	Good/Vegetated	5	Inlet/Outlet Condition	No Impairment	5	Road Approach Material	All Sand/Clay	3	Potential Eroded Volume Mean	<21 y ³	5	Approach Slope Mean	2.1-4%	3	Soil K Factor	<0.20	5	Upstream Rt Outlet	Bare soil	0	Upstream Lt Outlet	Vegetated	1	Upstream Rt Ditch	Bare soil	0	Upstream Lt Ditch	Bare soil	0	Downstream Rt Outlet	Vegetated	1	Downstream Lt Outlet	Vegetated	1	Downstream Rt Ditch	Bare soil	0	Downstream Lt Ditch	Bare soil	0	Outlet Total	Partially Improved Outlet System	3	Ditches Total	Unimproved Drainage System	1	SRI Total	Low Risk	50

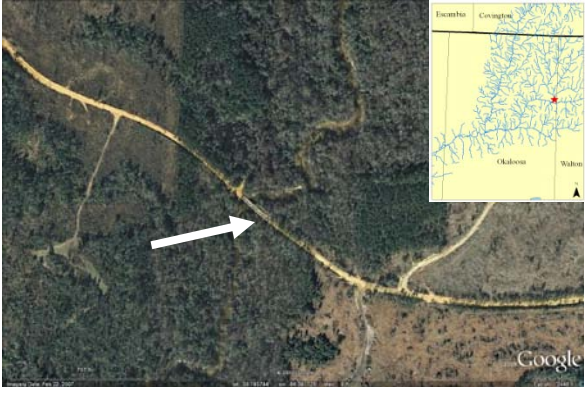
Notes: Small foot path DS Lt floodplain.
