Unnamed tributary		wa-0626-r-006	Sedimentation Risk Index 46																																																																		
<u>Common:</u> 5.1mi SE of Florala <u>Drainage:</u> Long Creek <u>GPS:</u> 30.941142, -86.284550 <u>Land owner:</u> Carla Bent-US, Adrian Geoghagan-DS		<u>County:</u> Walton <u>State:</u> Florida <u>PLSS(T-R-S):</u> 5N-20-07/18 <u>Parcel No.:</u> 2.5, 4 <u>Road Name:</u> Jackson Rd

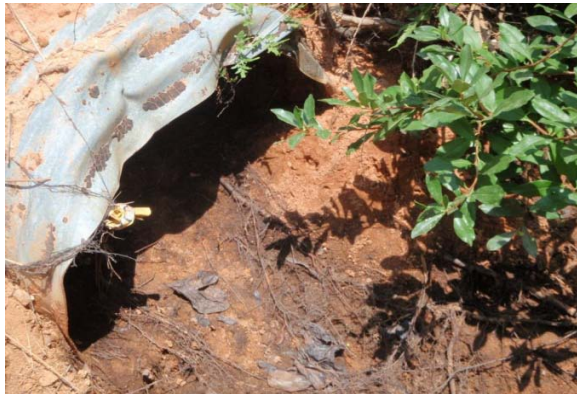
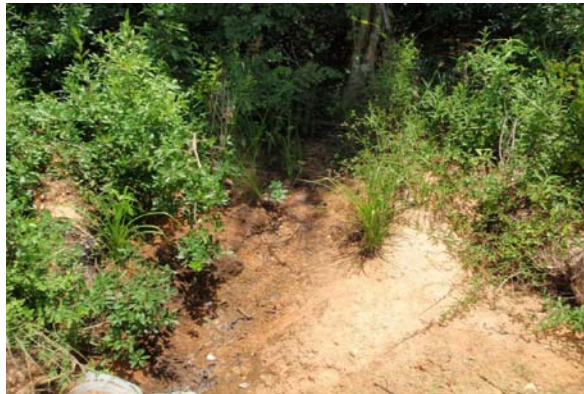
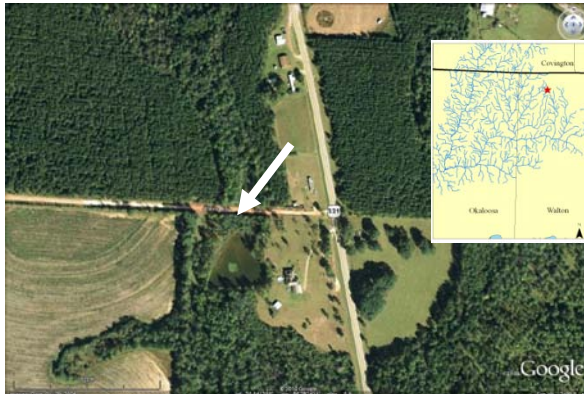
Crossing Structure: DS		DS																																																																			
<table border="1"> <thead> <tr> <th>Risk Factor</th> <th>Ranking</th> <th>Score</th> </tr> </thead> <tbody> <tr><td>US Channel Morph</td><td>C</td><td>5</td></tr> <tr><td>DS Channel Morph</td><td>PONDED</td><td>1</td></tr> <tr><td>DS Bank Alteration</td><td>MINOR/PARTIAL</td><td>3</td></tr> <tr><td>Upstream Skew Angle</td><td><5°</td><td>5</td></tr> <tr><td>Crossing fill condition</td><td>Poor/Bare soil</td><td>1</td></tr> <tr><td>Inlet/Outlet Condition</td><td>No Impairment</td><td>5</td></tr> <tr><td>Road Approach Material</td><td>All Sand/Clay</td><td>3</td></tr> <tr><td>Potential Eroded Volume Mean</td><td><21 y³</td><td>5</td></tr> <tr><td>Approach Slope Mean</td><td><2%</td><td>5</td></tr> <tr><td>Soil K Factor</td><td><0.20</td><td>5</td></tr> <tr><td>Upstream Rt Outlet</td><td>Vegetated</td><td>1</td></tr> <tr><td>Upstream Lt Outlet</td><td>Vegetated</td><td>1</td></tr> <tr><td>Upstream Rt Ditch</td><td>Vegetated</td><td>1</td></tr> <tr><td>Upstream Lt Ditch</td><td>Bare soil</td><td>0</td></tr> <tr><td>Downstream Rt Outlet</td><td>Vegetated</td><td>1</td></tr> <tr><td>Downstream Lt Outlet</td><td>Vegetated</td><td>1</td></tr> <tr><td>Downstream Rt Ditch</td><td>Vegetated</td><td>1</td></tr> <tr><td>Downstream Lt Ditch</td><td>Bare soil</td><td>0</td></tr> <tr><td>Outlet Total</td><td>Improved Outlet System</td><td>5</td></tr> <tr><td>Ditches Total</td><td>Partially Improved Drainage System</td><td>3</td></tr> <tr><td>SRI Total</td><td>Low Risk</td><td>46</td></tr> </tbody> </table>		Risk Factor	Ranking	Score	US Channel Morph	C	5	DS Channel Morph	PONDED	1	DS Bank Alteration	MINOR/PARTIAL	3	Upstream Skew Angle	<5°	5	Crossing fill condition	Poor/Bare soil	1	Inlet/Outlet Condition	No Impairment	5	Road Approach Material	All Sand/Clay	3	Potential Eroded Volume Mean	<21 y ³	5	Approach Slope Mean	<2%	5	Soil K Factor	<0.20	5	Upstream Rt Outlet	Vegetated	1	Upstream Lt Outlet	Vegetated	1	Upstream Rt Ditch	Vegetated	1	Upstream Lt Ditch	Bare soil	0	Downstream Rt Outlet	Vegetated	1	Downstream Lt Outlet	Vegetated	1	Downstream Rt Ditch	Vegetated	1	Downstream Lt Ditch	Bare soil	0	Outlet Total	Improved Outlet System	5	Ditches Total	Partially Improved Drainage System	3	SRI Total	Low Risk	46

Risk Factor	Ranking	Score																																																																			
US Channel Morph	C	5																																																																			
DS Channel Morph	PONDED	1																																																																			
DS Bank Alteration	MINOR/PARTIAL	3																																																																			
Upstream Skew Angle	<5°	5																																																																			
Crossing fill condition	Poor/Bare soil	1																																																																			
Inlet/Outlet Condition	No Impairment	5																																																																			
Road Approach Material	All Sand/Clay	3																																																																			
Potential Eroded Volume Mean	<21 y ³	5																																																																			
Approach Slope Mean	<2%	5

Soil K Factor	<0.20	5																																																																			
Upstream Rt Outlet	Vegetated	1																																																																			
Upstream Lt Outlet	Vegetated	1																																																																			
Upstream Rt Ditch	Vegetated	1																																																																			
Upstream Lt Ditch	Bare soil	0																																																																			
Downstream Rt Outlet	Vegetated	1																																																																			
Downstream Lt Outlet	Vegetated	1																																																																			
Downstream Rt Ditch	Vegetated	1																																																																			
Downstream Lt Ditch	Bare soil	0																																																																			
Outlet Total	Improved Outlet System	5

Notes: Lt approach partially paved. Sanded over.
