Unnamed tributary		co-0901-r-003	Sedimentation Risk Index 46																																																																		
<u>Common:</u> 7.8mi SE of Andalusia <u>Drainage:</u> Poplar Creek <u>GPS:</u> 31.201271576, -86.441651591 <u>Land owner:</u> David Sightler - US, Howard Sightler-DS		<u>County:</u> Covington <u>State:</u> Alabama <u>PLSS (T-R-S):</u> 3N-16E-27 <u>Parcel No.:</u> 2; 4 <u>Road Name:</u> Wamblesville Rd

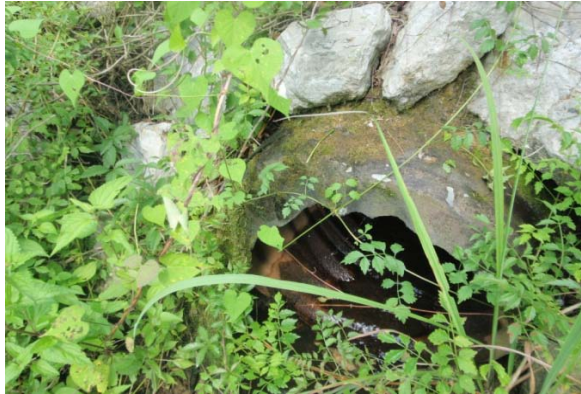
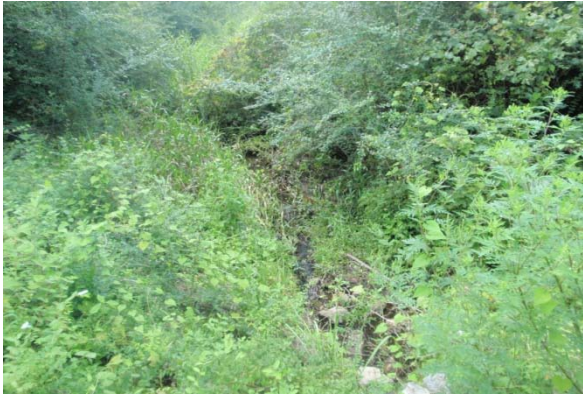
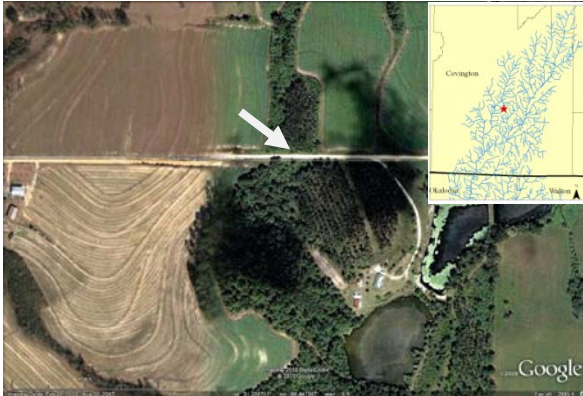
Crossing Structure: DS		DS																																																																			
<table border="1"> <thead> <tr> <th>Risk Factor</th> <th>Ranking</th> <th>Score</th> </tr> </thead> <tbody> <tr><td>US Channel Morph</td><td>C</td><td>5</td></tr> <tr><td>DS Channel Morph</td><td>E</td><td>5</td></tr> <tr><td>DS Bank Alteration</td><td>NATURAL</td><td>5</td></tr> <tr><td>Upstream Skew Angle</td><td>5-30°</td><td>3</td></tr> <tr><td>Crossing fill condition</td><td>Poor/Bare soil</td><td>1</td></tr> <tr><td>Inlet/Outlet Condition</td><td>Sed Islands/Scouring</td><td>3</td></tr> <tr><td>Road Approach Material</td><td>All Aggregate</td><td>5</td></tr> <tr><td>Potential Eroded Volume Mean</td><td><21 y³</td><td>5</td></tr> <tr><td>Approach Slope Mean</td><td>2.1-4%</td><td>3</td></tr> <tr><td>Soil K Factor</td><td>0.21-0.40</td><td>3</td></tr> <tr><td>Upstream Rt Outlet</td><td>Vegetated</td><td>1</td></tr> <tr><td>Upstream Lt Outlet</td><td>Vegetated</td><td>1</td></tr> <tr><td>Upstream Rt Ditch</td><td>Bare soil</td><td>0</td></tr> <tr><td>Upstream Lt Ditch</td><td>Vegetated</td><td>1</td></tr> <tr><td>Downstream Rt Outlet</td><td>Vegetated</td><td>1</td></tr> <tr><td>Downstream Lt Outlet</td><td>Vegetated</td><td>1</td></tr> <tr><td>Downstream Rt Ditch</td><td>Bare soil</td><td>0</td></tr> <tr><td>Downstream Lt Ditch</td><td>Bare soil</td><td>0</td></tr> <tr><td>Outlet Total</td><td>Improved Outlet System</td><td>5</td></tr> <tr><td>Ditches Total</td><td>Partially Improved Drainage System</td><td>3</td></tr> <tr><td>SRI Total</td><td>Low Risk</td><td>46</td></tr> </tbody> </table>		Risk Factor	Ranking	Score	US Channel Morph	C	5	DS Channel Morph	E	5	DS Bank Alteration	NATURAL	5	Upstream Skew Angle	5-30°	3	Crossing fill condition	Poor/Bare soil	1	Inlet/Outlet Condition	Sed Islands/Scouring	3	Road Approach Material	All Aggregate	5	Potential Eroded Volume Mean	<21 y ³	5	Approach Slope Mean	2.1-4%	3	Soil K Factor	0.21-0.40	3	Upstream Rt Outlet	Vegetated	1	Upstream Lt Outlet	Vegetated	1	Upstream Rt Ditch	Bare soil	0	Upstream Lt Ditch	Vegetated	1	Downstream Rt Outlet	Vegetated	1	Downstream Lt Outlet	Vegetated	1	Downstream Rt Ditch	Bare soil	0	Downstream Lt Ditch	Bare soil	0	Outlet Total	Improved Outlet System	5	Ditches Total	Partially Improved Drainage System	3	SRI Total	Low Risk	46
