Project 2

FYS5555

Furkan Kaya

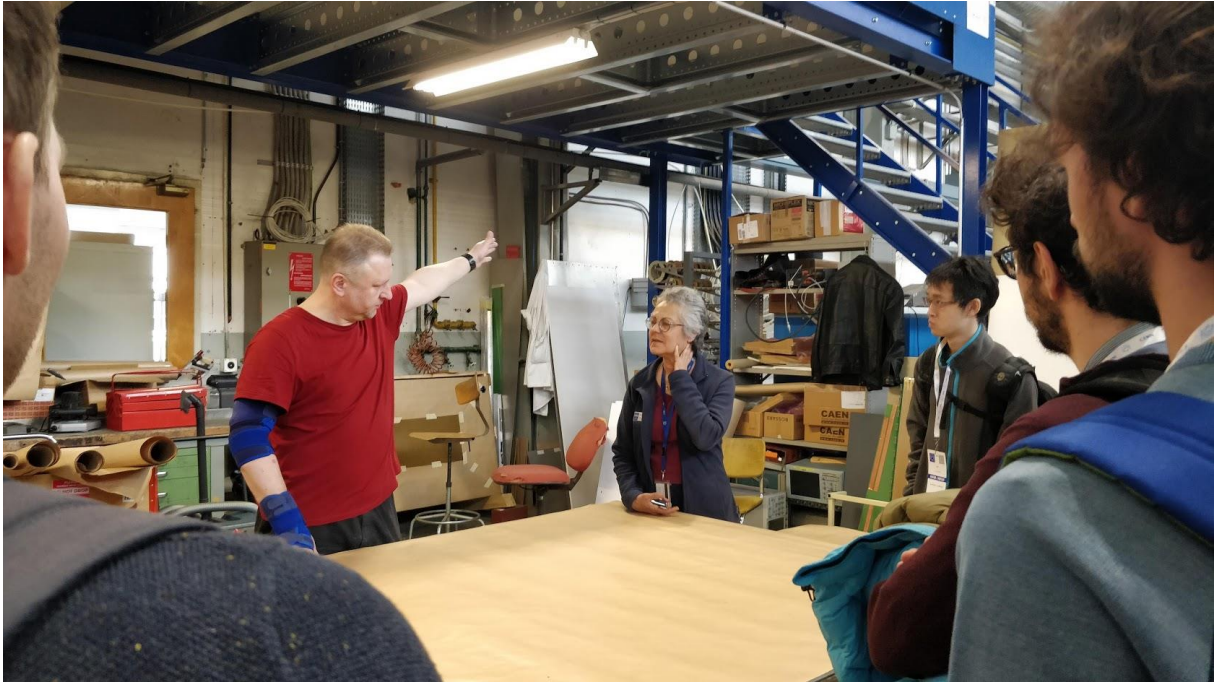
A metal-plate is placed on a table and cleaned by applying ethanol and using paper wipes. This involved a special wiping technique where one wipes to the sides firmly. Then a large, thin layer of Styrofoam was placed on top of the metal plate. Two aluminium metal rectangular shaped rods were bolted on the shorter side of the plate manually. How firm the screws were fixed was double checked manually. Then some glue was applied on these,

Figure 6: Image shows the mechanical engineering room with the engineer responsible for the work, Roman, and D. Hatzifoutiadou. Image at the courtesy of Eirik Sæther Hatlen

before two new aluminium rods were placed on the longer side. It should also be mentioned that the rods on the short side had electronic circuitry on them.

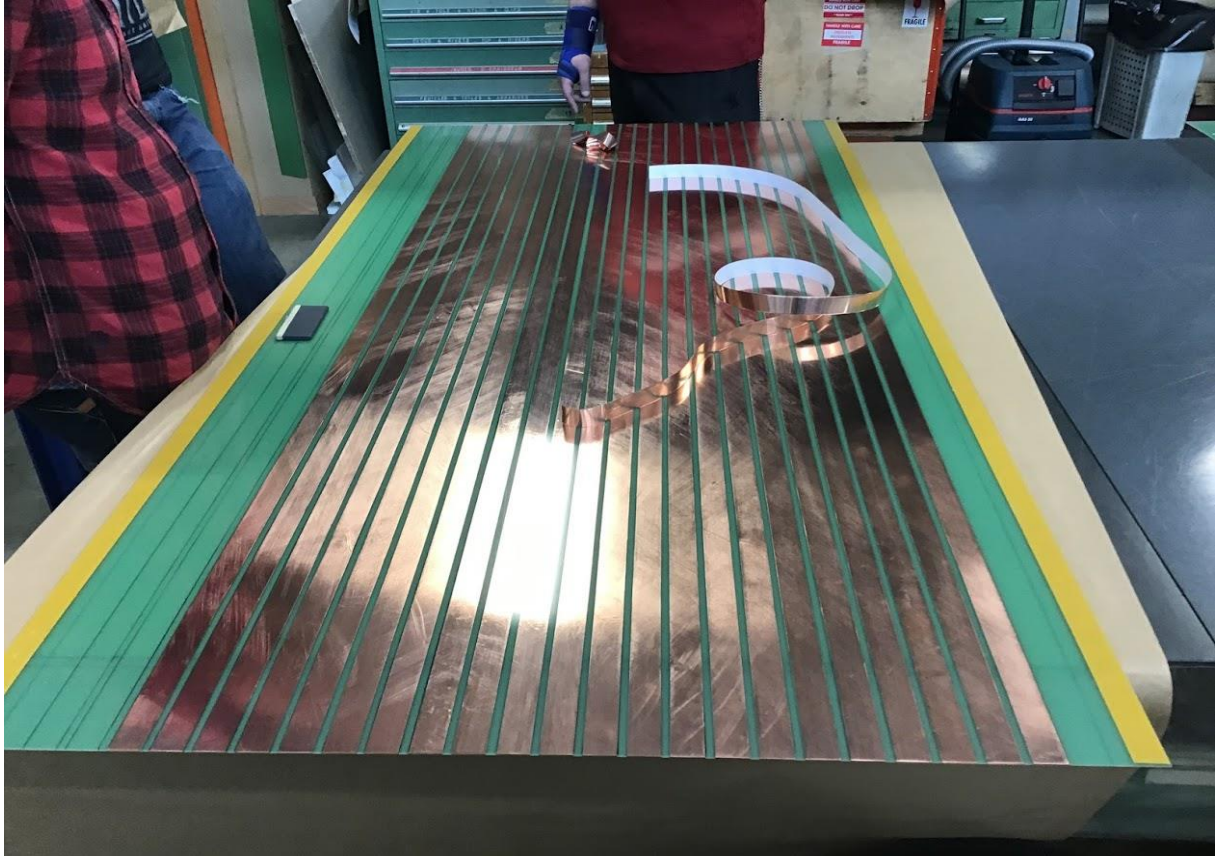
*Figure 8: Schematic shows the copper strips being put on the honeycomb panel. Image at the courtesy of Federico Nardi*

24 copper strips were placed on the two honeycombs after a meticulous process. First their lanes were drawn on. The drawing was required to be very precise, meaning at the millimetre scale. Then the strips were placed on the two panels (see figure 8). It was required that this work was done with a partner.

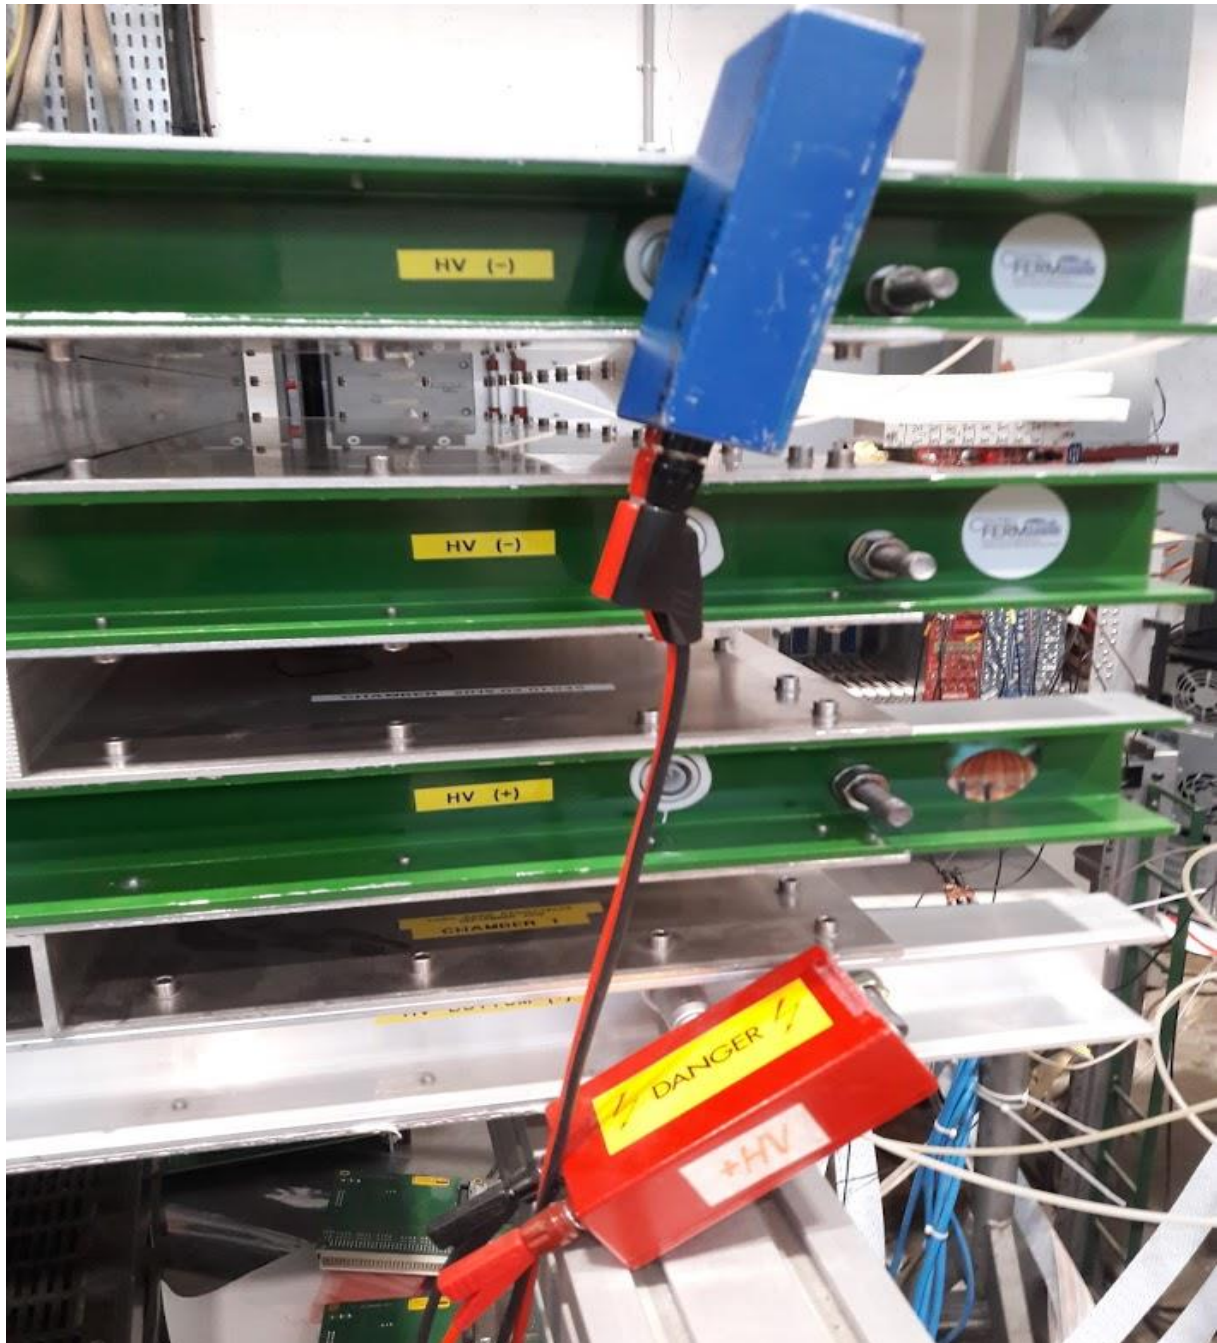
Figure 9: Image shows the setup of the chambers, each green part with the designation HV(+ or -) is a chamber. Image at the courtesy of Olav Grønbech

The work began with adjusting the voltage across the system. The value given at the generator had to be multiplied with a factor of 2000, meaning that the groups had to work with voltages in the kV-range. The voltage interval was increased with 0.5 kV for each read. There was a desired voltage, beginning at 12 kV that was to be compared with the voltage at HV+ and HV- (HV+ and HV- must be added together).

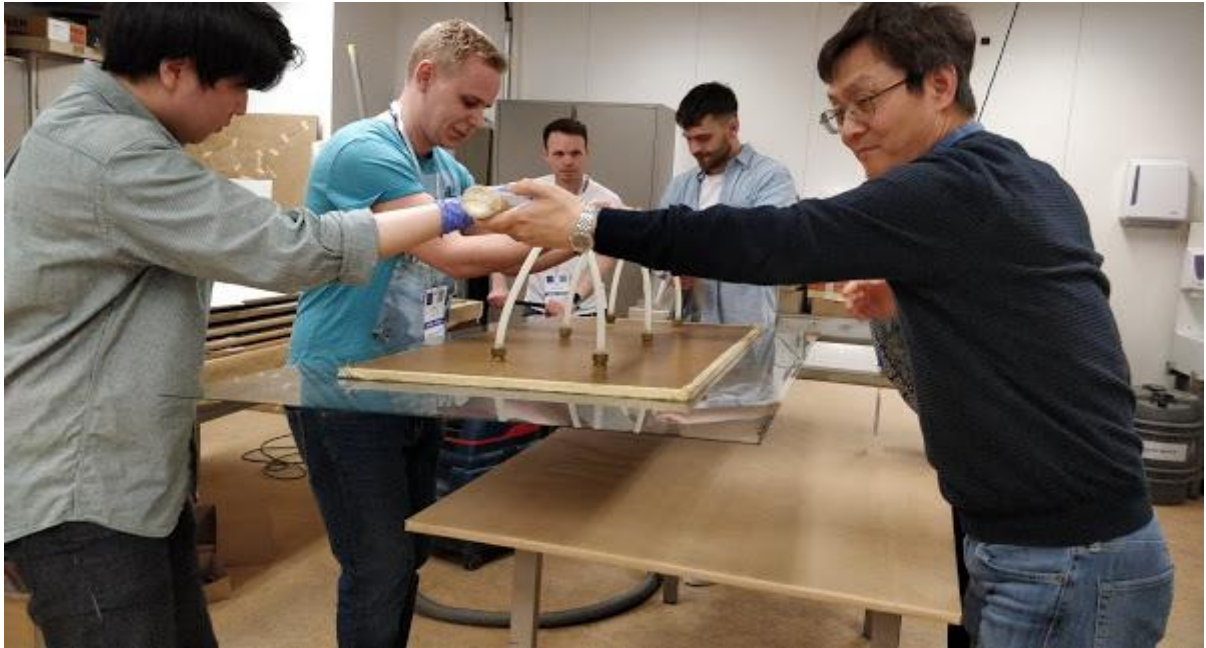
Figure 11: Image shows lifting of glass by the use of vacuum. Image at the courtesy of Eirik Sæther Hatlen

The glass was put on by lifting it with the use of vacuum.

Figure 11 shows how this was done. It required manpower and a vacuum machine. This part of the work was preceded by the placing nylon fishing lines in order to create a gap. For the entire detector there was a need for 6 gaps and therefore several glass stacked on top of each other.

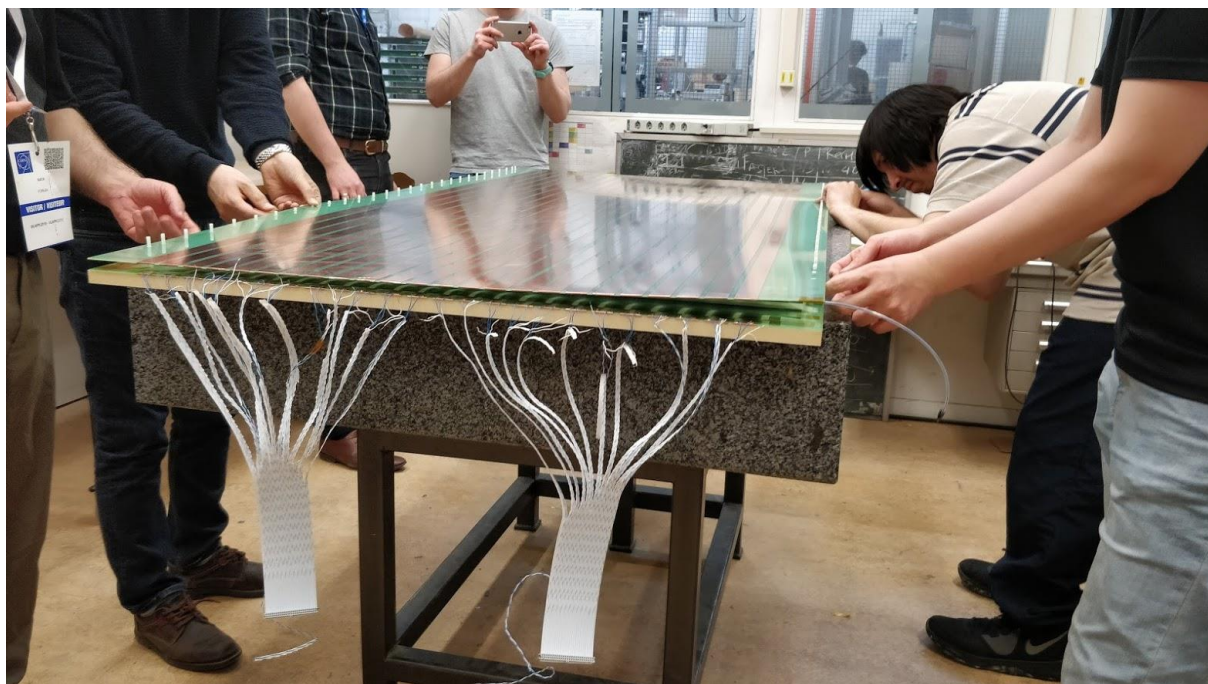
Figure 13: Image shows the soldering of wires to Copper. Image at the courtesy of Eirik Sæther Hatlen

After this part, soldering followed to connect wires to the Copper. The final product is seen on figure 13.

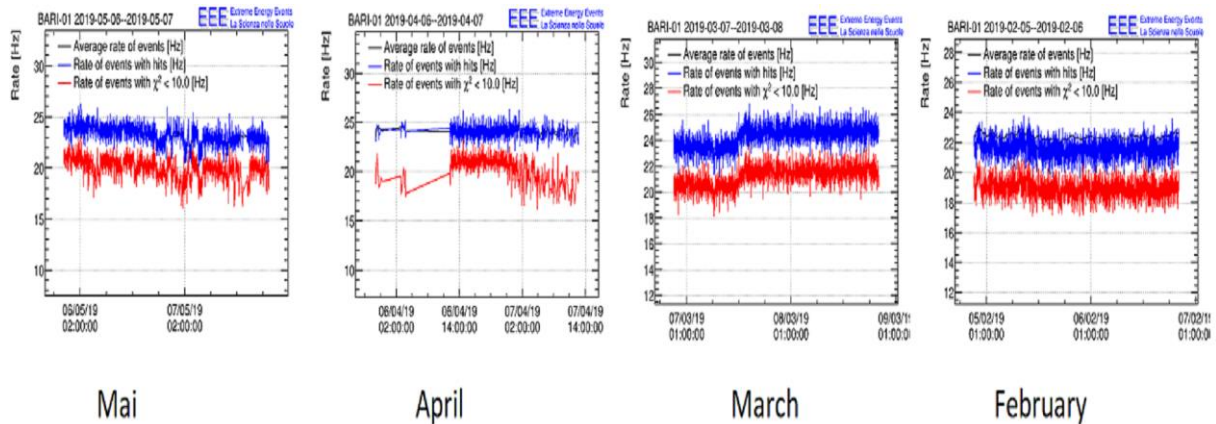
Figure 16: Schematic from the high school in Bari. Black = average rate of events, Blue = rate of events with hits, Red = Rate of events with  $\chi^2 < 10.0$ . [5]

Figure 16 shows the number of events and hits for the last 4 months (to February).
