Diablo Model 31, G5, serial number 28685/1440, Restoration Notes

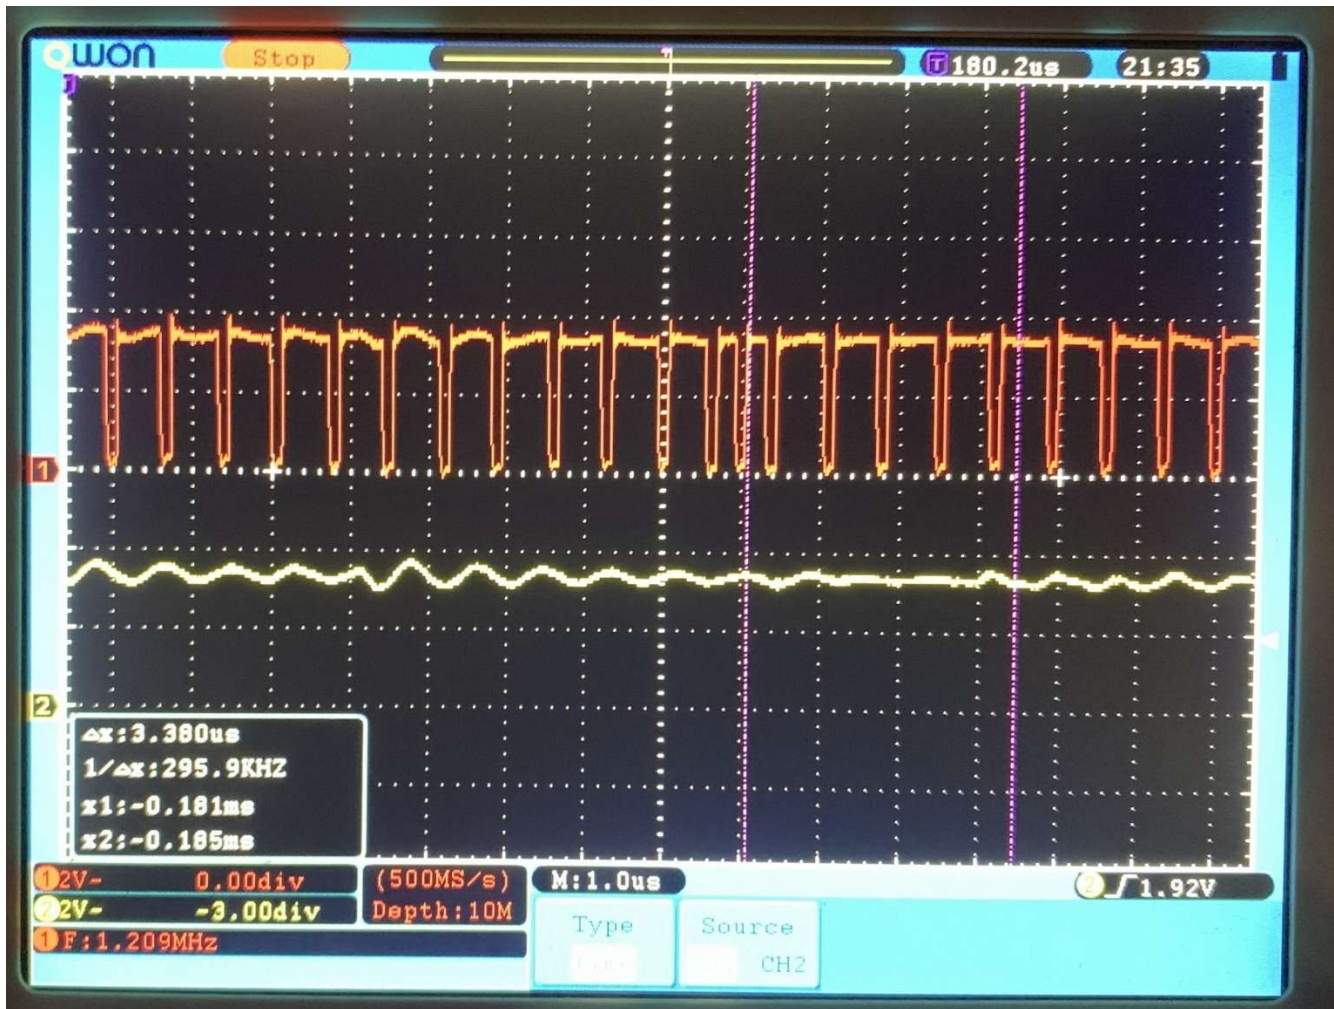
Read Clock is CH1 and Read Data is CH2. It appears that the data pulses are still present in the read clock, and data isn't being separated onto Read Data as it should be. The bit rate appears to be about 1.44 Mbps.

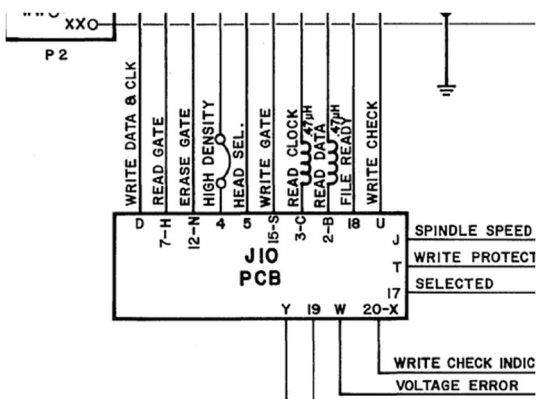
Trace Read Clock back from J10-3-C and Read Data back from J10-2-B.

On J10, TP3 looks like red trace above; TP4 always high; TP5 always low

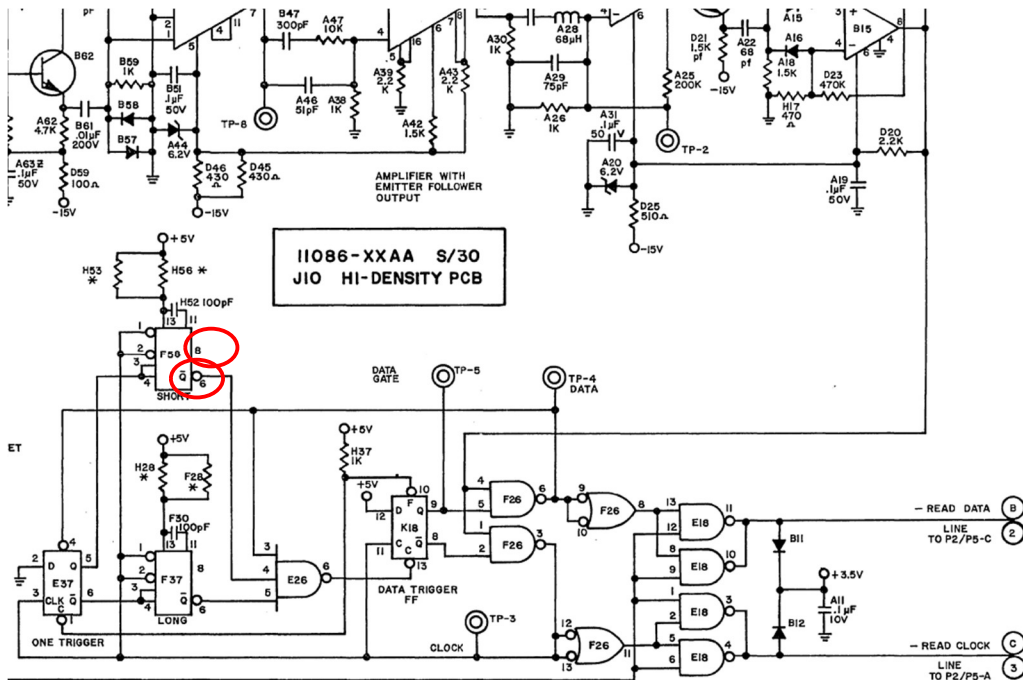
The schematic of the data recovery circuit on J10:

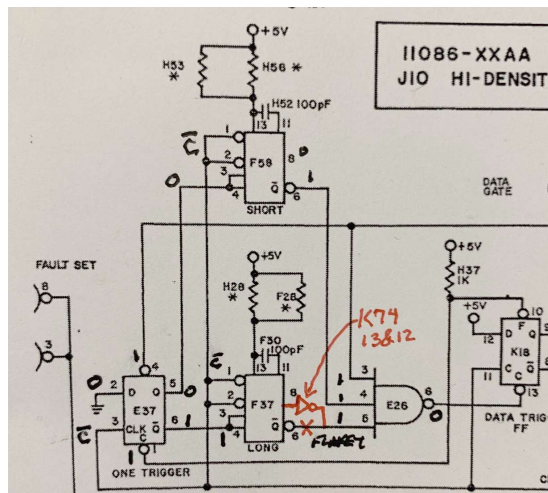
Since the Q-bar output seems defective, a temporary fix is to connect an unused inverter to the Q output of F37 (pin 8), and connect the output of that inverter to E26 pin 5:

Cut the leg of F37 pin 6, the Q-bar output of the DM8601 retriggerable one-shot. Connected a jumper from F37 pin 8 (the Q output of the one-shot) to K74 pin 13 (input of the spare inverter). Connected a second jumper from K74 pin 12 (output of the spare inverter) to the pad beneath F37 pin 6 (where the Q-bar output of the one-shot was connected before the pin was cut). This is a temporary work-around until the replacment DM8601 arrives.

Still need to properly repair the board in J10. A pair of DM8601 one-shot ICs are on order. Need to replace the one at location F37 on the J10 board and remove the temporary jumpers.
