## Diablo Model 31, G5, serial number 28685/1440, Restoration Notes

### Restoration list:

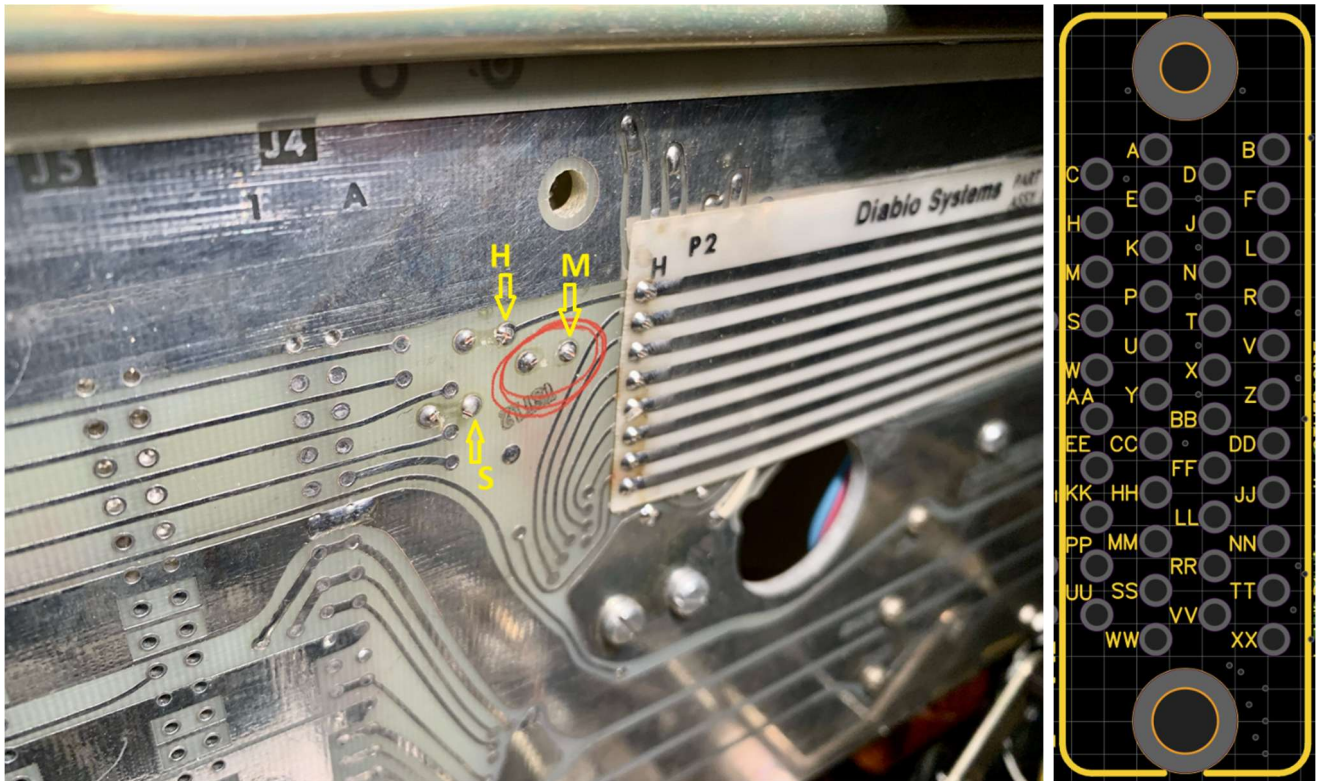
There's a problem with the "High Density Indication" signal on pin M, it's inactive when the drive is spun up and drive is selected. Traced it back to the module in J10 where I can see that "High Density Indication" is active. The schematics show a jumper on the backplane. Found it!

The jumpers for the signals on MRAC pins H, M, and S were apparently removed by the previous owner.

- H – “Write Protect Input”
- M – “High Density Indication”
- S – “Pseudo Sector Mark”

It's strange that the board in J10 is configured for high density but the backplane jumper for the “High Density Indication” signal is removed

Added the “High Density Indication” jumper on the backplane.

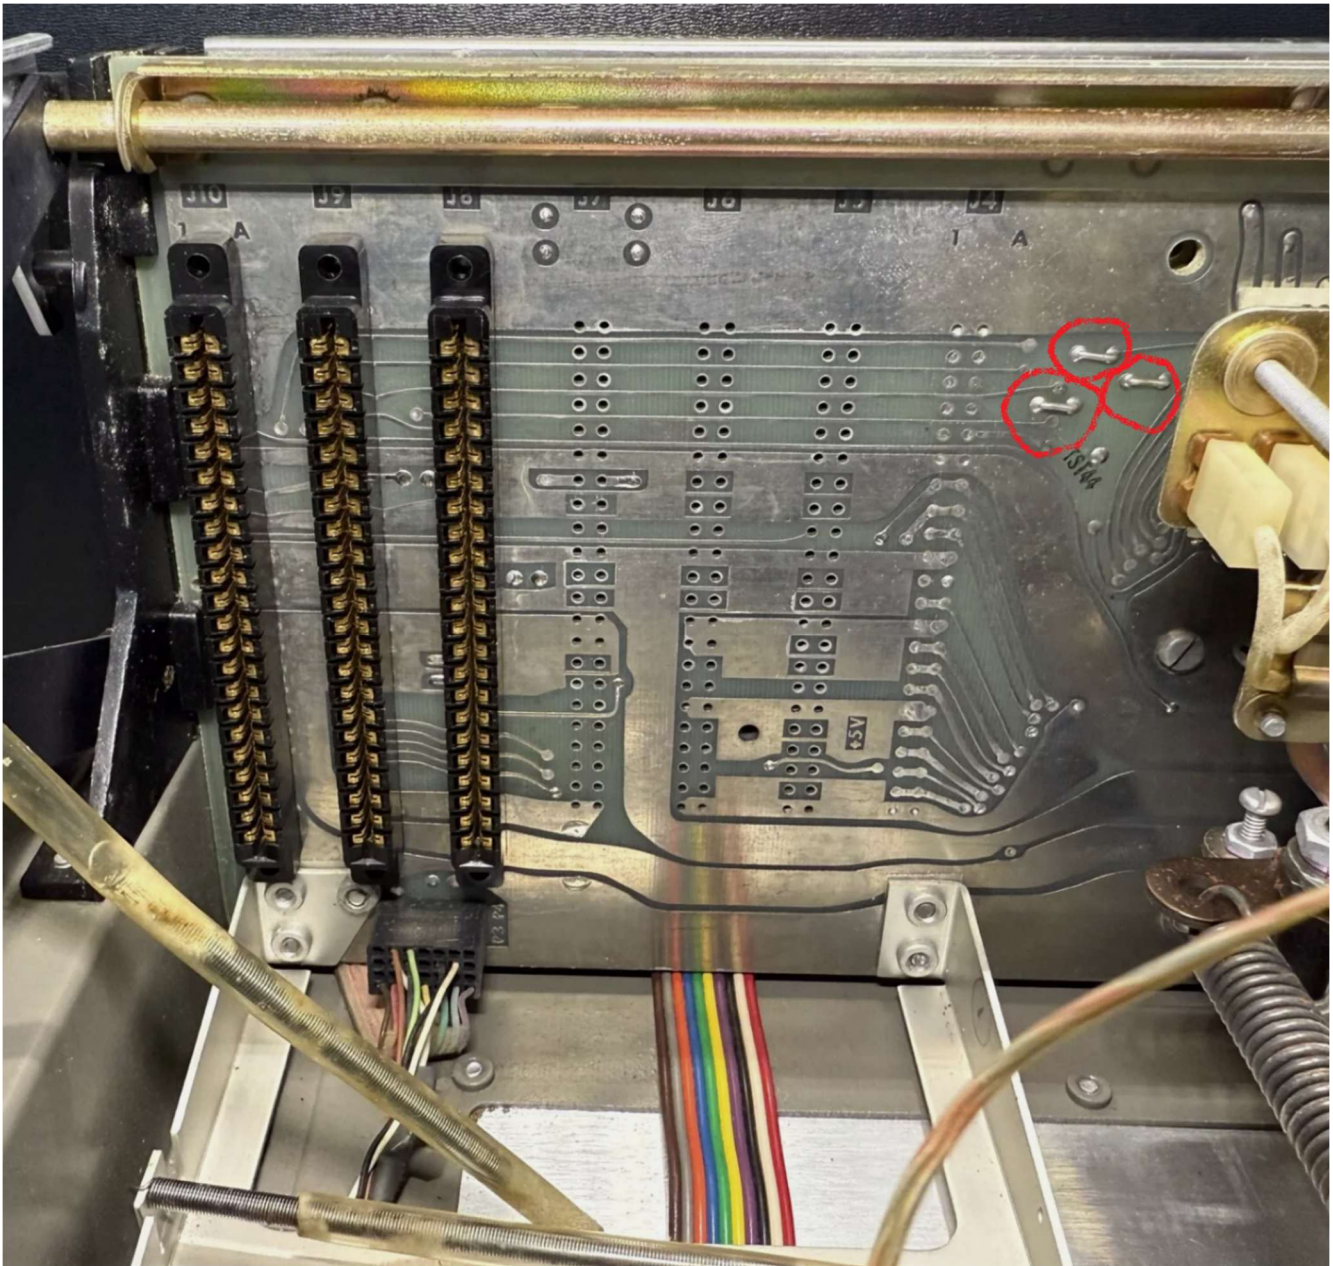
For example, this is another drive, photo captured from an eBay listing, that has all three jumpers installed:

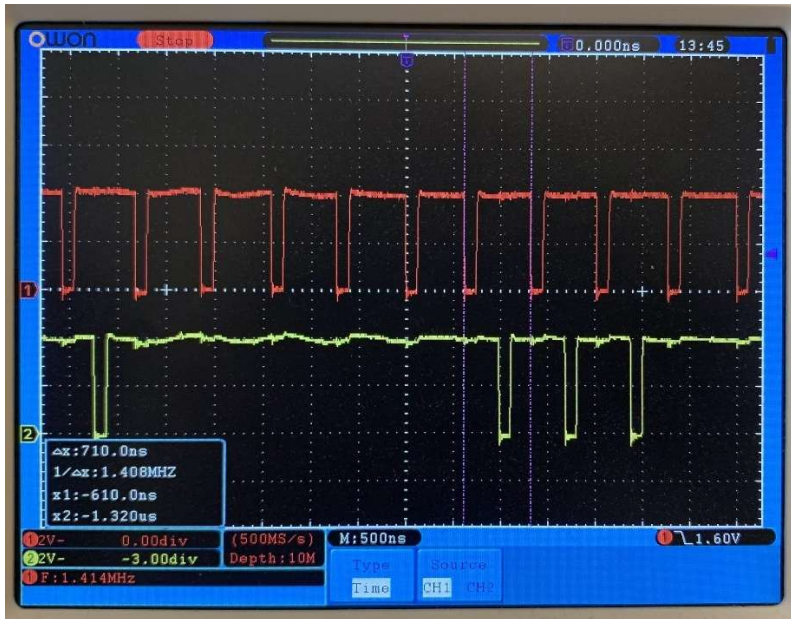
After this temporary fix, clock and data appear to be correct, with a stream of periodic clock pulses and data pulses that appear in the center between the clock pulses:

...and the data rate appears to be about 1.4 Mbps

Cut the leg of F37 pin 6, the Q-bar output of the DM8601 retriggerable one-shot. Connected a jumper from F37 pin 8 (the Q output of the one-shot) to K74 pin 13 (input of the spare inverter). Connected a second jumper from K74 pin 12 (output of the spare inverter) to the pad beneath F37 pin 6 (where the Q-bar output of the one-shot was connected before the pin was cut). This is a temporary work-around until the replacment DM8601 arrives.

Still need to properly repair the board in J10. A pair of DM8601 one-shot ICs are on order. Need to replace the one at location F37 on the J10 board and remove the temporary jumpers.

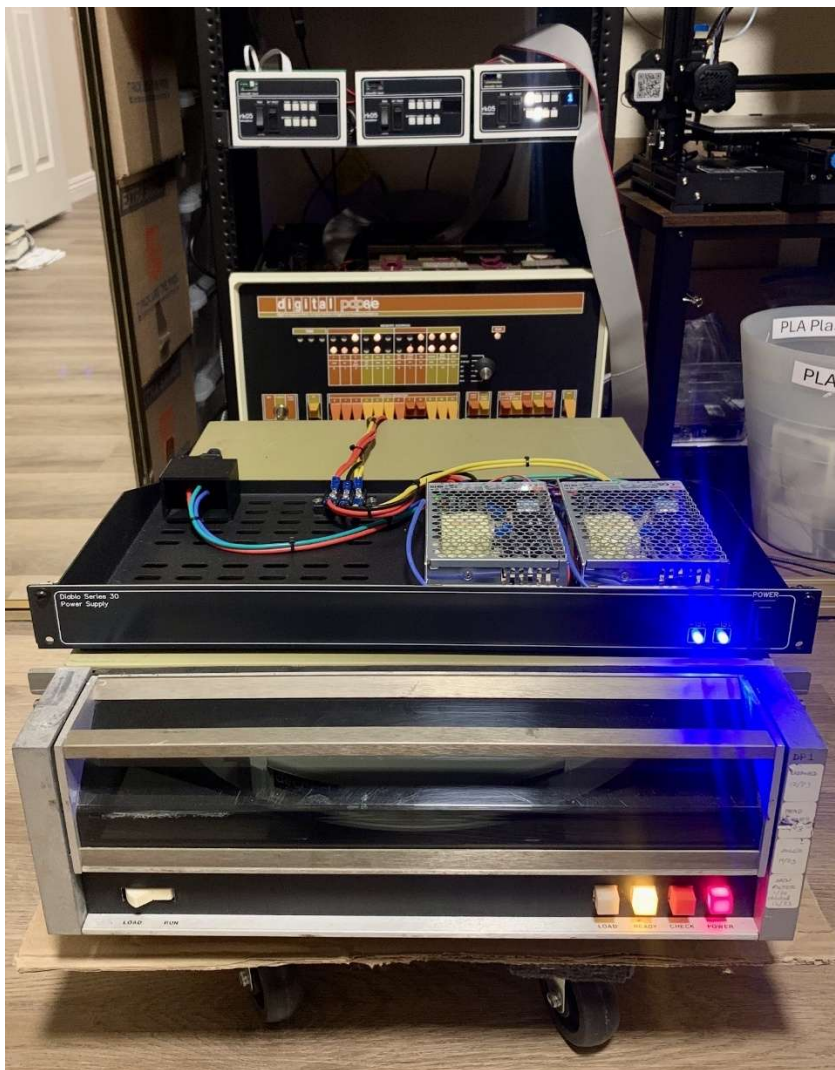
Then connected the Diablo drive to the PDP-8. Connected through the emulator on the right which is not loaded and set to drive 1. This emulator is only a pass-through for the disk signals. The Diablo drive is configured as drive 0. So, the Diablo is the only drive connected to the RK8-E controller in the PDP-8.

Was able to boot OS8 from the Diablo drive!
