## Vibration Bearing Data

### *Test Rig Setup*

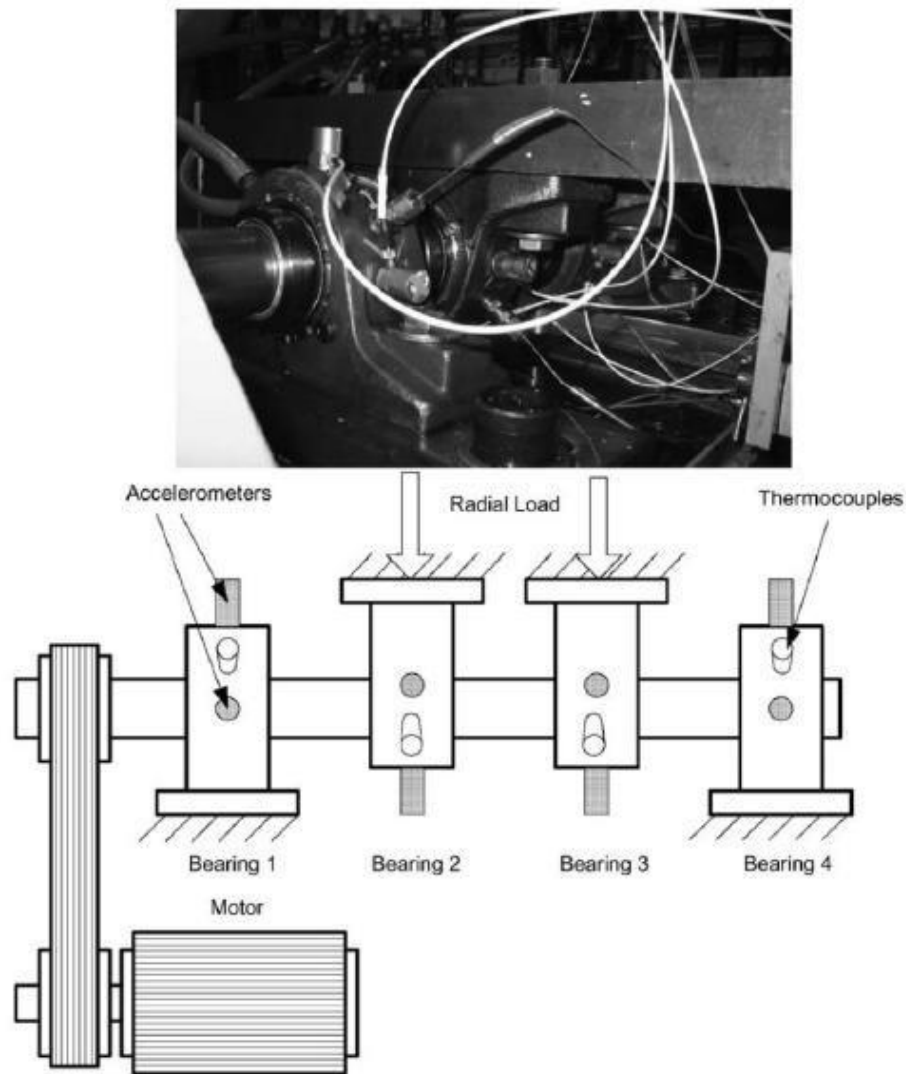
Rexnord ZA-2115 double row bearings were installed on the shaft as shown in Figure 1. PCB 353B33 High Sensitivity Quartz ICP accelerometers were installed on the bearing housing (two accelerometers for each bearing [x- and y-axes] for data set 1, one accelerometer for each bearing for data sets 2 and 3). Sensor placement is also shown in Figure 1. All failures occurred after exceeding designed life time of the bearing which is more than 100 million revolutions.

Four bearings were installed on a shaft. The rotation speed was kept constant at 2000 RPM by an AC motor coupled to the shaft via rub belts. A radial load of 6000 lbs is applied onto the shaft and bearing by a spring mechanism. All bearings are force lubricated.
