Variation analysis of leak  
value in the engine cylinder  
head sub-assembly.

- Our project focuses on proving the R&R value for the leak testing machine in Cell1 and Cell2 in machine shop as well as in Engine Assembly. It also deals with setting the specification in leak testing machines through various experiments.

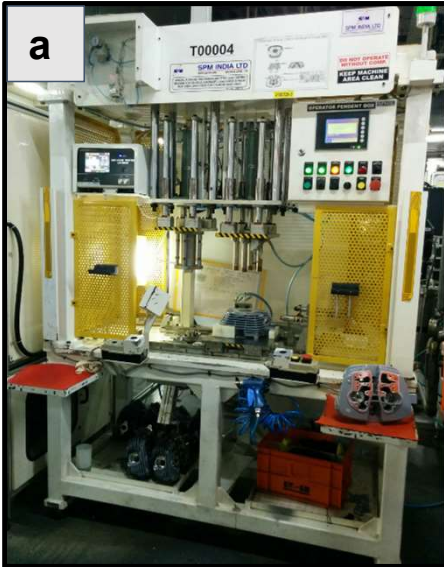
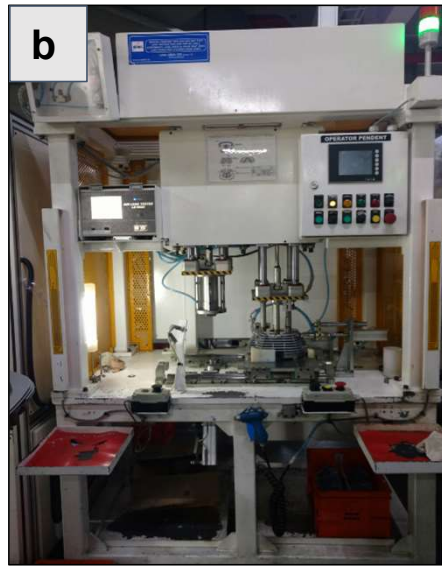
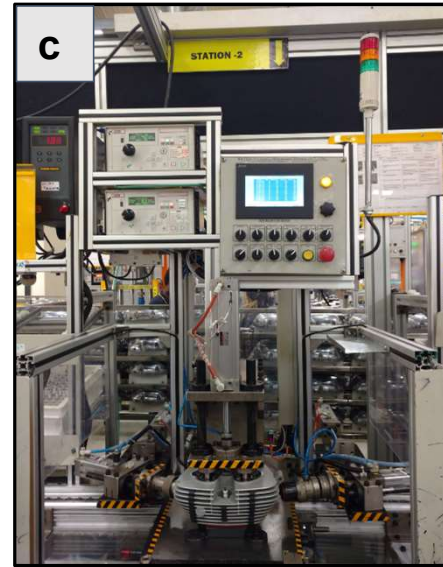
## Leak Testing Machines

a- Cell 1 Machine Shop

b- Cell 2 Machine Shop

C- Engine Assembly

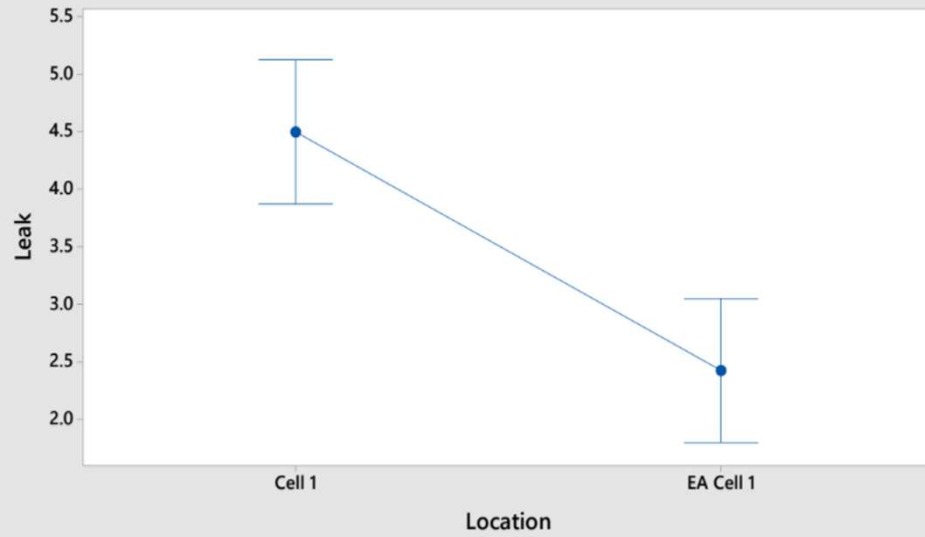
Interval Plot of Leak vs Location  
95% CI for the Mean

Source	DF	Adj SS	Adj MS	F-Value	P-Value
Location	1	215.0	215.01	21.33	0.000
Error	198	1995.9	10.08		
Total	199	2210.9

The pooled standard deviation is used to calculate the intervals.

After conducting the One-Way ANOVA for the cell data using Minitab, we find that the p value is very small, almost approximating to 0. Since  $0 < 0.05$  ( $\alpha$  value), we reject the null hypothesis and accept the alternate hypothesis that states that at least one mean is different.
