## Observed stream temperature, conductivity, and stage from the Koeve River, British Columbia between 2017 and 2020

*Methods and metadata for Koeve River sensor time-series version 1.0*

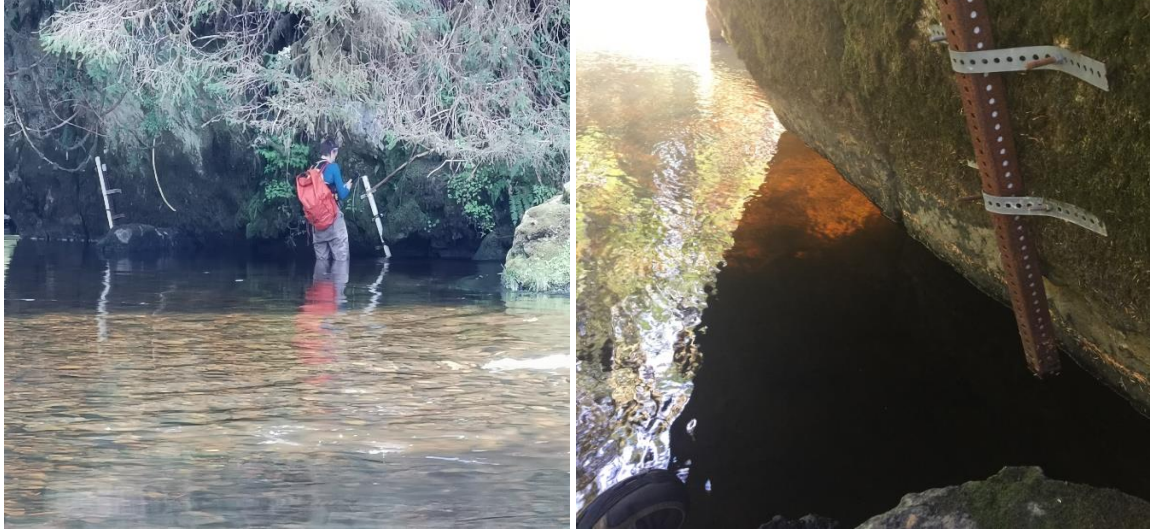
*Figure 1) Sensors located on river left with water level sensor 2m upstream (left) of the conductivity sensor (right).*

Both the stream stage (HOBO U20L-01) and conductivity (HOBO U24-001) sensors are mounted in separate installations that are side-by-side on river left, inside double-walled instrument housing, comprised of a PVC inner tube and surrounded by a rigid metal box-tube (Telespar). The housing is rigidly attached to exposed bedrock with metal strapping and anchor bolts (Figure 1). Atmospheric pressure (HOBO U20L-01) is measured directly across the river, on river right, and the sensor is housed in a 1.5 m length of slotted PVC pipe inserted 1 m into the ground (Figure 2).

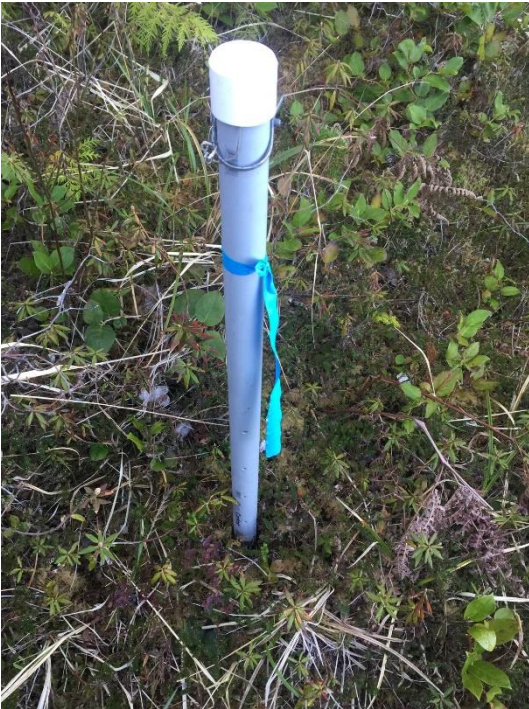
*Figure 2) Barometric pressure sensor in PVC housing 3 m inland on river right.*

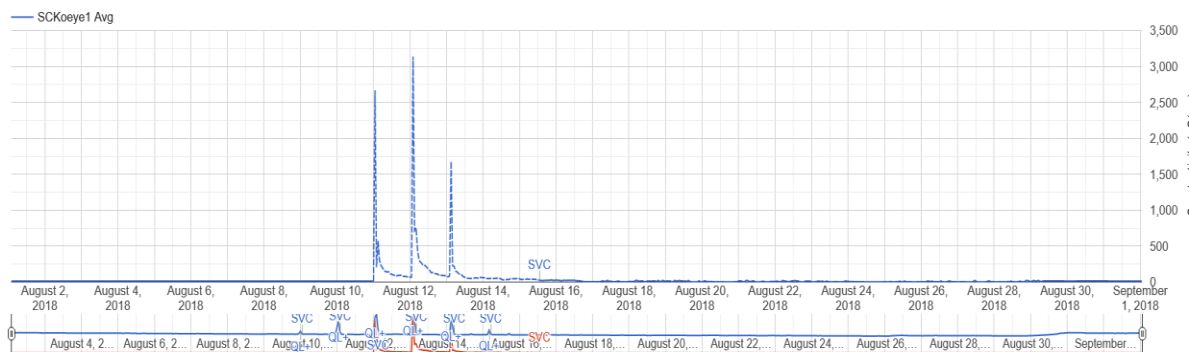
Figure 1: Instance of **Suspicious Value Caution** flagging at KR01 EC, likely attributed to tidal influence.

SCKoeye1	-Large tidal event Aug 2018 data affected	<ul style="list-style-type: none"> <li>• Data kept as spikes are likely due to tidal influence               <ul style="list-style-type: none"> <li>◦ Flagged as <b>SVC</b></li> </ul> </li> </ul>	<a href="#">SC</a>

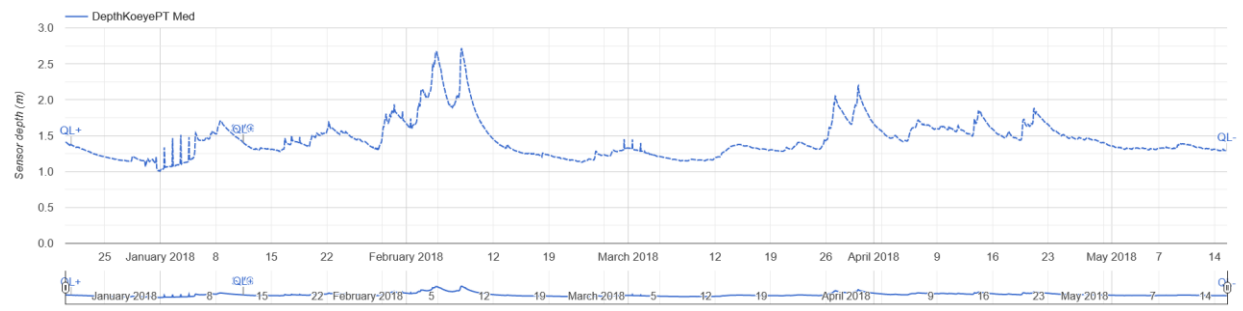
Figure 2: Example of **Estimated Value** flagging. This example highlights a time period where water level data was estimated due to a failing barometric pressure sensor.

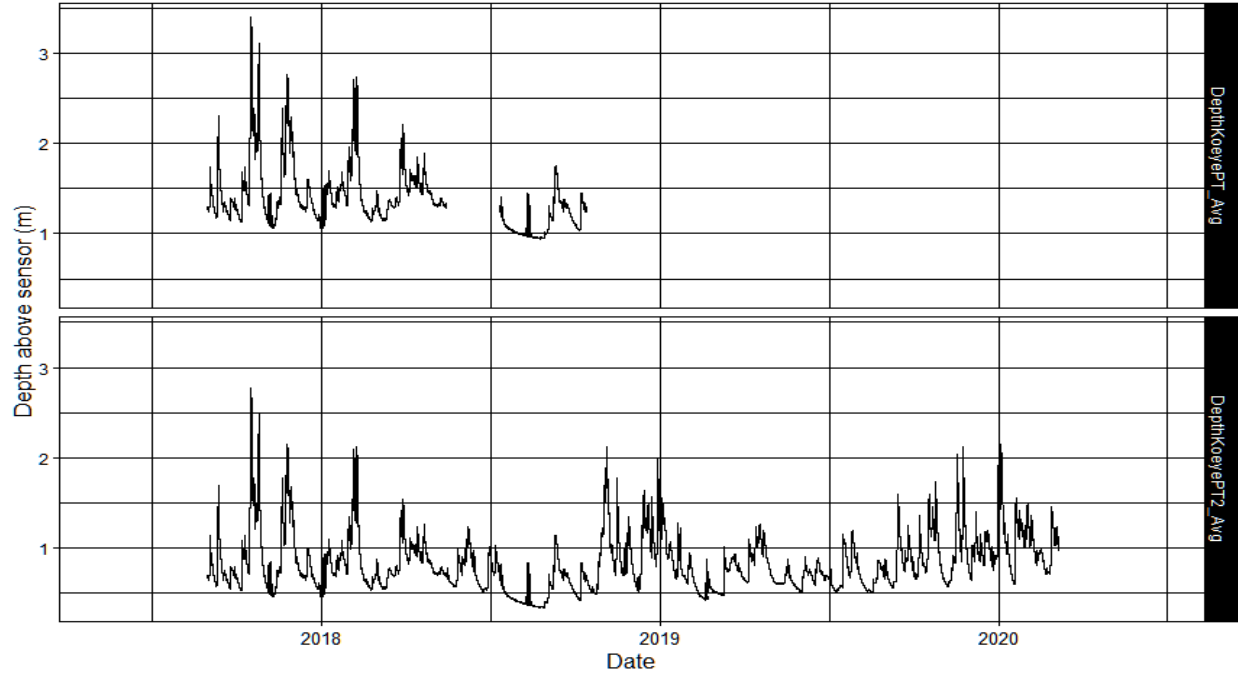
Figure 3) Water level time-series from both pressure transducer installations.

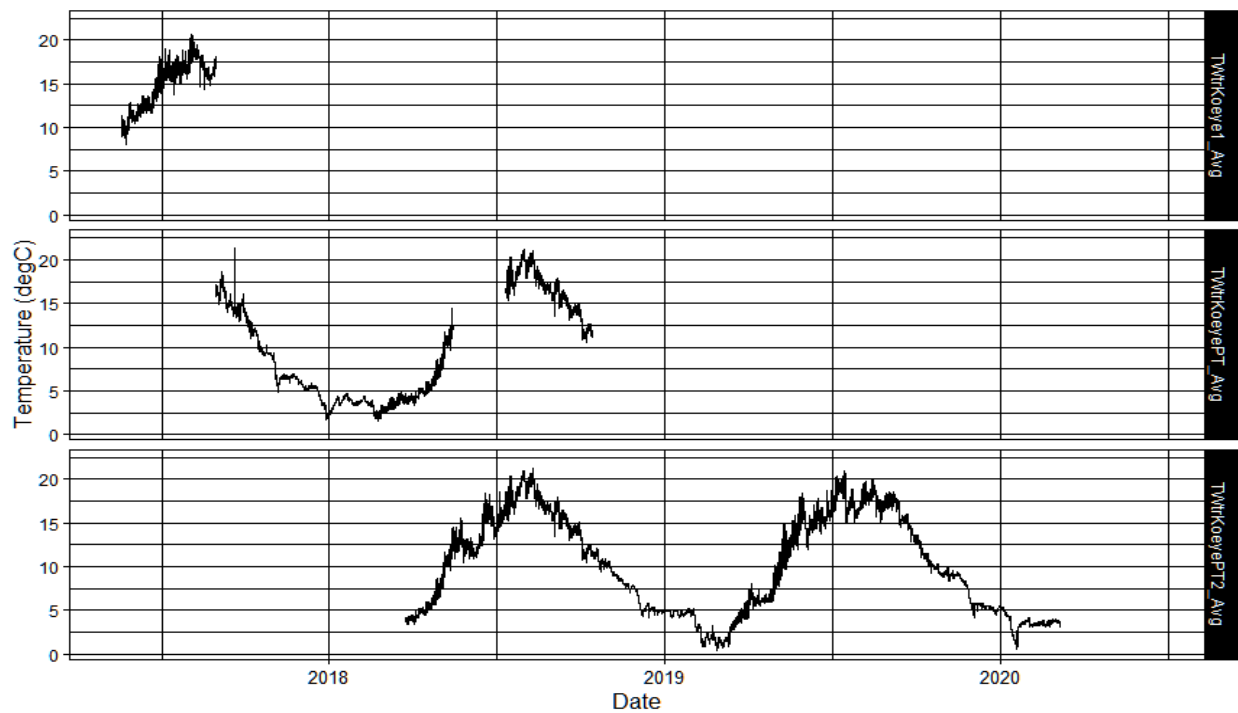
Figure 4) Water temperature time-series from the pressure transducer and conductivity sensors.

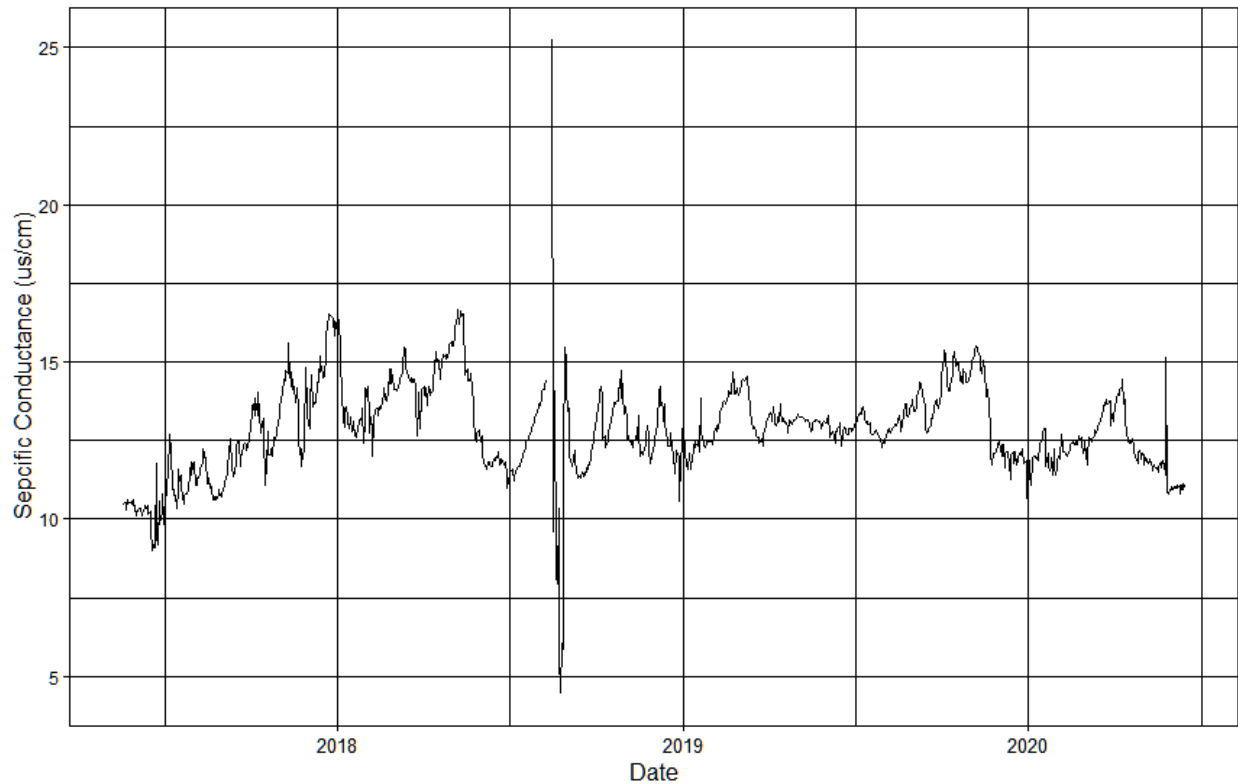
*Figure 5) Conductivity time-series data over the period of record. The fall 2018 spike coincides with a large tidal event and is likely indicative of salt wedge.*

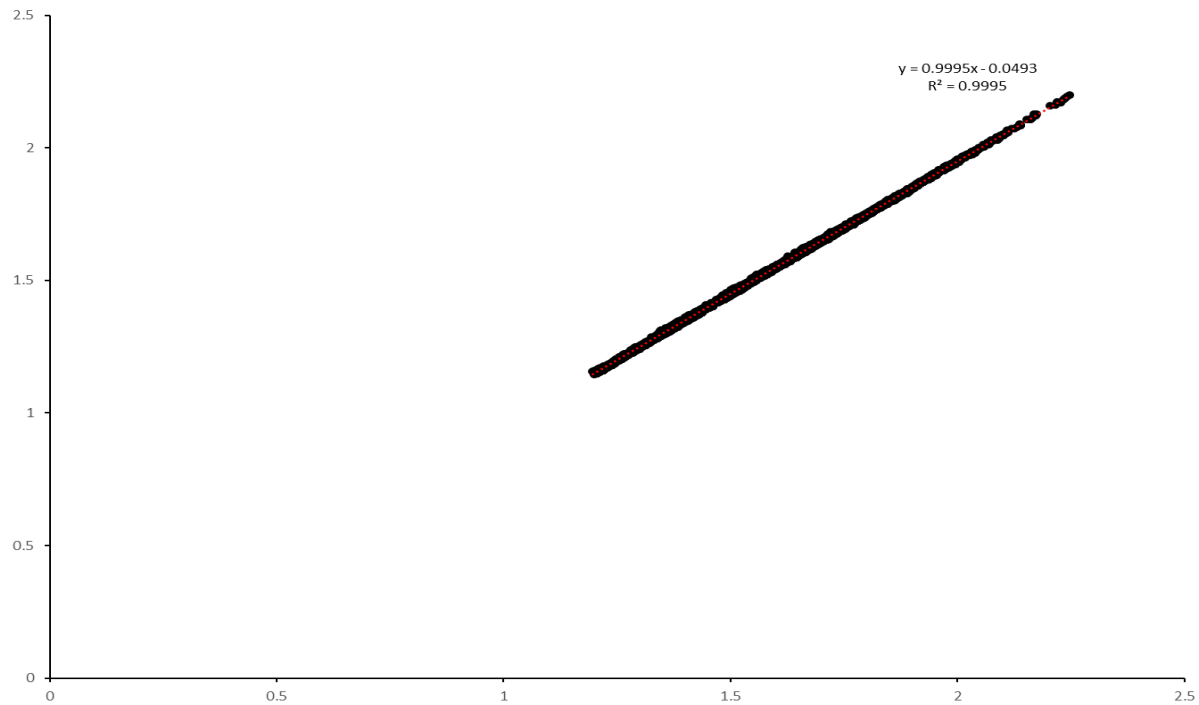
*Figure 6) Scatterplot illustrating relationship between the Koeve BaroP sensor and Koeve Stn Pres sensor. This relationship was used to gap-fill bad Koeve BaroP data. This data was then used for barometric compensation to derive the DepthKoevePT water level time-series.*

The barometric pressure sensor began intermittently malfunctioning in December 2017 likely caused due to ice build-up in the PVC housing. A second sensor (Koeve StnPres) was regressed with Koeve BaroP to develop a linear relationship (Figure 6) between the two sensors during overlapping periods when Koeve BaroP was functioning as expected (Figure 7). This relationship was used to gap-fill periods Koeve BaroP data was obviously bad. Koeve BaroP2 was installed in July 2018 to replace Koeve BaroP.

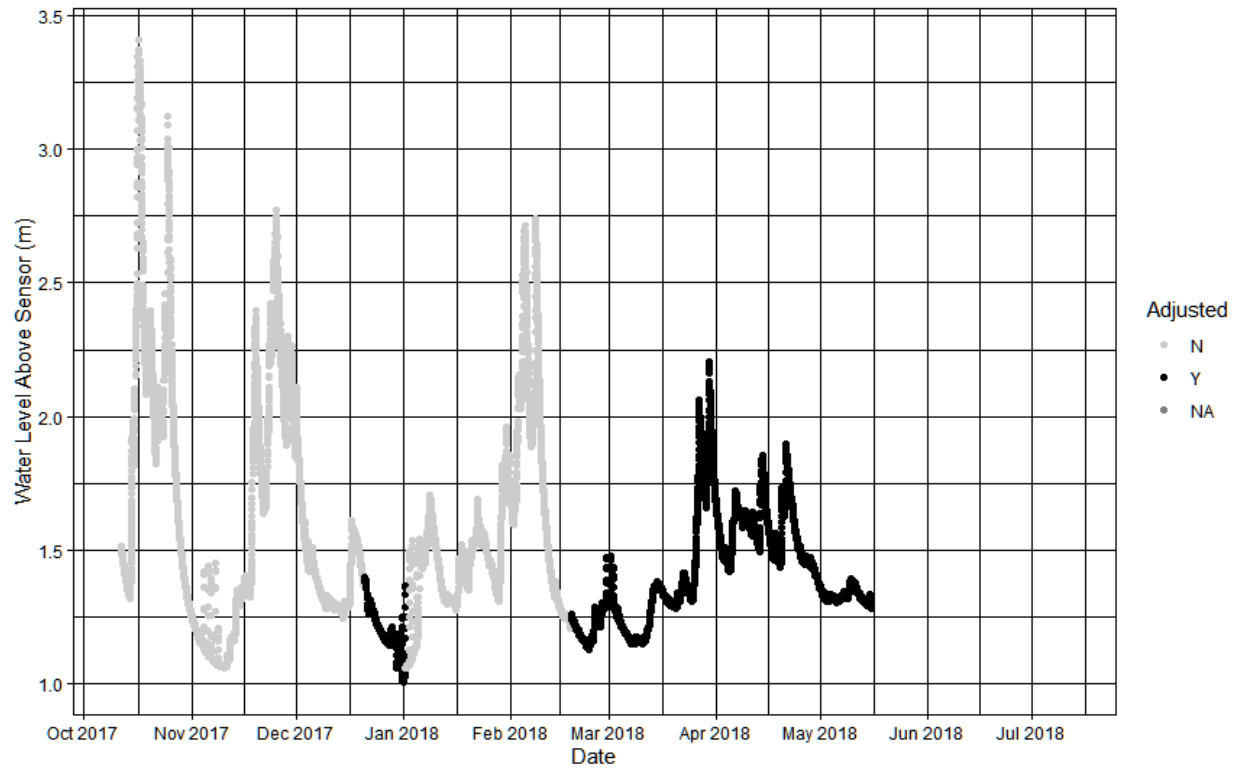
Figure 7) Scatterplot illustrating Koeye PT time-series. The series is colour coded to illustrate where barometric compensation was computed using the relationship between Koeye PT and KoeyeStnPres.
