AT MIDSOUTH, MEMPHIS, TN
BUILDING S-79 - FLOOR PLAN
(FLOORS AND WALLS)

AT MIDSOUTH, MEMPHIS, TN
 BUILDING S-79 - FLOOR PLAN
 (CEILING AND MISCELLANEOUS)

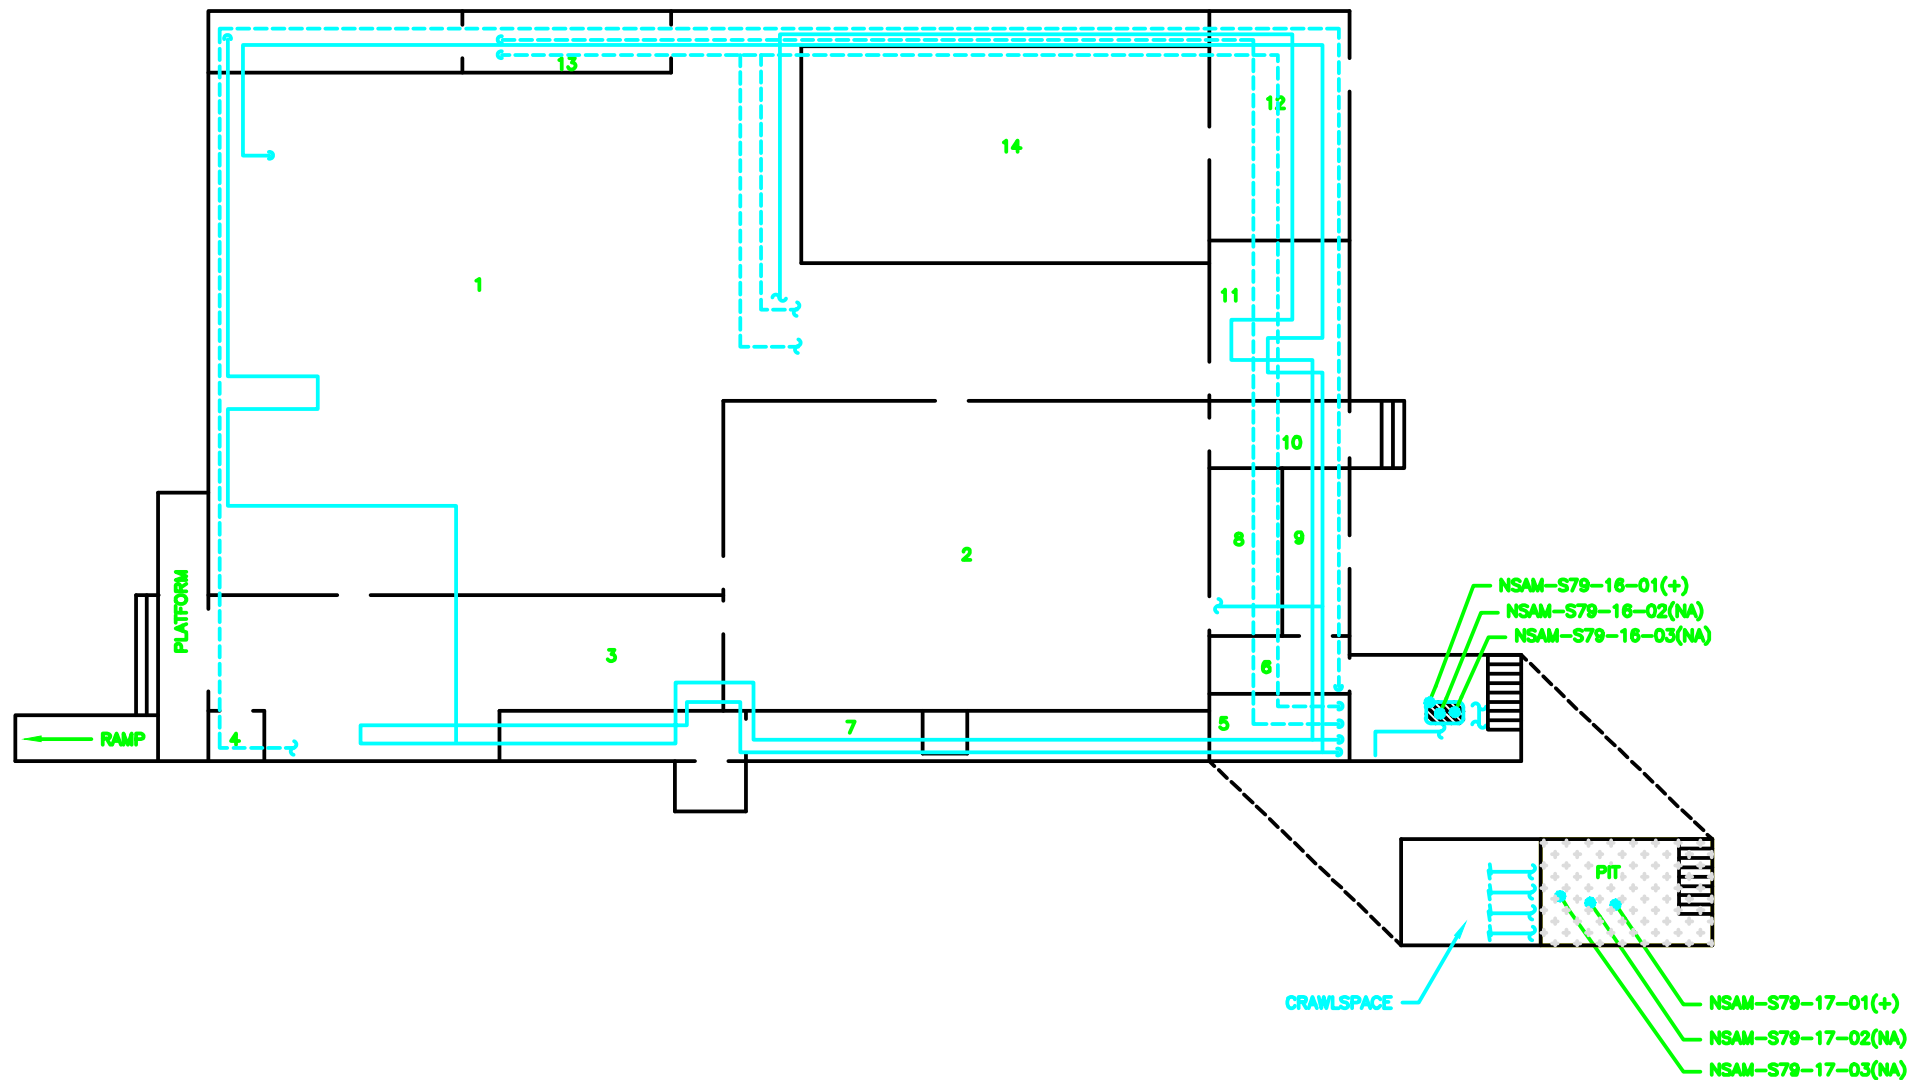
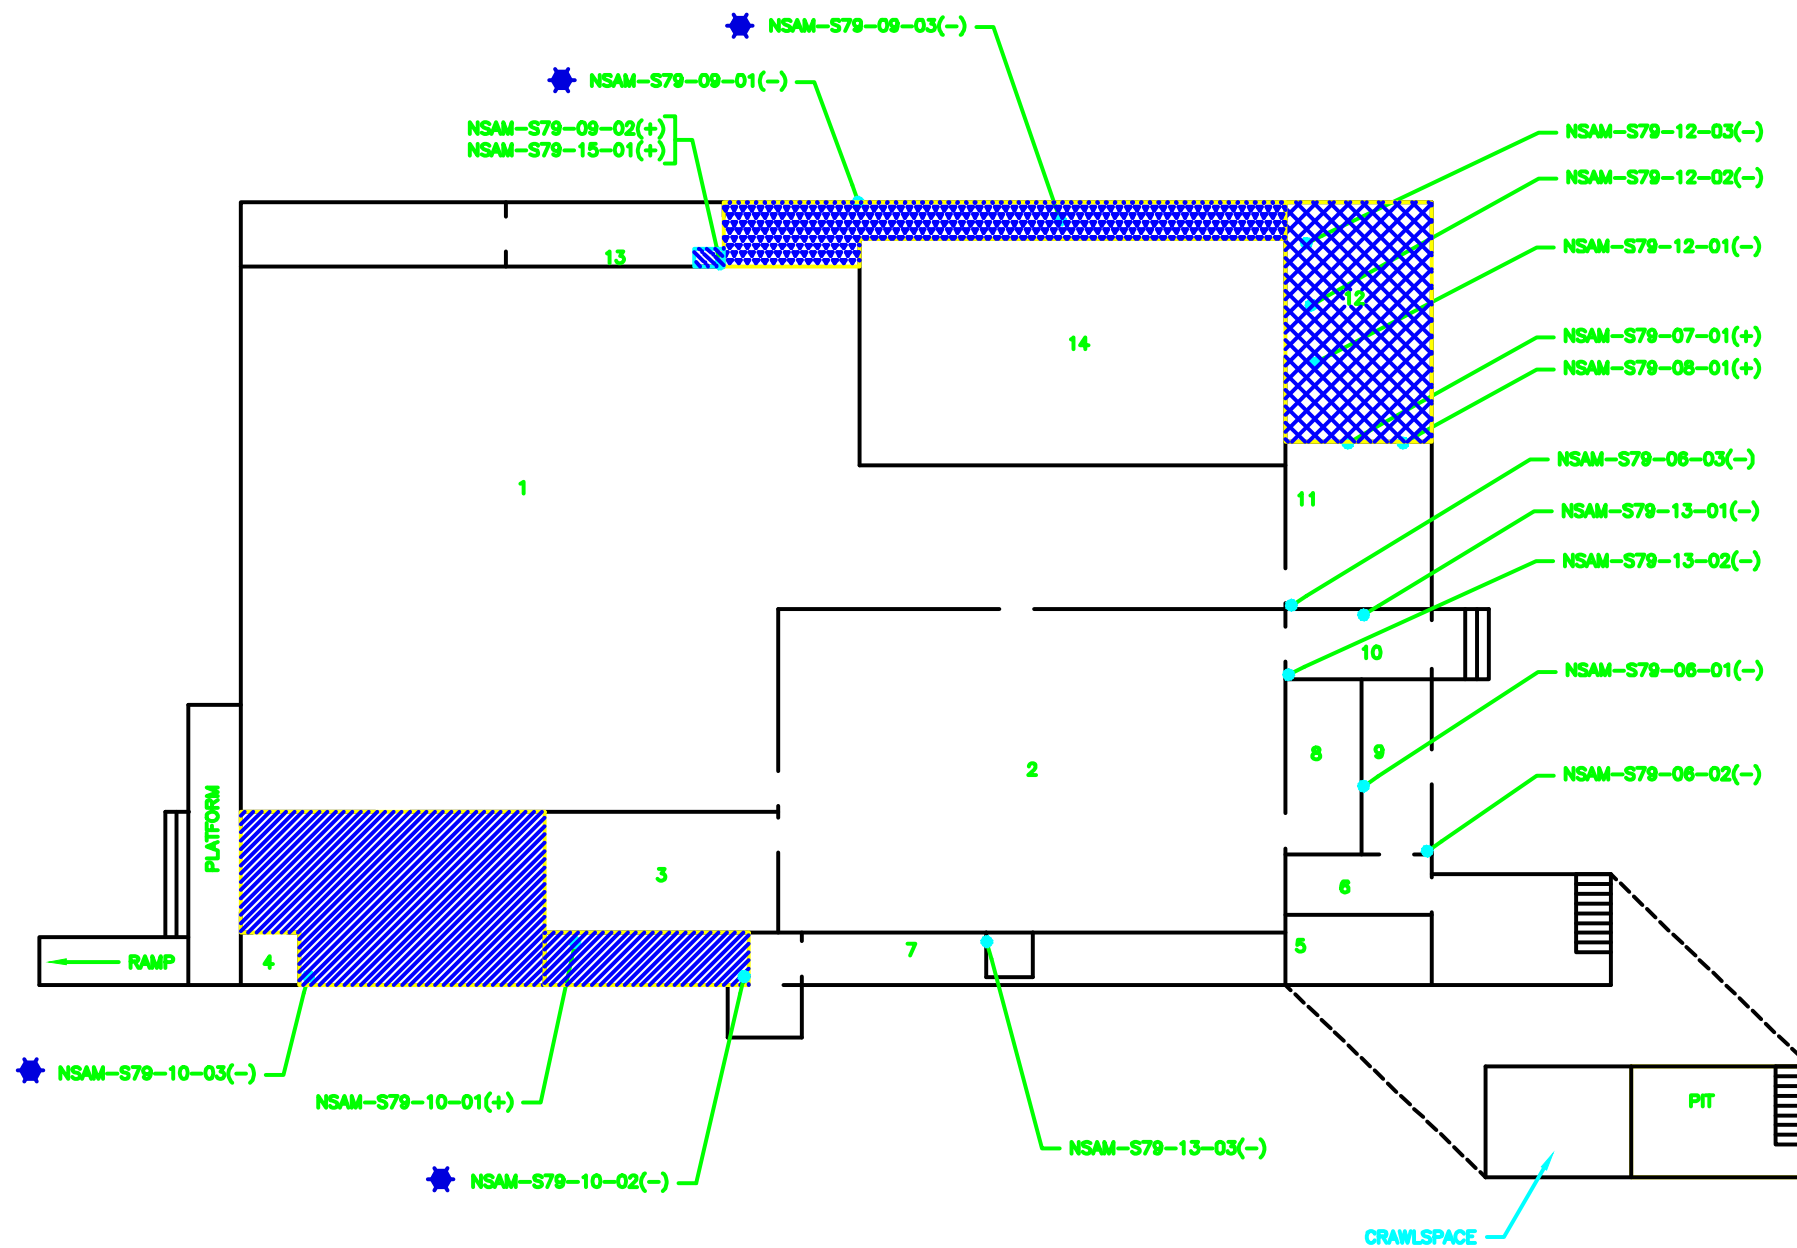
BUILDING S-79 - FLOOR PLAN

ASBESTOS-CONTAINING MATERIALS (ACM)
IDENTIFIED - FLOORS AND WALLS

NOTE
NO ASBESTOS-CONTAINING WALL MATERIALS WERE IDENTIFIED
IN THIS BUILDING.

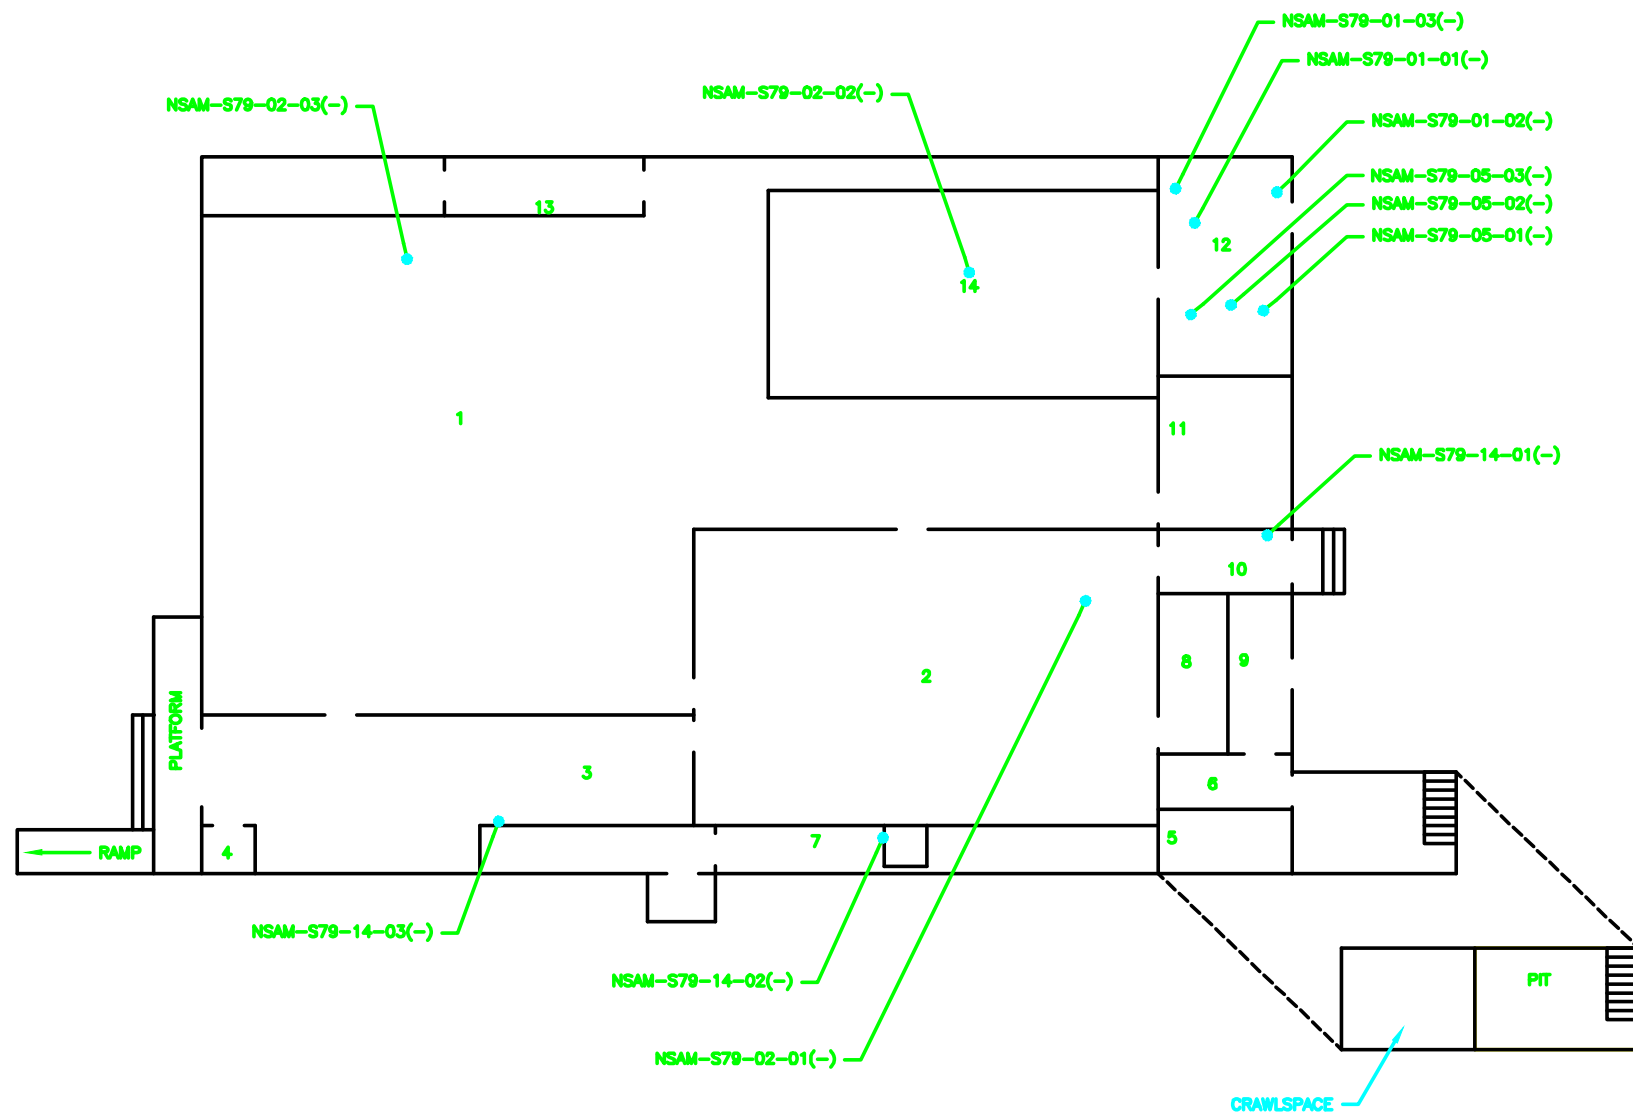
BUILDING S-79 - FLOOR PLAN
 SCALED 1/8" = 1'-0"

NOTE
 NO ASBESTOS-CONTAINING CEILING OR OTHER MISCELLANEOUS MATERIALS WERE IDENTIFIED IN THIS BUILDING.
