BUILDING S-79
FLOOR PLAN
FLOORS AND WALLS
2003-2004 ASBESTOS RE-INSPECTION

RE-INSPECTION: S79HM01_2004

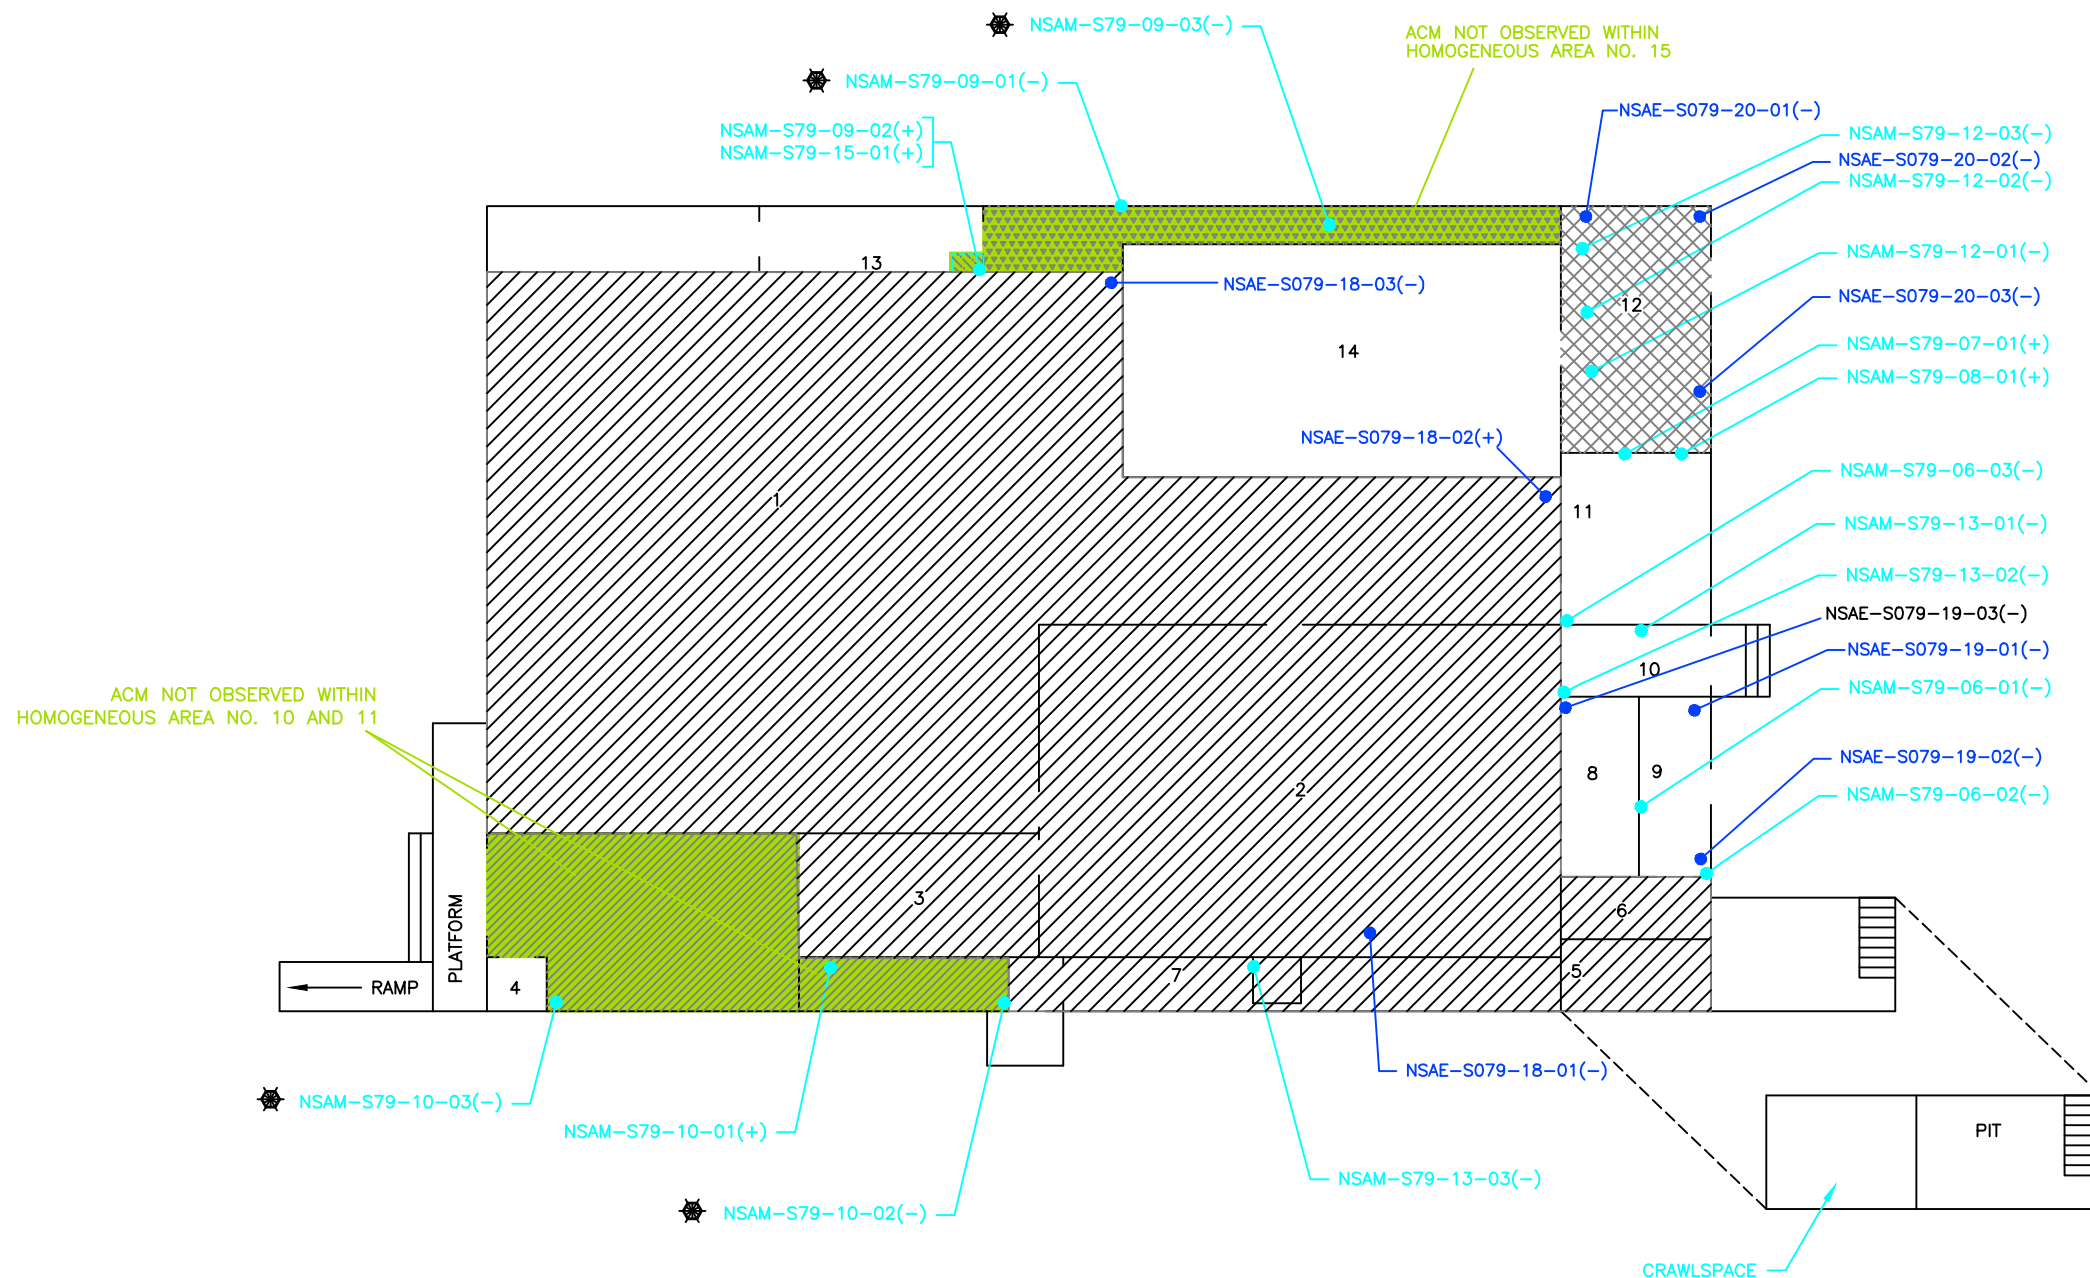
ASBESTOS-CONTAINING MATERIALS (ACM)
IDENTIFIED - FLOORS AND WALLS

NOTE
NO ASBESTOS-CONTAINING WALL MATERIALS WERE IDENTIFIED IN THIS BUILDING.
