A STUDY OF THE BROOKLYN BRIDGE

Y L CHENG

*Department of Civil and Architectural Engineering,
University of Bath, Bath, UK*

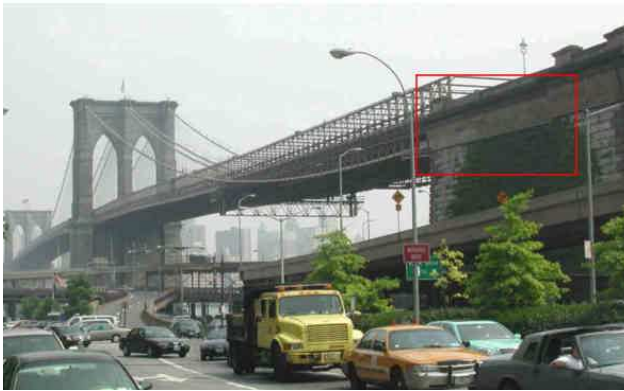
of the bridge. They meet in two rooms, 5.4 meters to 7.2 meters below the walkway as shown in Fig 7.

Figure 7: Cable storage

As this is most vulnerable point along the bridge, terrorists may break into the room and destroy the cables, thus it is essential to tighten the security for future improvements. Sensors, security cameras and alarms may be installed so that police officers are able to respond to a tripped alarm in seconds and shut down traffic on the bridge. There may be 24-hour foot patrols and a police boat kept nearby. Ref. [5]

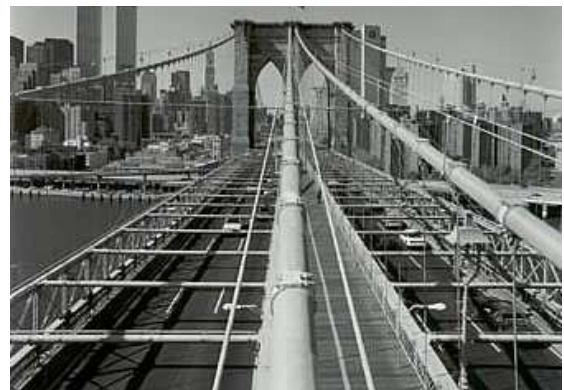
Figure 8:

Assume the dead loading simply consisted of three major elements: transverse trusses at the bottom Fig 5, steel fences 5 meters apart as shown in Fig 8 and 4 pairs of longitudinal trusses along the deck. Calculations below are based on every 5 meters:
