# Lunar Roving Vehicle (LRV) Missing Fender Extension Saga

# Extracts From Apollo Mission Flight Evaluation Reports

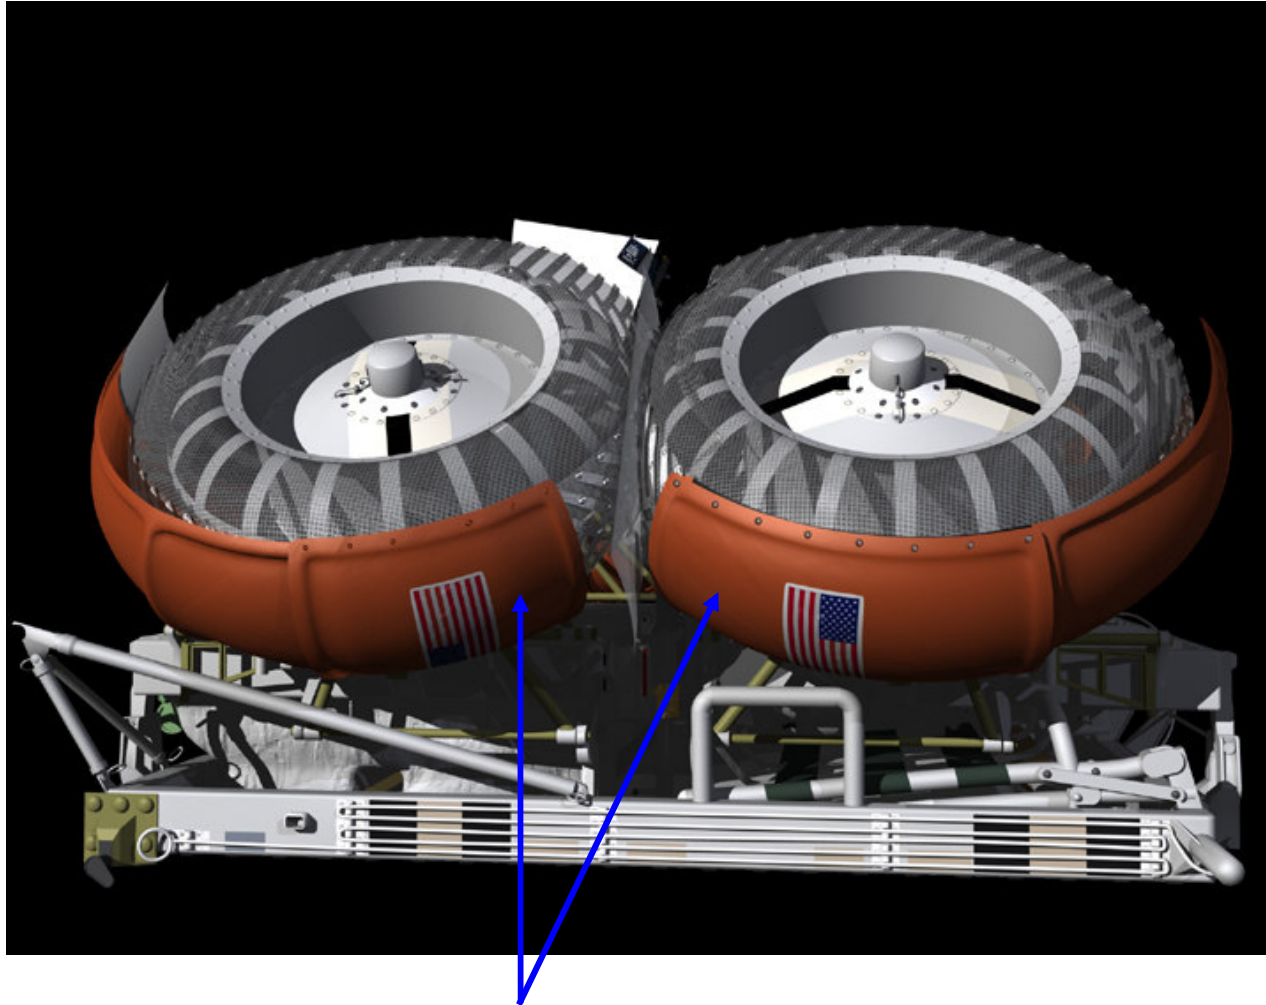
Retractable Fender Extensions Required For Folding of LRV Wheels

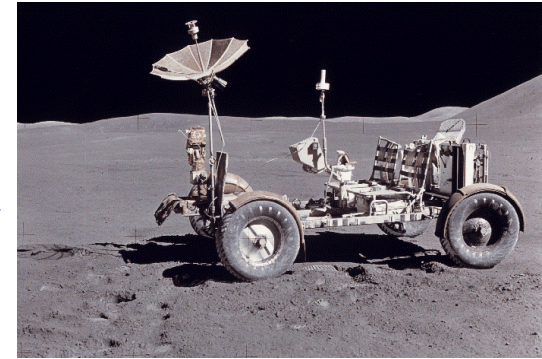
## Loss of LRV Left Front Fender Extension on Apollo 15

No structural damage to the LRV was noticed by the crew, although a close inspection was not performed. A preliminary review of LRV photos reveals no wheel wire mesh breakage. These photos, however, do show that the forward portion of the left front fender was missing after EVA-1. Cause of this is unknown.

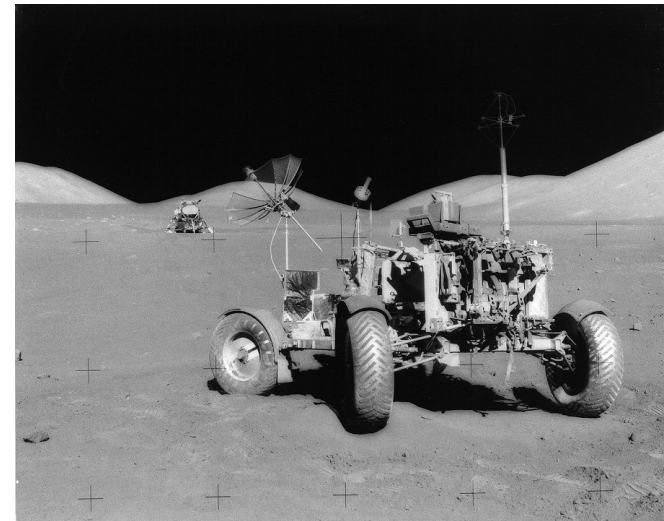
LRV Parked For Lunar Module Ascent Observation

In the process of preparing “Back to the Future” retrospective LRV thermal control experiences presentation, discovered picture of Apollo 17 in it's last parked position that shows missing left front and left rear fender extensions, and missing right rear fender extension and fender map fix

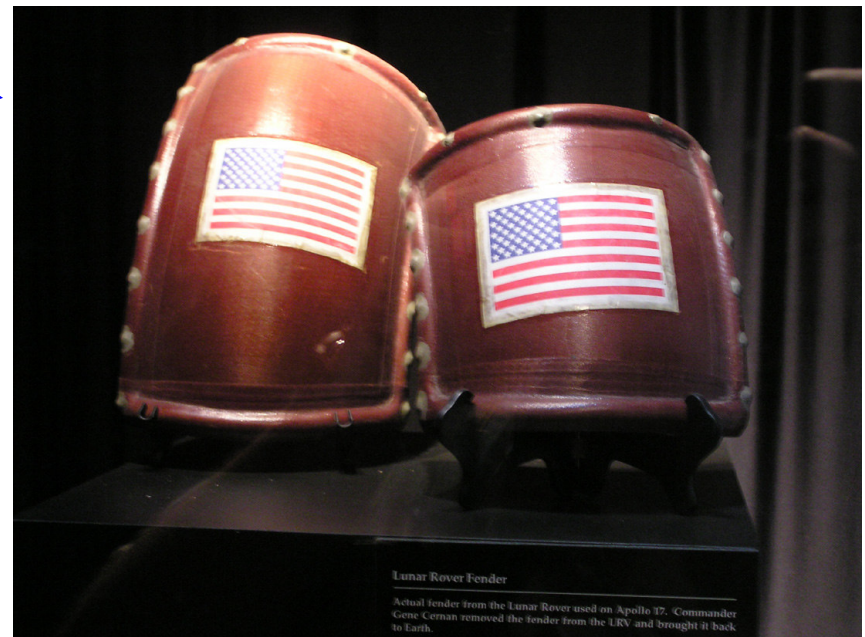
Picture of Apollo 17 Extensions Taken by Ben Nault

Fender extensions claimed to be: “Actual fender from the Lunar Rover used on Apollo 17” discovered on display at Kansas Cosmosphere museum.

Could possibly be used for future “dust mitigation” studies and testing for the “Moon, Mars, and Beyond” Space Exploration Initiative

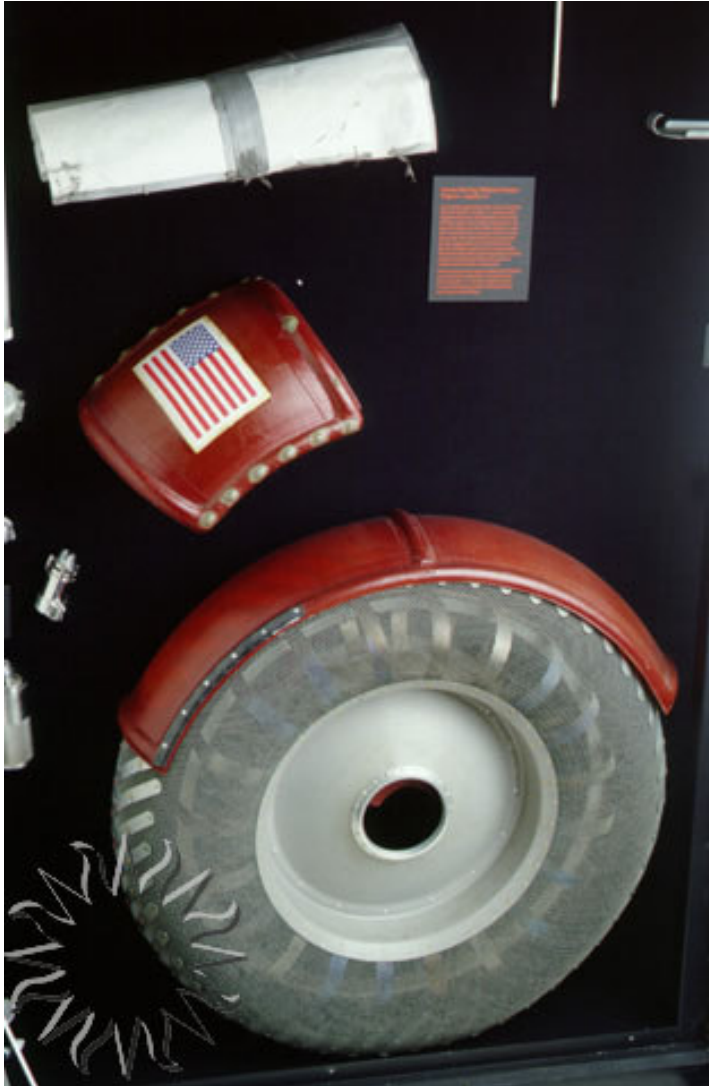
## Apollo 17 Fender Extension and “Map Fix” Located at Smithsonian National Air and Space Museum (NASM)

LRV Artifacts On Display at National Air and Space Museum

- The saga about the missing LRV fender extensions is important because, had we known about them being returned to Earth, we could have inspected them and gained knowledge about exposure of materials to the lunar environment, and the nature and extent of the damage which had resulted in their being removed – accidentally or on purpose
- Perhaps we can now extract them from their resting places in the museum in Kansas and at the NASM and take a new look at them
- It would also be useful to ask whether similar LRV parts were returned from Apollo 15 and/or Apollo 16
