LOW VOLTAGE UNDERGROUND ELECTRIC CABLE DISCHARGED CAUSING MINOR BURN INJURIES

Summary of Incident:

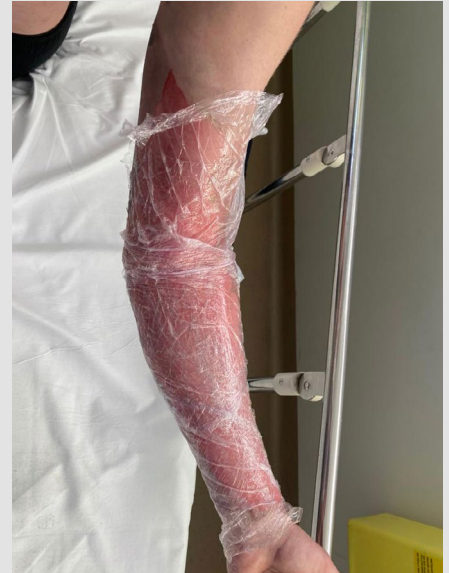
On reaching an approximate depth of 700mm the operative had inadvertently damaged a Low Voltage 300mm (.5) Steel Taped Paper Insulated Lead Covered (PILC) armoured cable causing it to discharge. This resulted in minor burn injuries to the left forearm and left facial area of the body.

- The Genny was not utilised in conjunction with the C.A.T to increase the effectiveness of locating underground services
- Inappropriate selection and wearing of Personal Protective Equipment, leaving large areas of the body (arms) exposed
- Insufficient hazard identification and control measures identified and recorded on the On-Site / Point of work Risk Assessment

- Always ensure you adopt the correct working methods in line with your training, skills, experience, and knowledge
- Risk assess your activities, identify all associated hazards, implement appropriate control measures and record via the on-site / point of work Risk Assessment App
- Always ensure Personal Protective Equipment (PPE) is suitable and sufficient for the task (e.g., flame retardant, anti-static, arc resistant) and worn correctly to provide you with the necessary protection
- When working in and around underground apparatus, always comply with HSG47 avoiding dangers from underground services; utilising both C.A.T and Genny in conjunction with utility drawings, visual identification of street furniture, previous excavation scarring, marking up and establishing exclusion zones
- If unsure, Stop Work and Ask
