# Fast Facts Alert

Subject: Vehicle retaining bar damage

Chippenham Portfolio  
Core Valley Lines Transformation Project

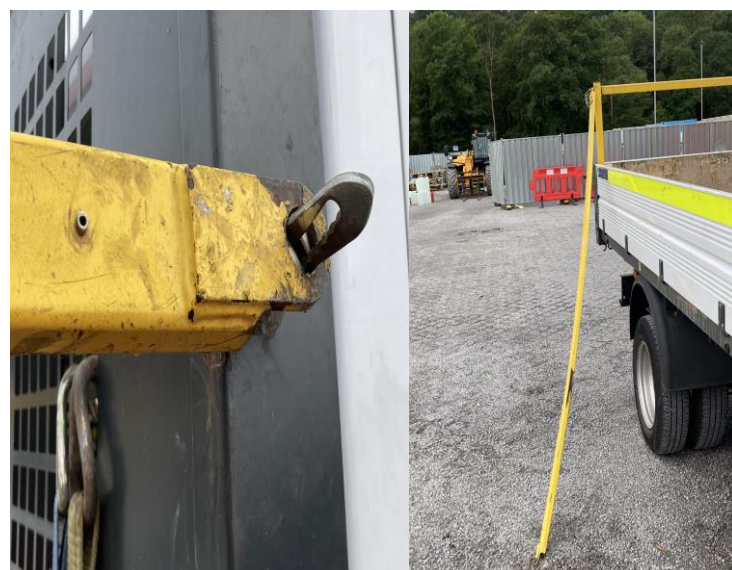
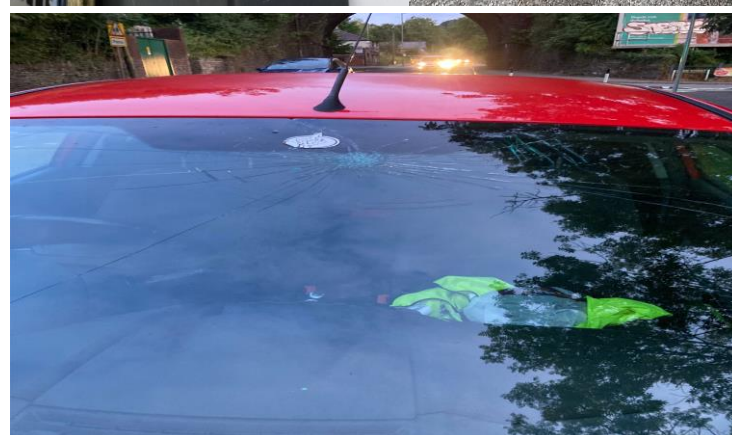
On Thursday 19<sup>th</sup> August 2021 a supervisor driving to the Core Valley Lines project offices noticed as he was driving that the offside retaining bar (Edge protection for working on rear of vehicle) was hanging down into the road supported only by the rear retaining post.

The retaining bar had become detached from the fixing and fallen, hitting a member of public's vehicle and causing damage to the windscreen, front bumper and a front spotlight. Luckily the driver was not injured.

The side retaining bar is a removable bar which is fitted to offer edge protection in case an operative needs to work on the flatbed of the vehicle. The bar is secured by the use of a latch which is then further secured by a small carabiner which prevents the latch becoming unsecured. The carabiner is attached to a link chain and pop riveted onto the retaining bar. Upon initial investigation, it appears that the chain and carabiner was missing, however it is uncertain whether the chain was not present before the journey or if it came off during impact with the vehicle or road. It appears that the when the retaining bar is released without control it flies away from the vehicle approximately 1 metre.

The link chains are only riveted on with a aluminium rivet and appear to be quite weak. These rivets mushroom over the chain but are not sturdy allowing movement of the chain.

Check all vehicles immediately. Ensure the daily checks are taking the retaining bars are secure and the correct use of the carabiner and chain into account on inspection.
