# Bleeding Poles

## Important briefing for Poling Teams

Issue 1 - 02/06/2021

Issued by Openreach Chief Engineer and Plant Safety Team

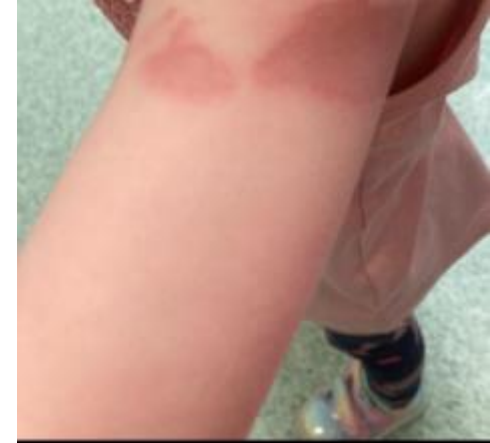
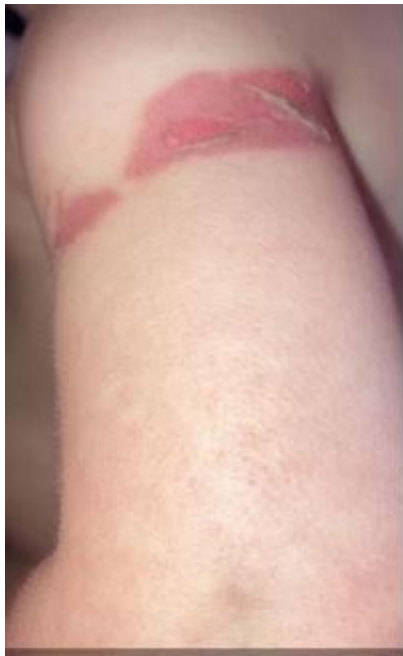
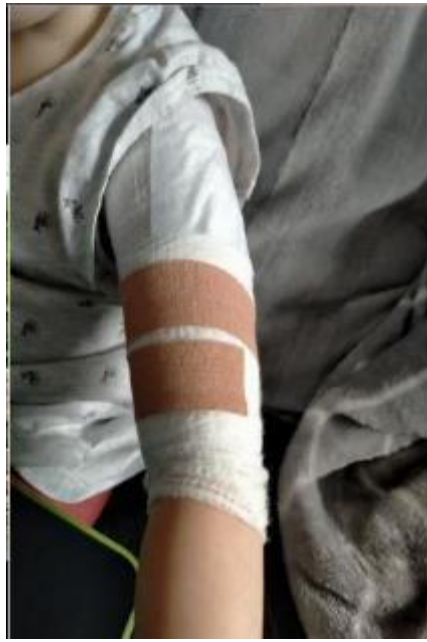
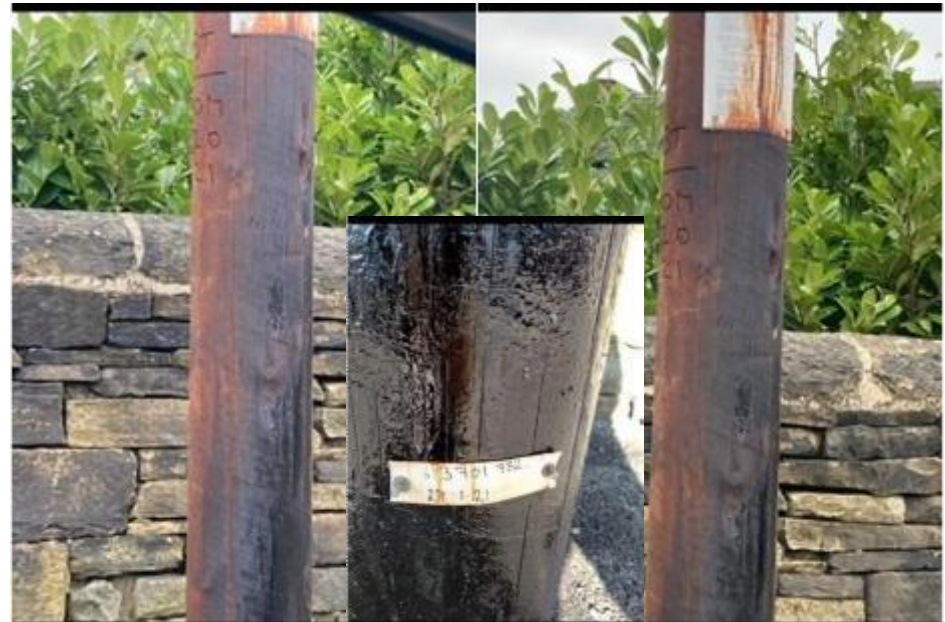
BTP63151

- Child touched Pole which was wet with Creosote
- Suffered burns to arm / shoulder
- 2 x visits to A&E and visit to specialist burns unit

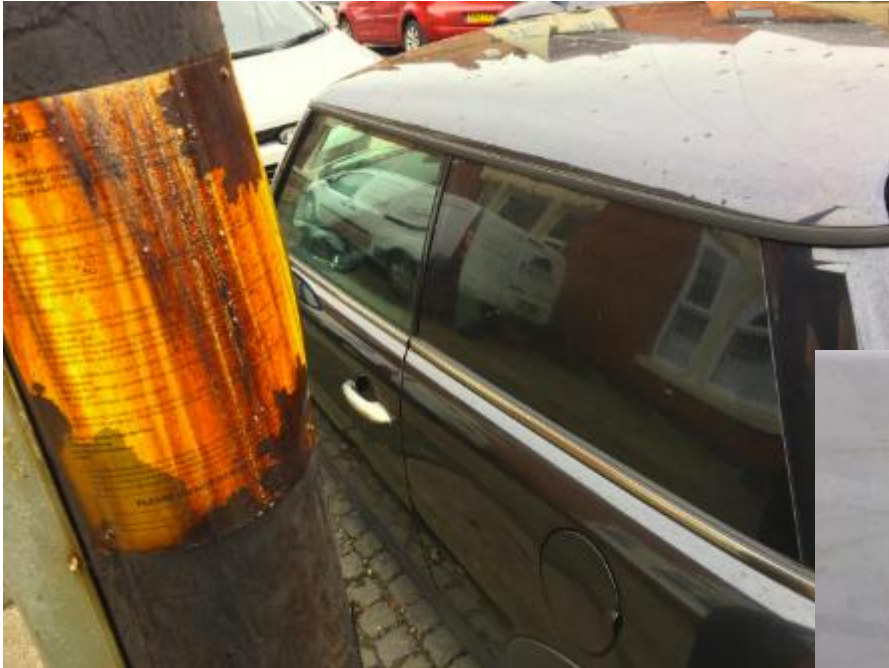
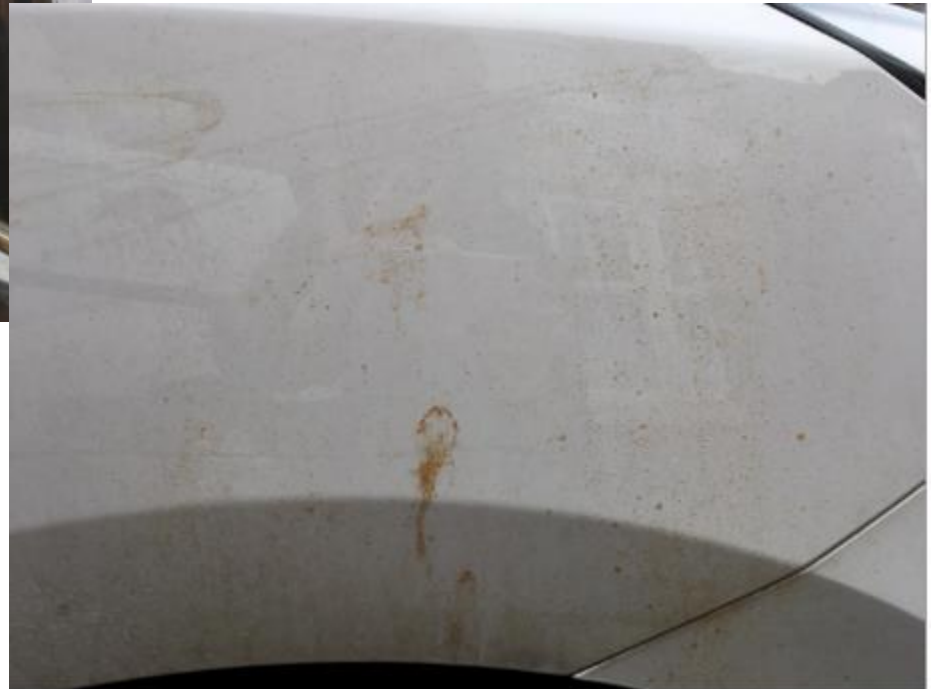
BTP60158

Pole Details: 2020 9 Metre Light - Job Completed: 30 November 2020 Claim 10.2.21

Wind blown Creosote has caused contamination on car

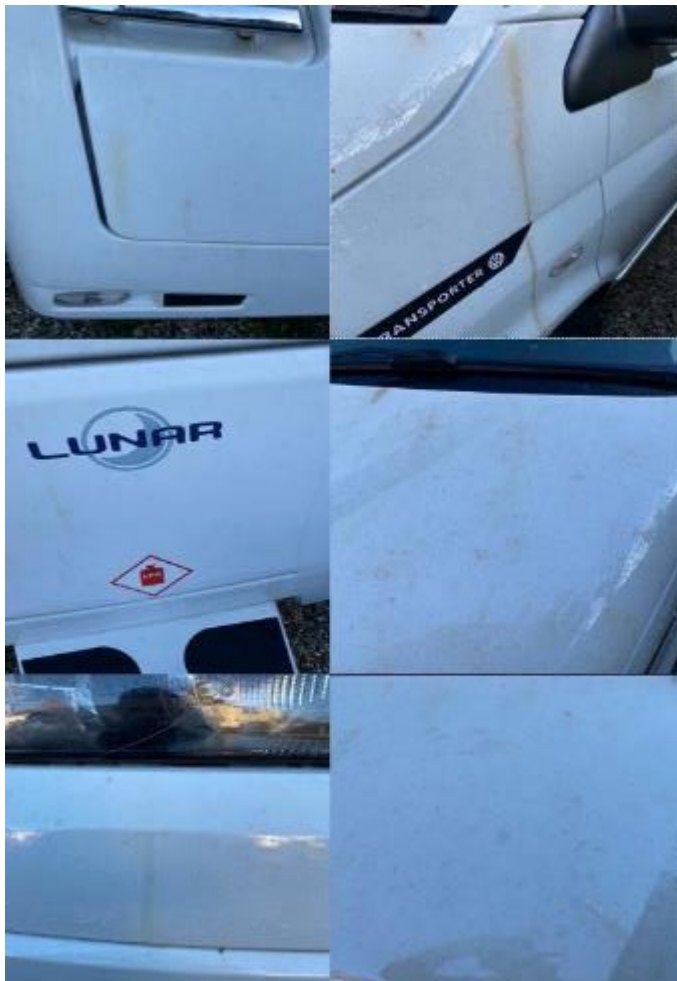
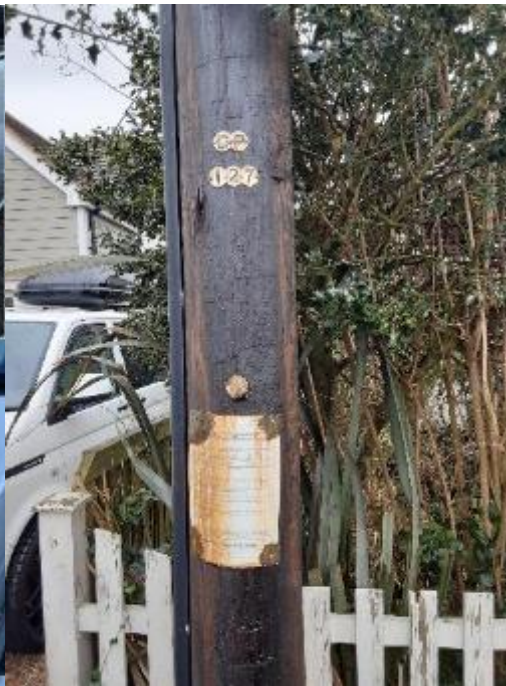
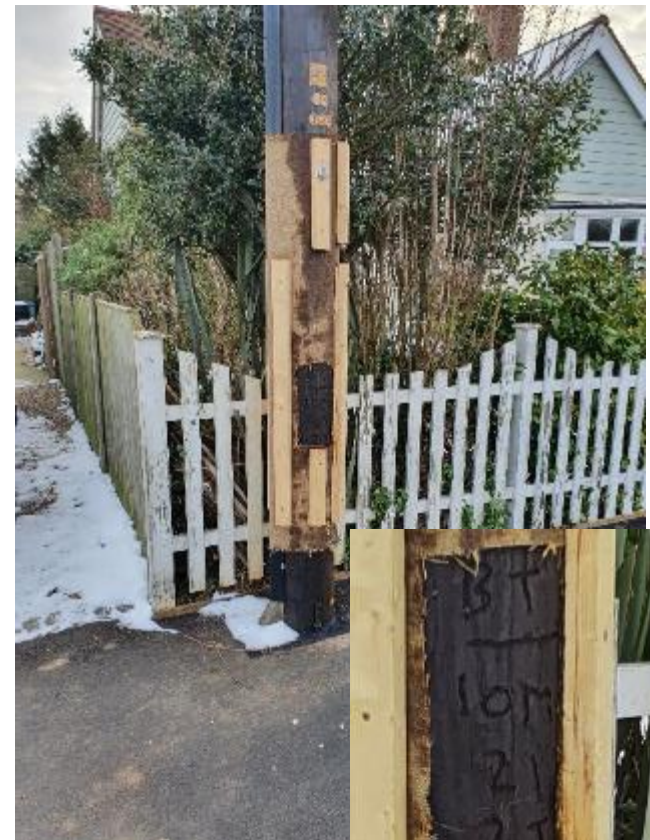
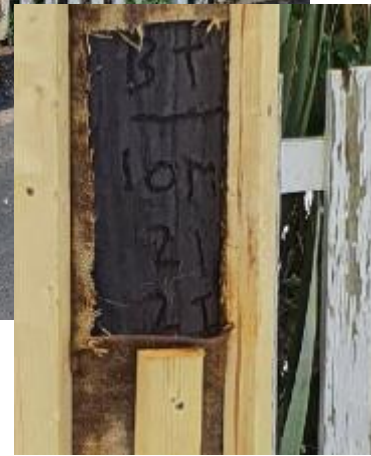
BTP59900

- Van damaged by Creosote contaminated rainwater, driven of Pole during windy conditions
- Every single panel of vehicle affected, including the glass
- Caravan and other Car also similarly affected

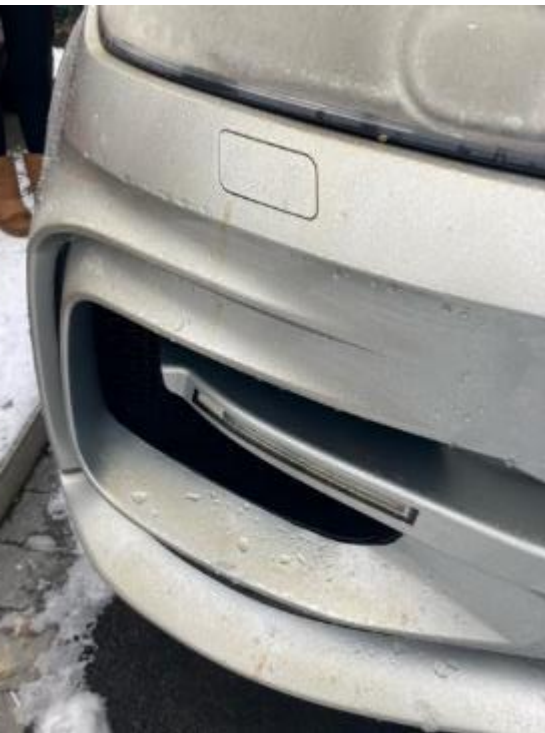
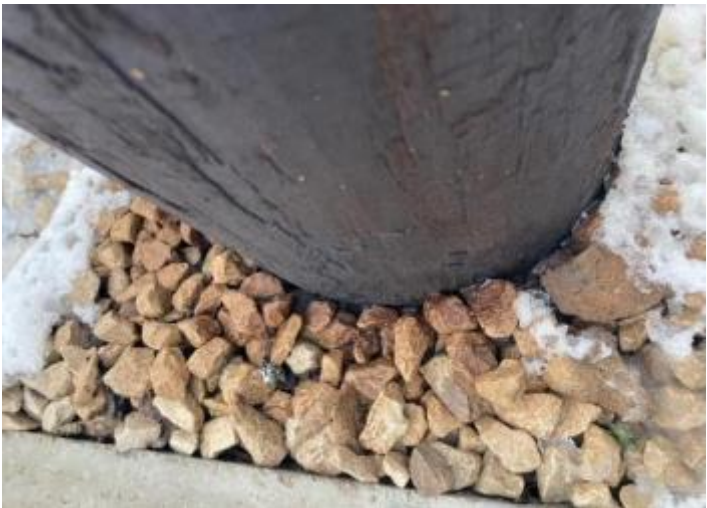
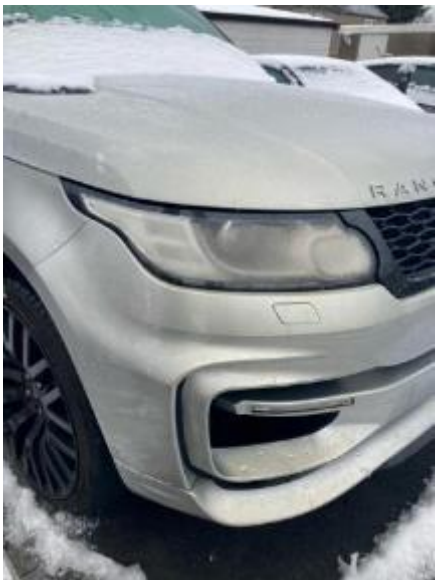
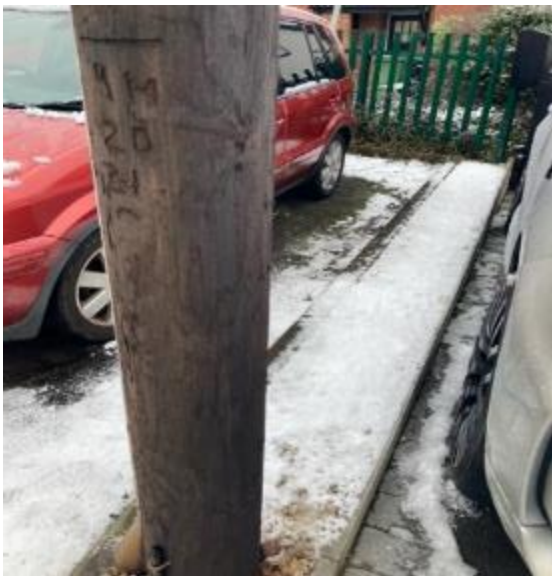
BTP59957

Newly installed Pole placed at the end of driveway, adjacent to car.

The Pole is covered in wet creosotes tar

Car and Driveway has been contaminated with Creosote.

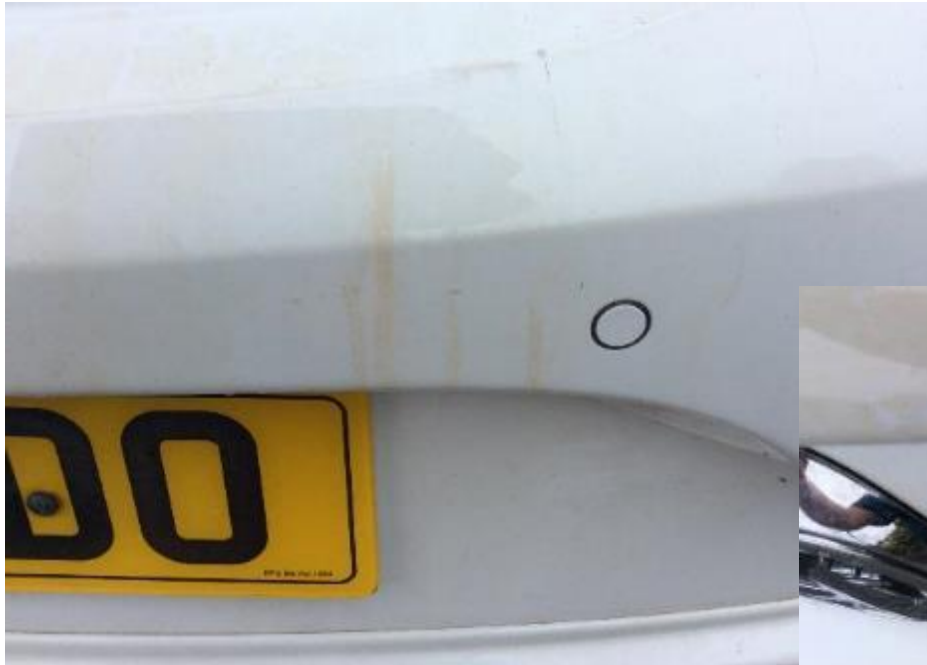
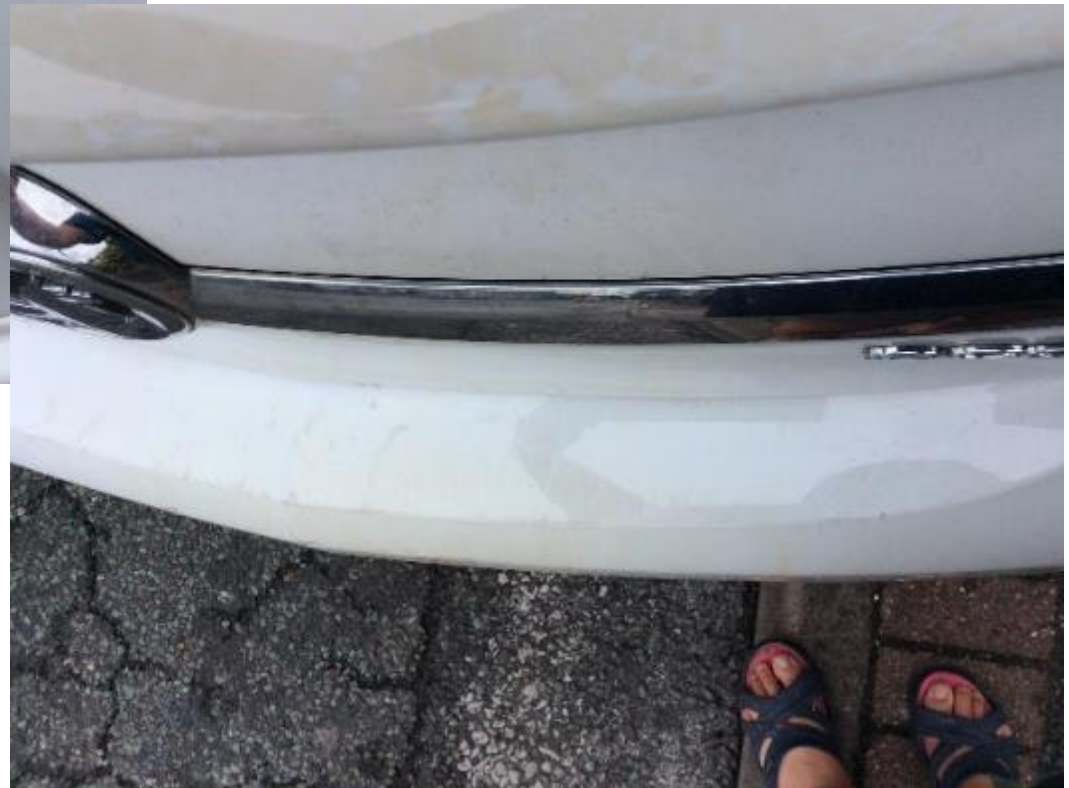
GRO1/154358

Car paintwork contaminated due to wind blown Creosote

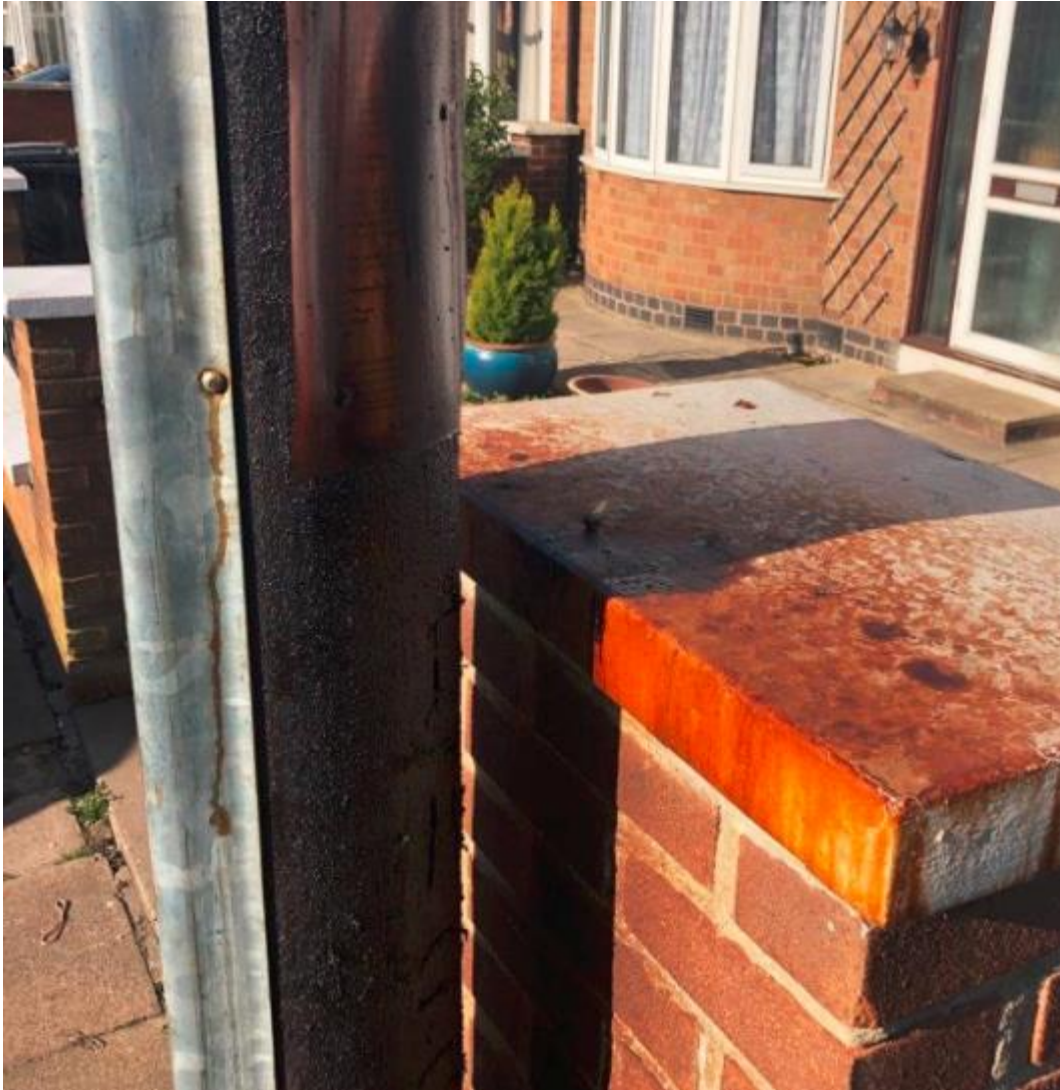
Contamination of wall due to wind blown Creosote

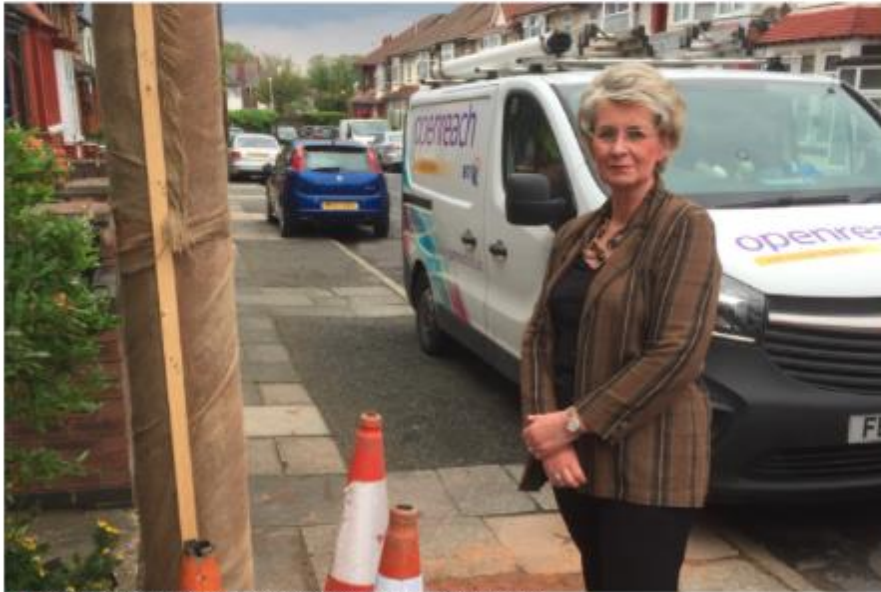
Local councillor Lesley Rennie with the pole that has been 'bleeding'

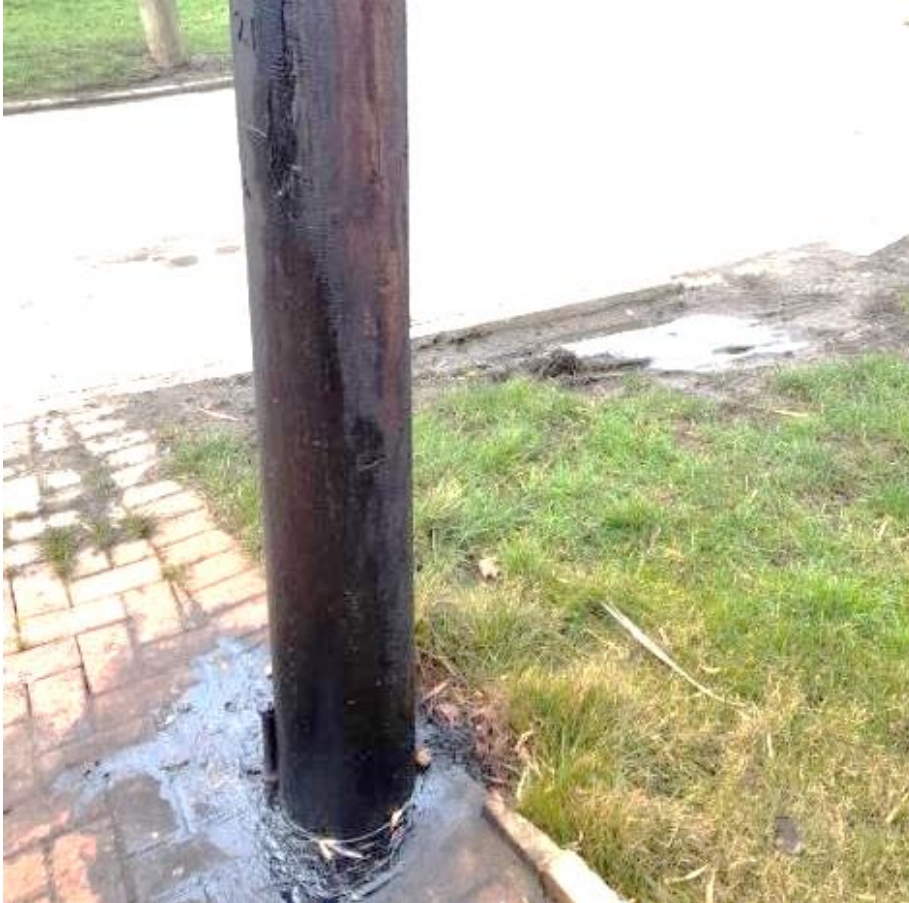
Northern England

Pole wet with Creosote and contamination of pavement

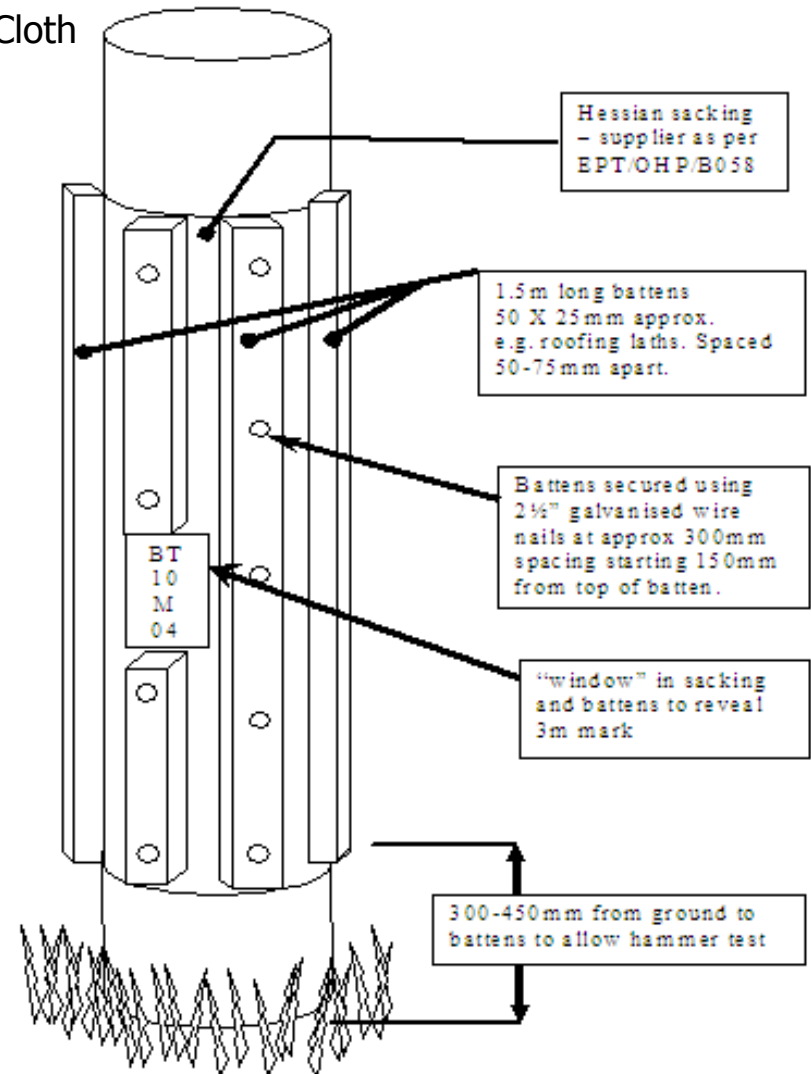
### Correct Hessian & Batten protection

Hessian for lagging or wrapping poles (Untreated Hessian Cloth 36" wide) can be obtained from:

*NB: Hessian & Batten is only applicable to existing poles.*

*All newly installed poles must be dry when erected.*
