## OPERATIONAL CLOSE CALL

No – 22.23

An Operational Close Call occurred recently on a Dyer & Butler site when a machine / crane controller gave permission for his operator to place the rail trailer unit on the track before the worksite had been granted by the authorising person.

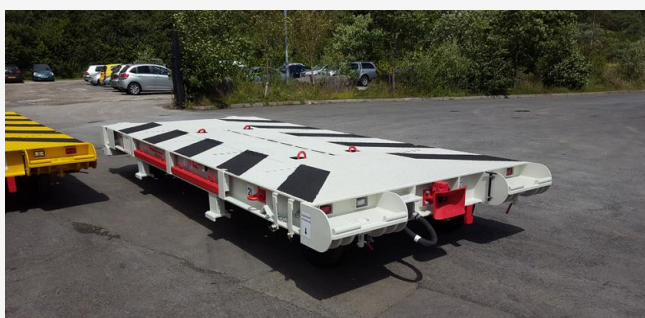
On the 26<sup>th</sup> of May 2022 at 01:01 hours, an incident occurred on a Dyer & Butler rail site in the West Midlands. A rail trailer unit was allowed to be placed on the Down Wellington line prior to the work site being confirmed by the Person in Charge Of Possession (PICOP). This action of placing the trailer operated a track circuit which led to the signaller contacting the PICOP due to the Down Wellington line being shown as occupied within the area of possession.

**Remember:** Always follow official procedures and processes when accessing the track environment.

**Remember:** Authority to access the track can only proceed once the work site has been fully established and handed over to the Engineering Supervisor.

**Remember:** Only act on instructions given by the appropriate authorising person.

**Remember:** Where instruction is received from a non-authorised person, the instruction must be challenged and declined.
