Safety Alert

Faulty Drilling Rig Interlock

5 April 2022

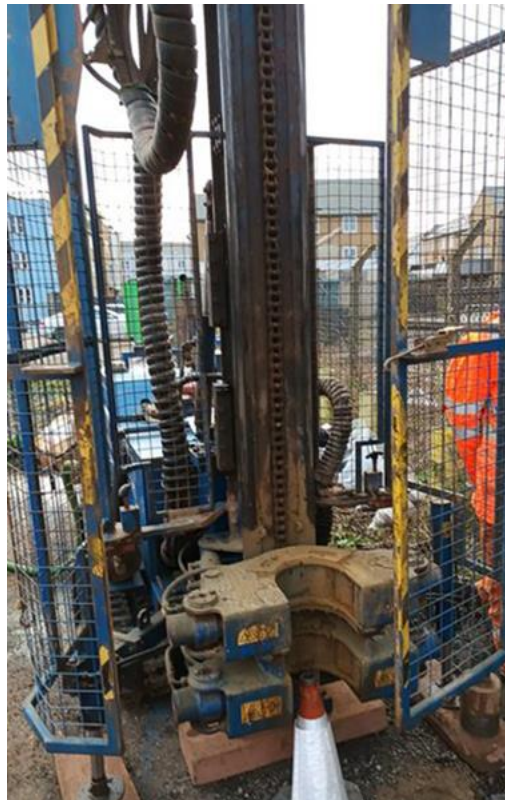
Faulty Interlock

During a site investigation, the cage interlock on the rotary drilling rig was checked during a CDM-A site visit. When checked, it was found that each rig cage door could be opened approximately 10-12 inches before the interlock operated to stop the rotating parts of the rig, leaving an opening of 20-24 inches.

The failure of the interlock meant there was an increased potential of entanglement with the rotating parts of the drilling rig i.e. the 'danger zone'.

As the interlock was found to be faulty and there was not a valid inspection check sheet, works were stopped onsite. The drilling rig was not used until the faulty interlock had been rectified.

- The Principal Contractor must ensure that daily plant checks have been carried out prior to any plant being used onsite.
- Where any faults are found with plant prior to or during operation, then the equipment must be quarantined until the fault has been rectified.
- The operation of interlocks should be part of the daily checks and maintained in accordance with the manufacturer's instructions. As this is a key safety function for the drill rig.
