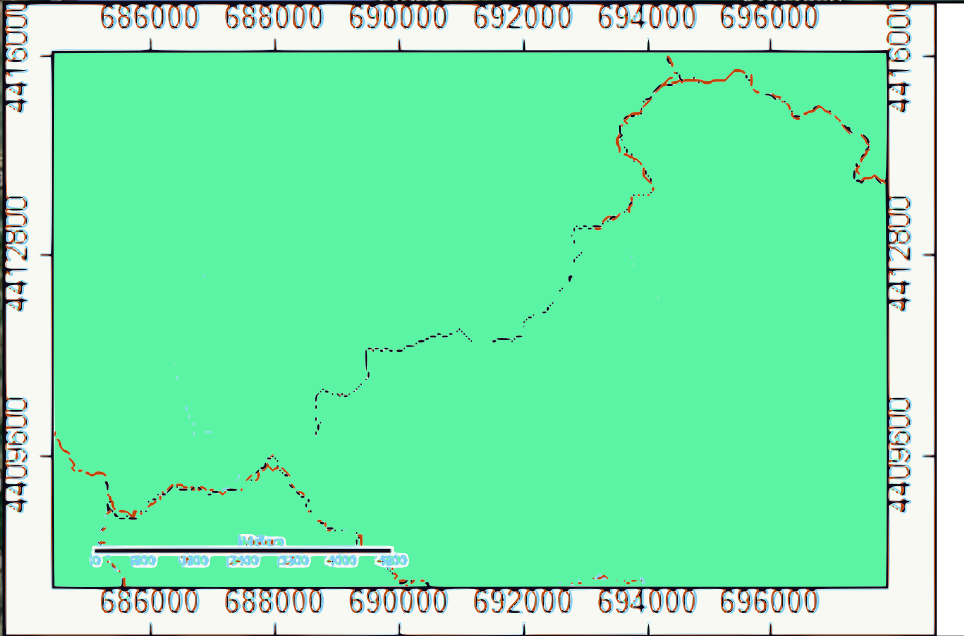
The southern terminus of the hydrology analysis error. Information explained in text box immediately to the north.

Hydrological analysis performed using SRTM satellite data does include a continous stream at this location. The map annotated map provided demonstrates the hydrological analysis differences between ASTER and SRTM data. The blue line on the annotated map is the area on our baseline map that the error occurs. This blue line, and lack of a red line, means that SRTM data determined that there is a flow at the location, but ASTER data did not.

According to hydrology analysis, this large flow suddenly ends at this location and then a large flow suddenly appears to the south (at other text box). However, satelittle imagery reveals that the river is actually continuous. A visual analysis of the source of data revealed that the entirety of the data involved in this error was acquired from the 3rd version of the joint US-Japan Global Digital Elevation Model project. A potential reason for this data is that the river occurs in the base of a valley with one slope slightly steeper in this area of error than before or after the area. It is possible the elevation gradiant of this physical feature may have been inaccurately measured - potentially with a higher elevation being recorded at the actual stream bed than is reality. This error could have manifested itself in my analysis when I determined the locations for water sinks, which would have then viewed the higher elevation than is reality as forcing the stream to come to an abrupt end and pool.

This large area of visual error is because this is a lake. This location could not be masked as nodata, as the ocean locations are, because this lake is not the lowest-elevation feature on the map and there are locations of land with the same elevation as the lake. I would not be able to mask the elevation of the lake without also masking land.

According to hydrological analysis, this stream abruptly ends here. This is the same stream as the error explained in the two text boxes to the right. The data of this area is from the Japan-US Global Digital Elevation Model version 3. the elevation of this area may have been inaccurately measured, even though it is a flat river valley and presumably not the most difficult of terrains to measure.

The stream recontinues here, but the analysis has the size of the stream at a smaller level than it is upstream (text box immediately to the right). This is because the input data does not recognize the presence of the stream between these two locations, and as far as the hydrological analysis data is concerned, these two disjointed ends belong to two entirely different water features. However, satelittle imagery demonstrates that these ends are indeed the same water feature. All data in this area of error is from the United States-Japan Global Digital Elevation model version three. This error may be a result of inaccurate elevation measurement which could portray the missing segment of the water feature as a high elevation than upstream.

This stream suddenly comes to an end here and recontinues at the text box immediately to the left.
