# ME 401: Mechatronics Lab

## Final Project: 3D Scanner

Titus Battisti & Rafael Romero

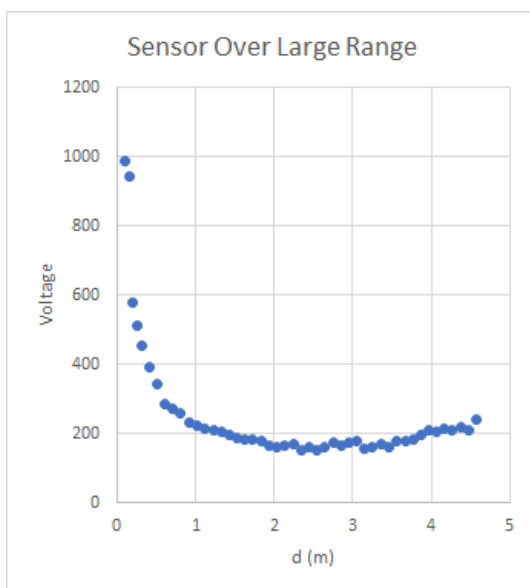
**Figure 5:** Measurement of voltages at expected distances.

After the motors themselves are tuned, the IR sensor itself has to be tuned in order to get the bounds of the 3D scanner itself. In addition to the curve used to generate distances needed to calculate 3d coordinates. First the IR sensor range is tested from 0-5m in order to find the most effective range. **Figure 5** shows the first initial testing of the IR sensor.

After the initial testing is done the IR sensor data shows that the measured value can only be one to one in the first two meters or so (which is necessary for generating the polynomial curve fit shown in **Figure 6**). The data was fit in

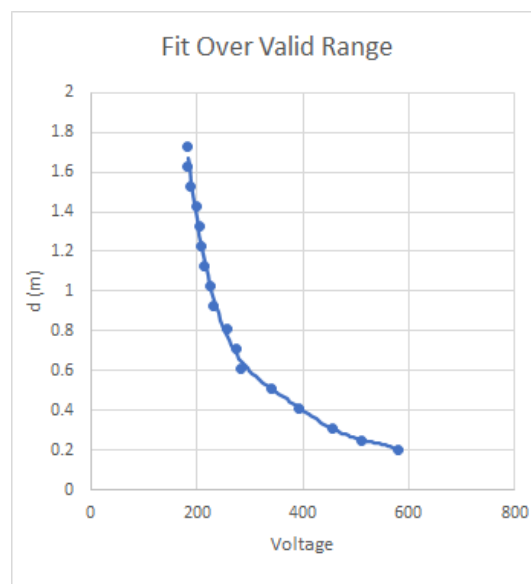
**Figure 6:** Points and fit from the usable range of measurements from **Figure 5**.

the range of 200 to 600 voltage reading which gave an output from 0.2m to 1.78m from the point of measurement.

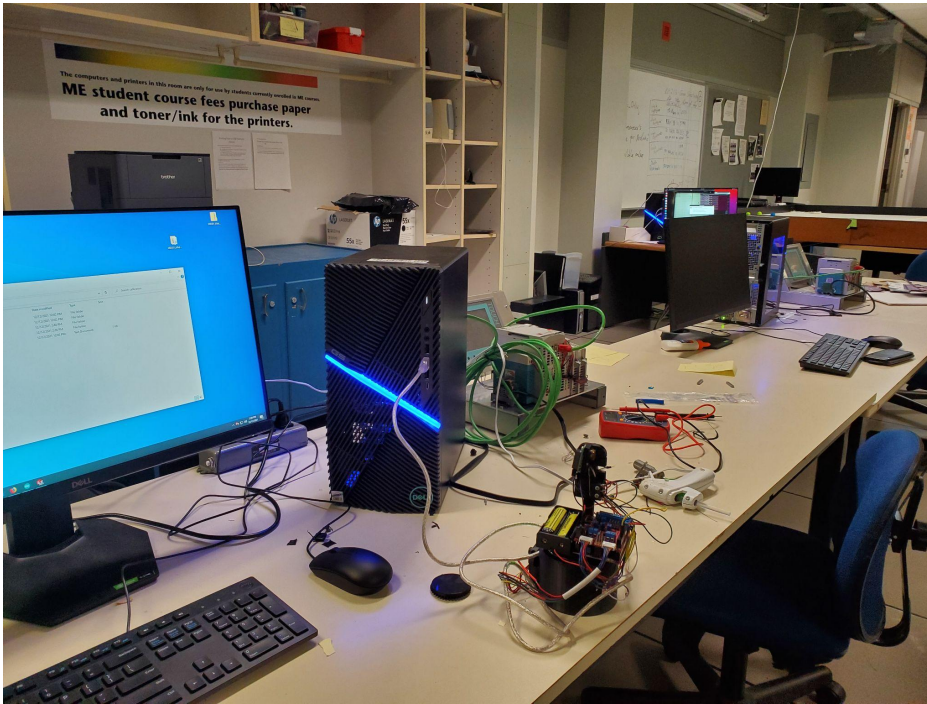
**Figure II1:** Location of first scan, “scan1”.

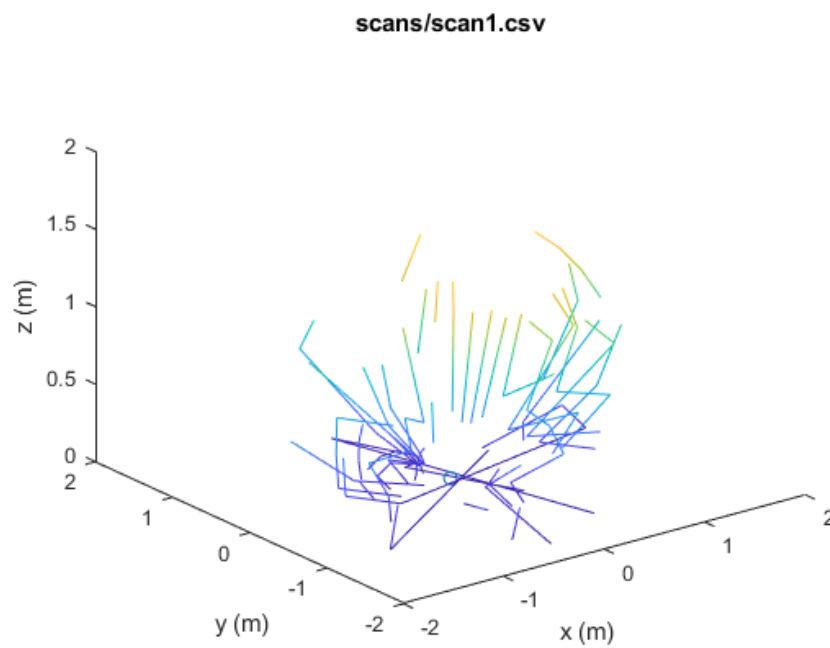
**Figure II2:** First scan, “scan1”. The resolution was set to 20 (441 points) on this one, and not much can be seen.

The first scan, scan1, was done at the lowest used resolution of 20. It can be seen in **Figure II2**. Resolution was a number specified in our programming which decided how many distinct points the pitch and yaw motors ranges would be divided into. Because of the nature of the code, the number of points,  $P$ , which follows from a resolution,  $R$ , will be as follows:

In addition to having the lowest resolution, scan1 was done in a mostly open environment. As points outside of the IR sensor's calibrated range are deleted, the overall environment shown in **Figure II2** is indistinct.

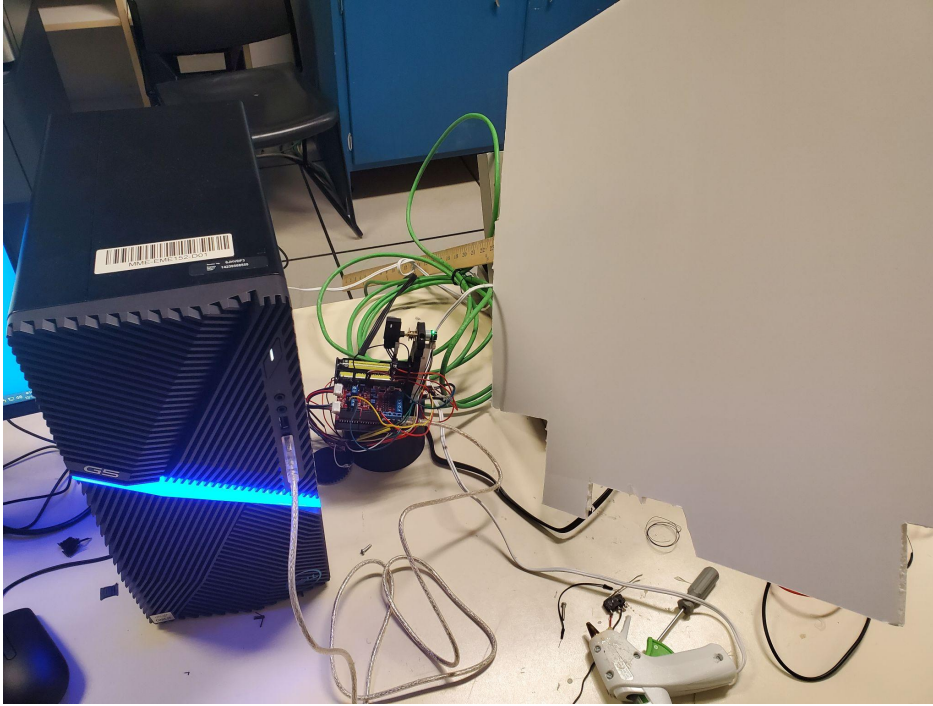
**Figure II3:** Location of a scan between two walls, “walls”.

The walls were more stable, and had a slightly different error. They seemed to curve as they went up. This was likely due to faults in calibration. As a failure to correctly observe a straight line as straight implies the sensor saw points near where it should have, but slightly off in a way that became more pronounced at farther distances.

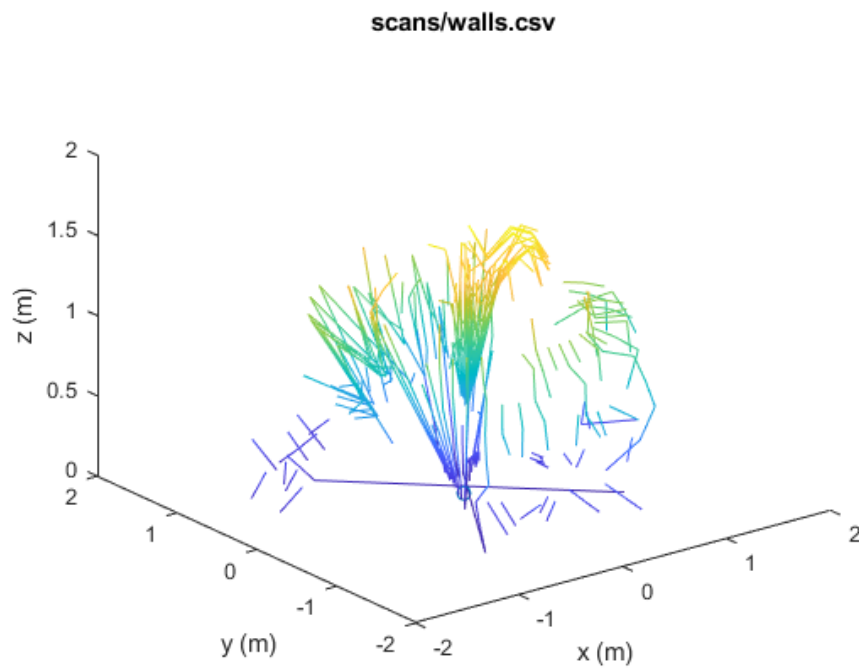
**Figure II4:** Scan of “walls”. The resolution was set to 30 (961 points).

The second scan, walls, was done at a resolution of 30, and in an environment more suitable for its sensor. **Figure II5** shows the scan at a similar angle to the

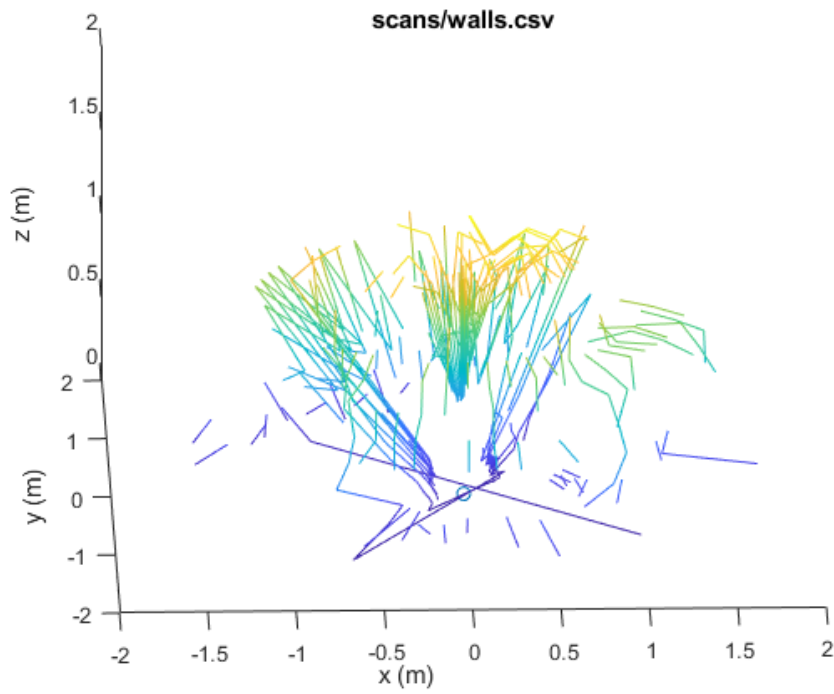
**Figure II5:** Another angle of “walls” with the walls more visible.

picture taken in *Figure II3*. *Figure 8* attempts to connect features seen in the scan to real life, although the scan features something between the red and magenta circles which doesn't seem to be there in the picture.

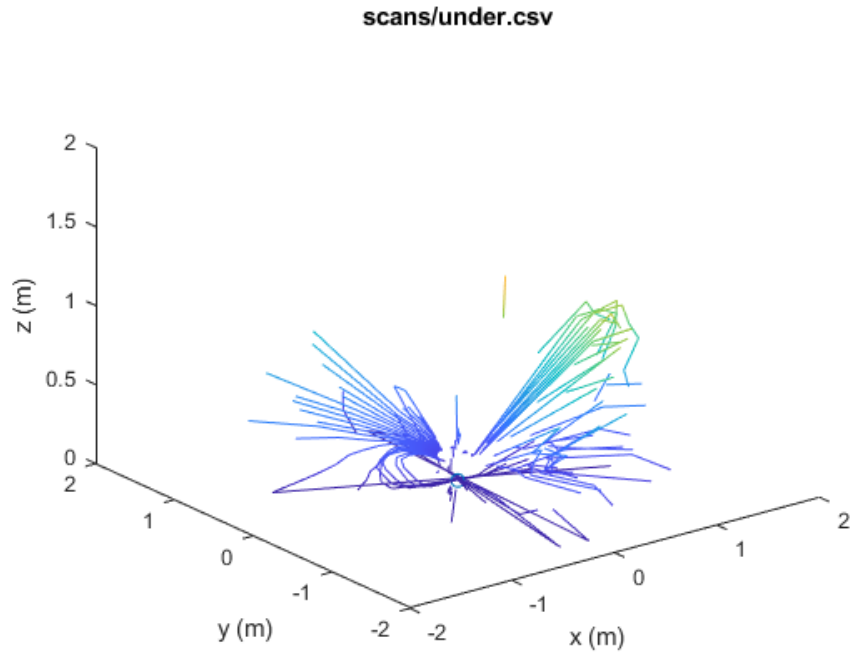
**Figure II7:** Scan of “under”. The resolution was set to 40 (1681 points).

The third scan, under, again seems to roughly correspond to reality as shown in *Figure II6*. These images (*Figure II7-II9*) seem to feature one shallow plane and one harsher plane. These might correspond to the underside of the table and to the back of the chair.

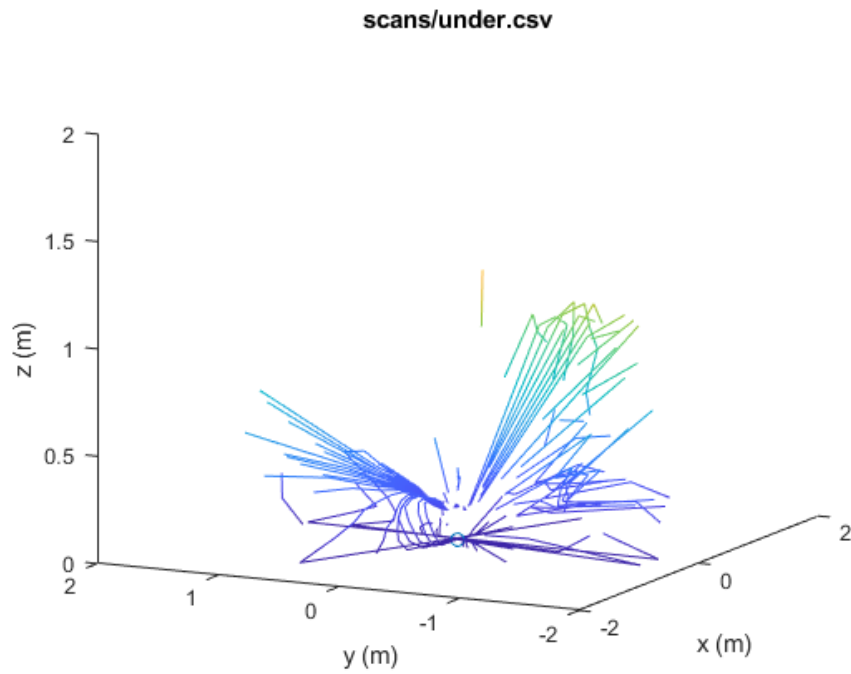
**Figure II8:** Another angle of “under”.

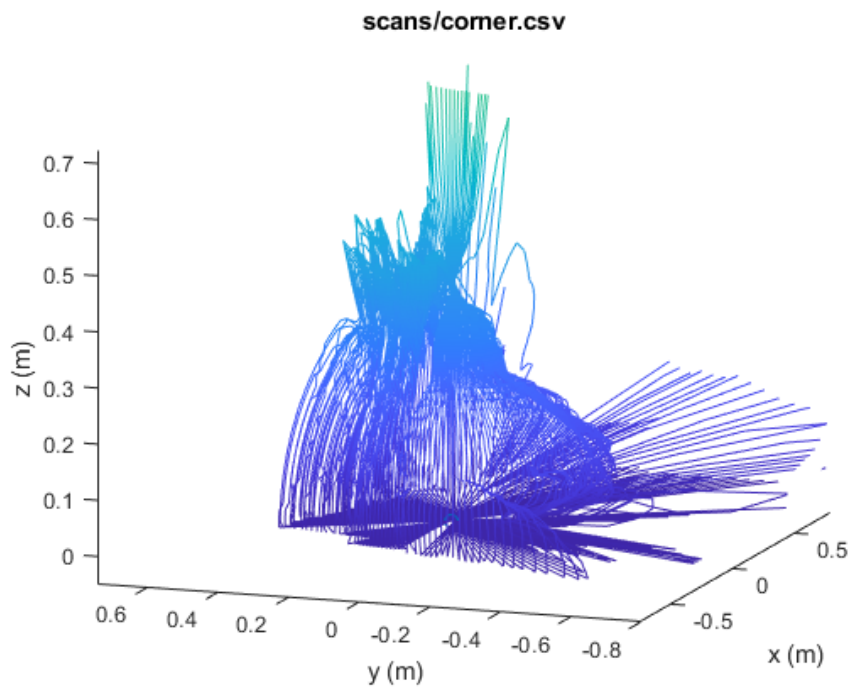
**Figure II12:** Another angle of “corner showing a clear floor, two walls and a ceiling. The walls are a bit disturbed and the ceiling more so, likely because it was a 30 minute long scan with the environment being held up by hand..

The fourth scan was done at a much higher resolution (of 100), and in a more suitable environment. This scan took the longest at about half an hour, but produced obvious walls and possible ceiling, best seen in *Figure II13*. The glitches in the ceiling were likely due to operator error, as the experimenter was holding the ceiling there and it likely moved quite a bit in the experiment.

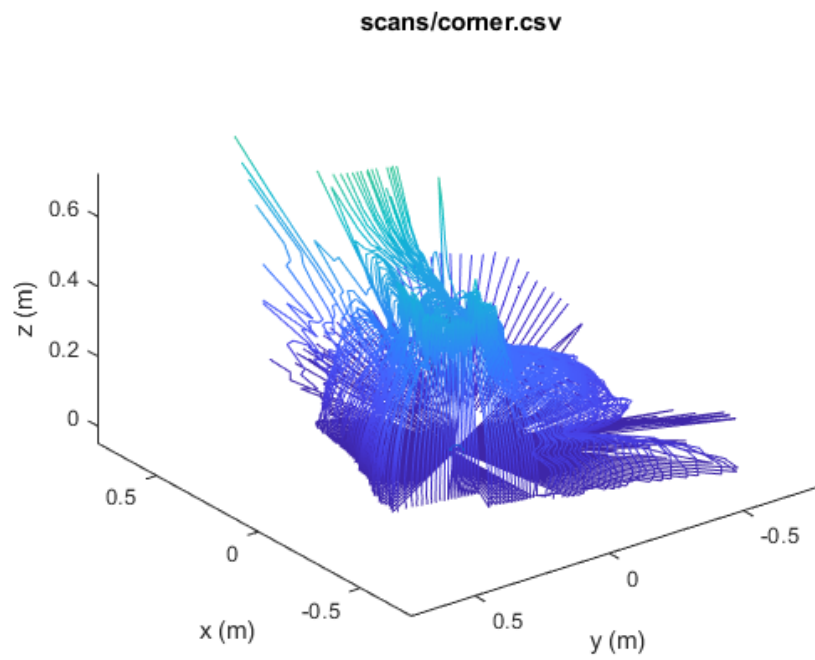
**Figure II13:** Another angle of “corner”, from the perspective of the corner..
