Subject: HOUT BAY SEWAGE - COUNCILLOR/MINISTERIAL ENQUIRY ON CITY'S PLANS FOR DEALING WITH SEWAGE

HOUT BAY CATCHMENT POLLUTION ABATEMENT STRATEGY AND ACTION PLAN (PASAP)

Document Ref:	CSRM/PASAP/HOUT BAY CATCHMENT
Version:	Rev 12
Department:	Bulk Services (Water and Sanitation)
Branch:	Catchment, Stormwater and River Management

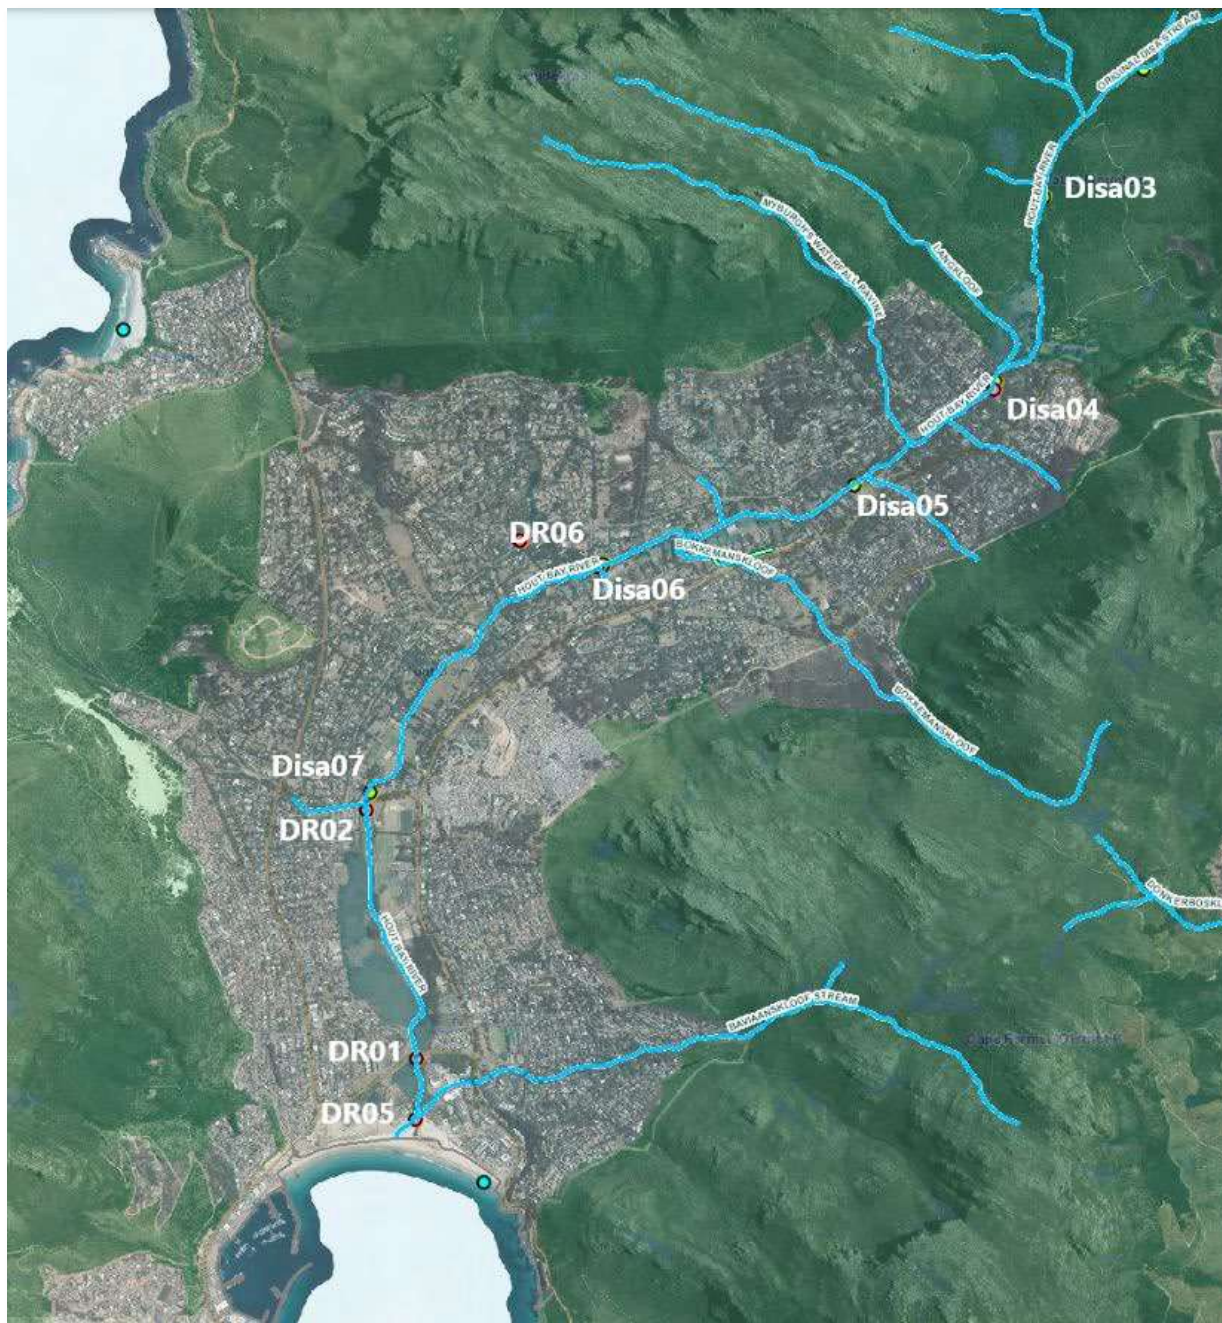
Figure 2-1: Hout Bay Rivers Catchment - Monitoring Points

The City has a monthly sampling programme, which includes various sample locations within the Hout Bay Catchment area, as shown in **Figure 2-1**.

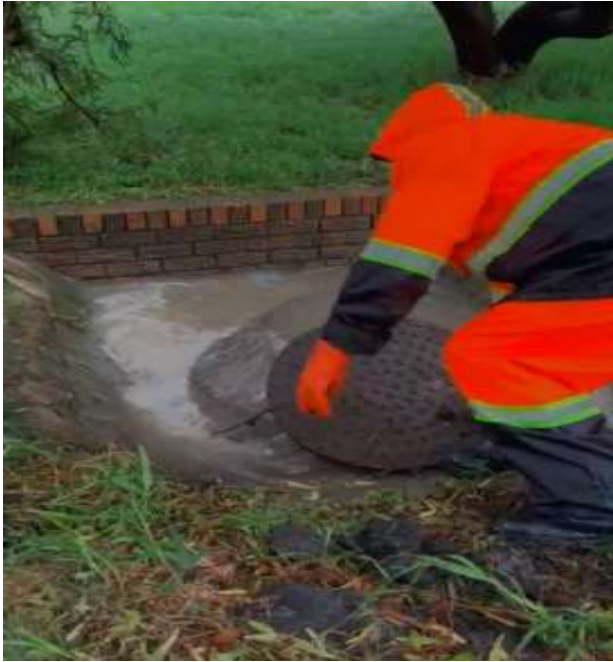
Figure 4-2: Overflowing sewer manhole connected directly to the Hout Bay River

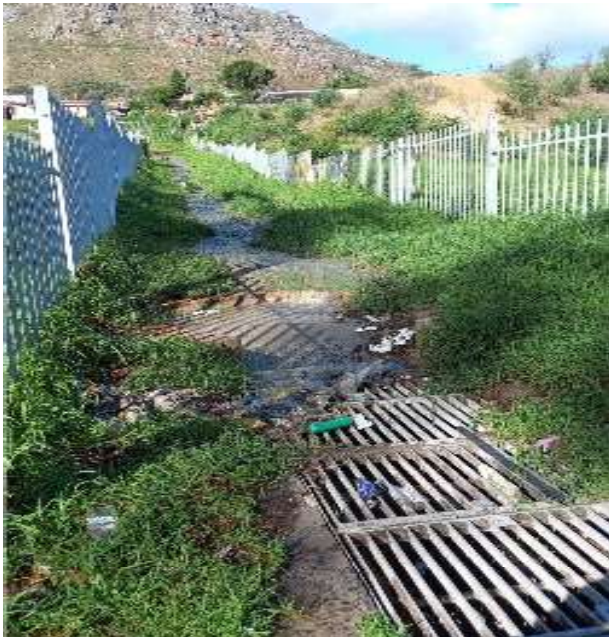
Figure 4-3: Overflowing sewer manhole

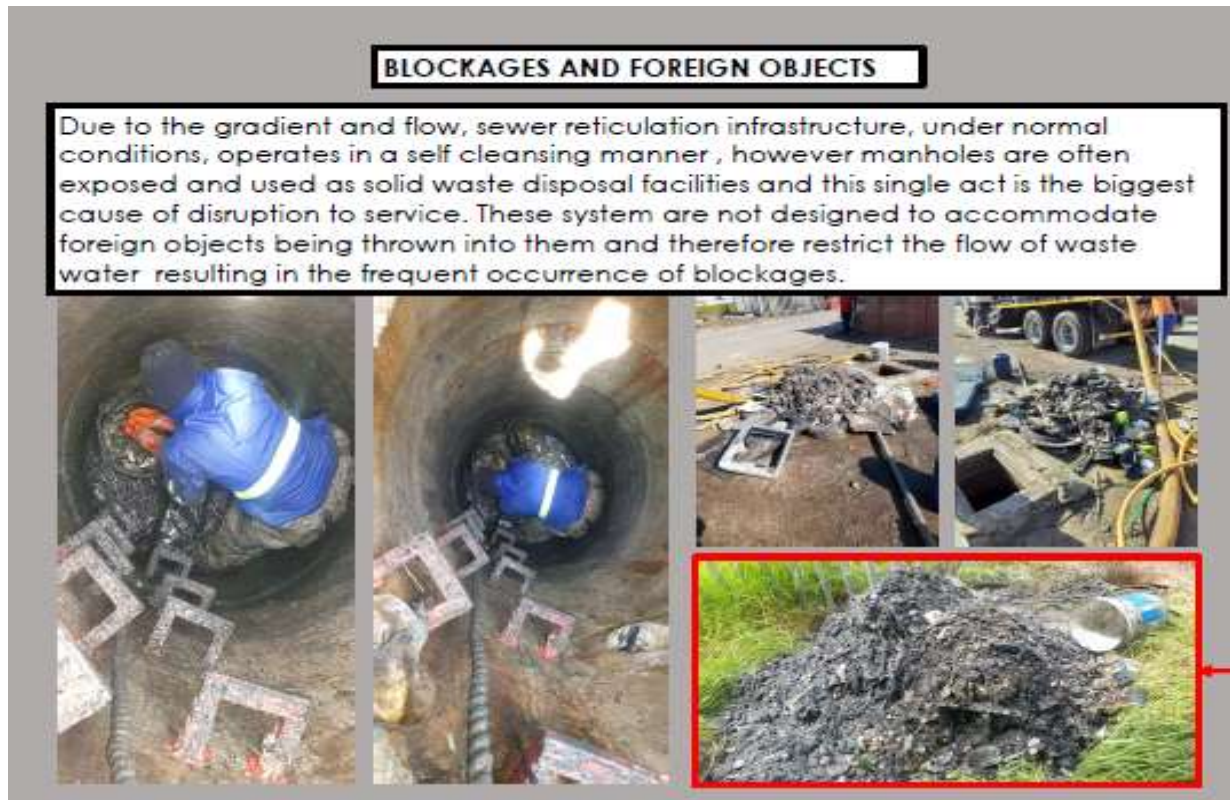
Figure 4-4: Impacts of sewer blockages and foreign objects dumped into the sewer manhole

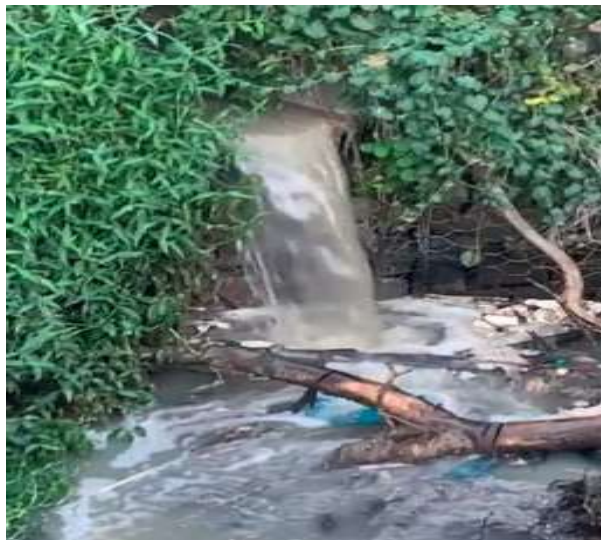
Figure 4-5: Highly Polluted water flowing from one of the stormwater outfalls

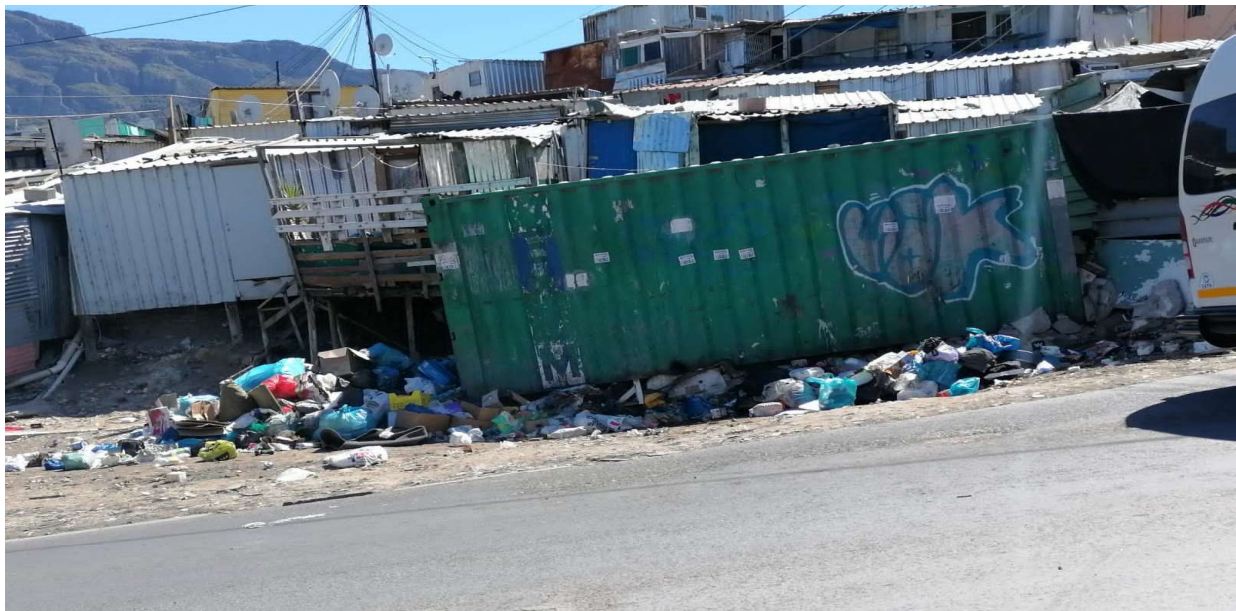
Figure 4-7: Inadequately managed solid waste, resulting in solid waste landing in the stormwater and sewer networks

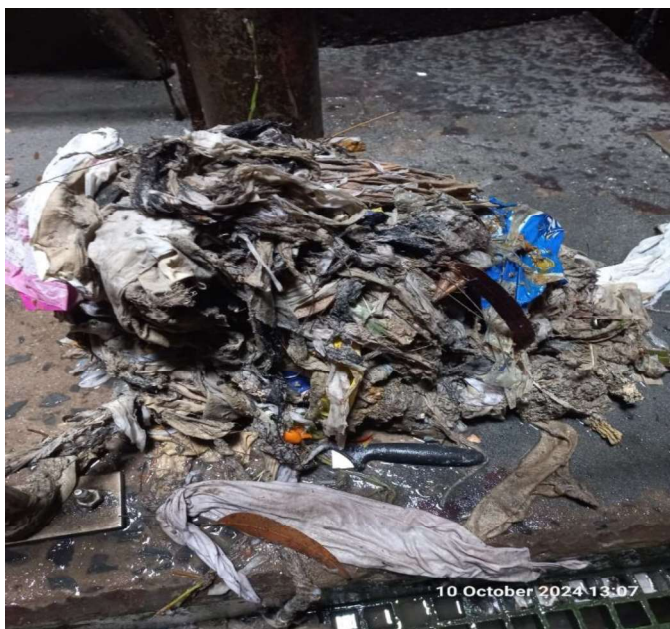
Sand ingress, along with foreign objects have been identified as the reason for the sewer system challenge experienced. The build up of this foreign material at the pumpstation inlet section and subsequently, in the sewer network, created a restriction for sewer water entering the pumpstation.

Clearing and cleaning of the affected infrastructure started and concluded on the 9th and 10th of October 2024. Material found in the Pumpstation manhole is in the picture that follows (Figure 1).

Figure 1. Material found at the inlet section of Disa Pumpstation
