# KNOW YOUR COAST, 2021

Key findings from over 10 000 sample bacterial tests at 99 sites along 307 km of coastline.

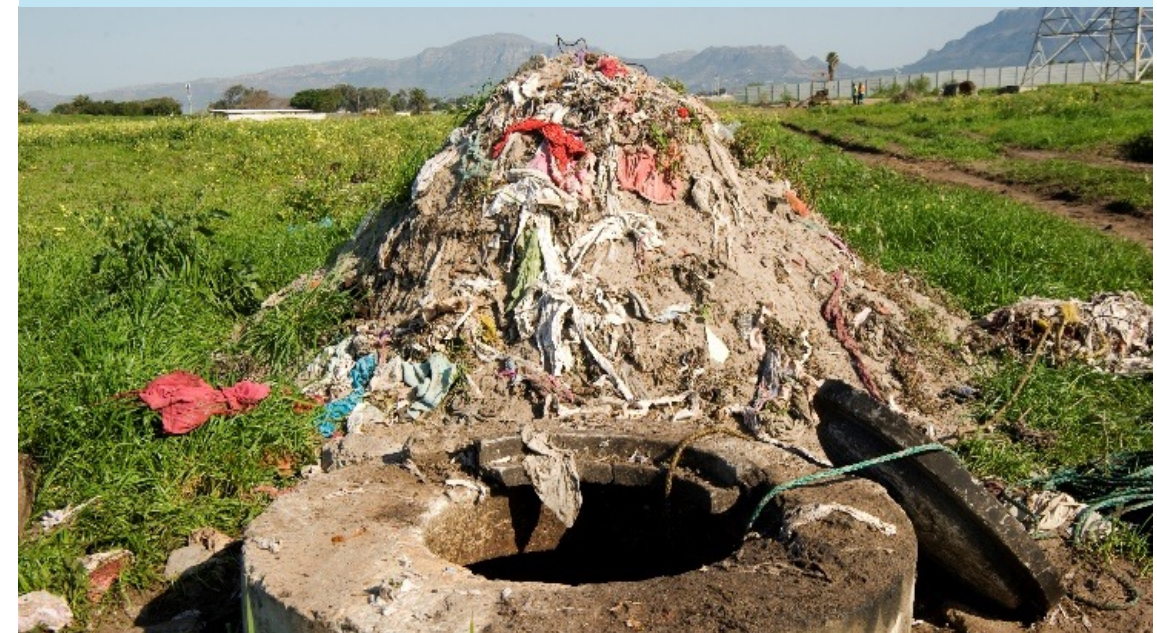
FIGURE 1: FOREIGN MATERIALS REMOVED FROM THE CITY'S SEWER SYSTEM

While blockages from misuse are a major issue, there are also cases of sand ingress into sewer lines, leading to blockages and leaking, which requires ongoing maintenance (more information on this can be found on pg. 17 of this report). There are also cases of damaged or collapsed pipes causing leakages into the environment. Investment into upgrades and response efficiency to address these challenges are provided in this report.

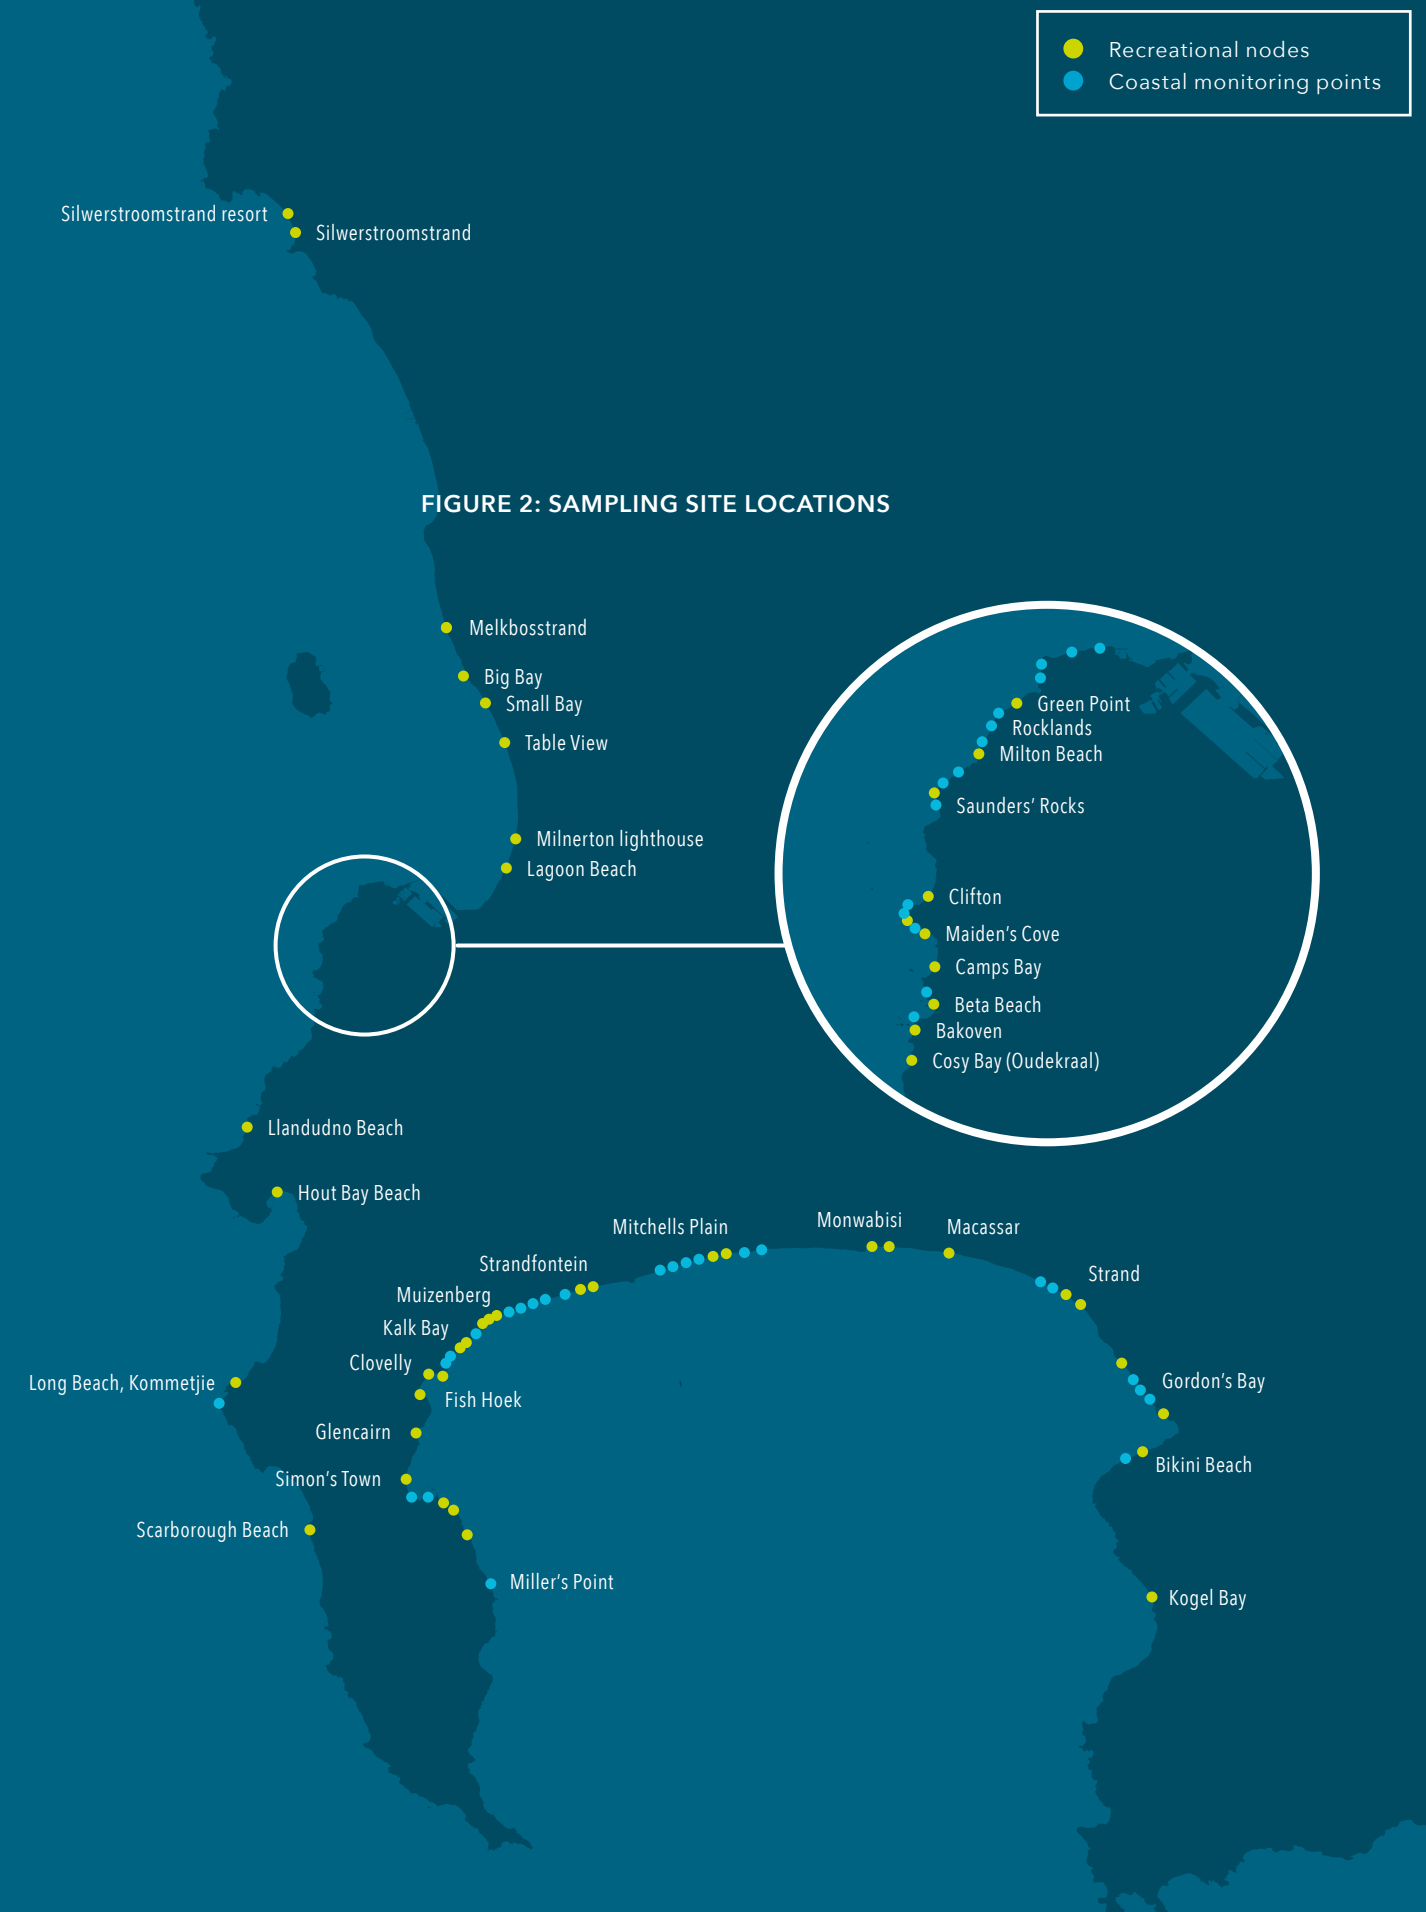
In 2020, the City added 11 additional sites to its 88 coastal quality-sampling points, taking the total points monitored twice per month to 99 sites (Figure 2). These new sites were added specifically to advance our knowledge at certain locations in respect of the drivers behind poor coastal water quality. This, in turn, will aid the City in formulating appropriate management interventions towards improving coastal water quality for these areas. The detail of these new sample sites, and the rationale for choosing these sites, may be found on page 8 of the [KYC, 2020](#) report.

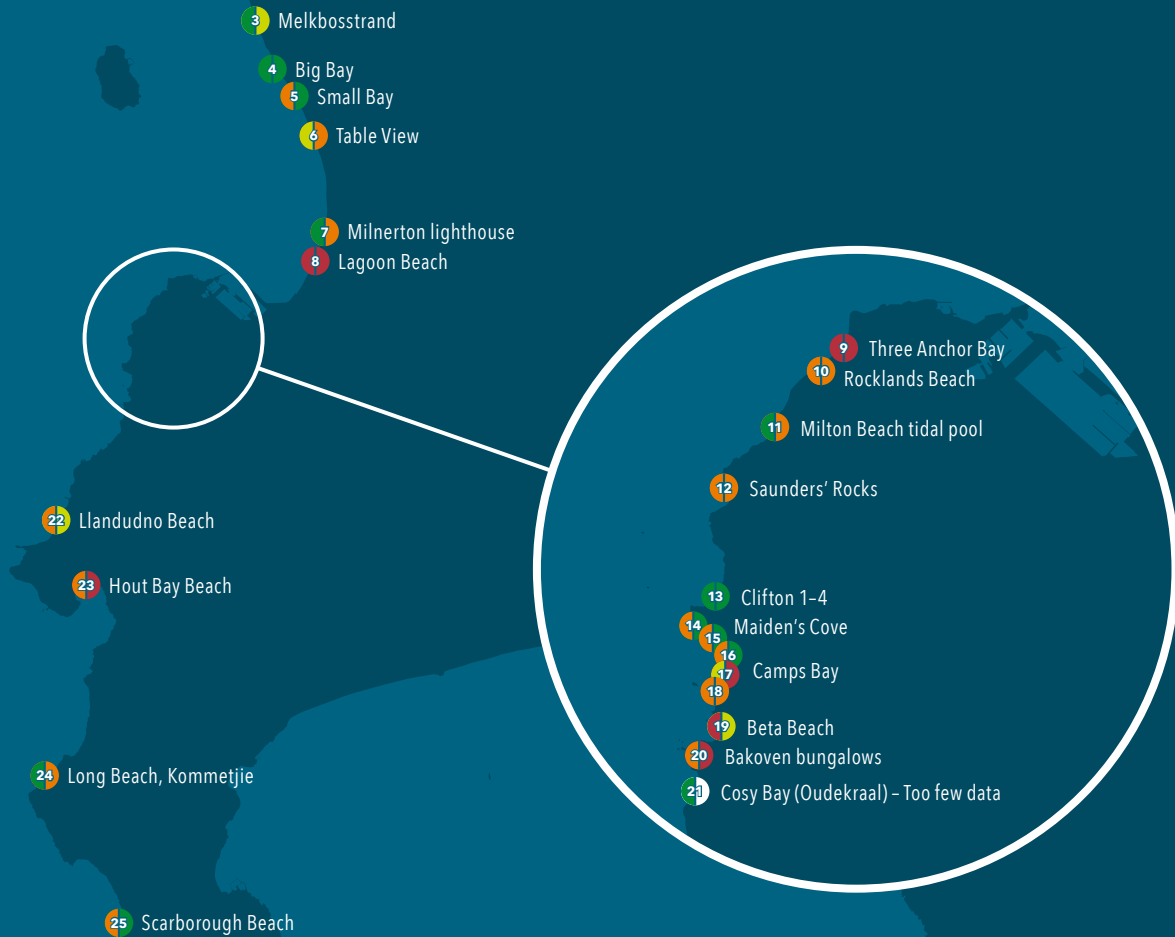
FIGURE 3: WATER-QUALITY RATINGS FOR RECREATIONAL NODES ALONG THE ATLANTIC COAST

- Water quality at 20 (71%) of the recreational nodes (Figure 4) met the minimum requirement for recreational use in 2021 (eight were rated 'excellent', two 'good' and ten 'sufficient').
- Seven (25%) of the recreational nodes were rated as 'poor'. These were Lagoon Beach, Three Anchor Bay, Saunders Rocks tidal pool, Bakoven bungalows, Bakoven Beach, Hout Bay Beach and Long Beach, Kommetjie.
- Cosy Bay (Oudekraal) had insufficient data to complete an accurate analysis.

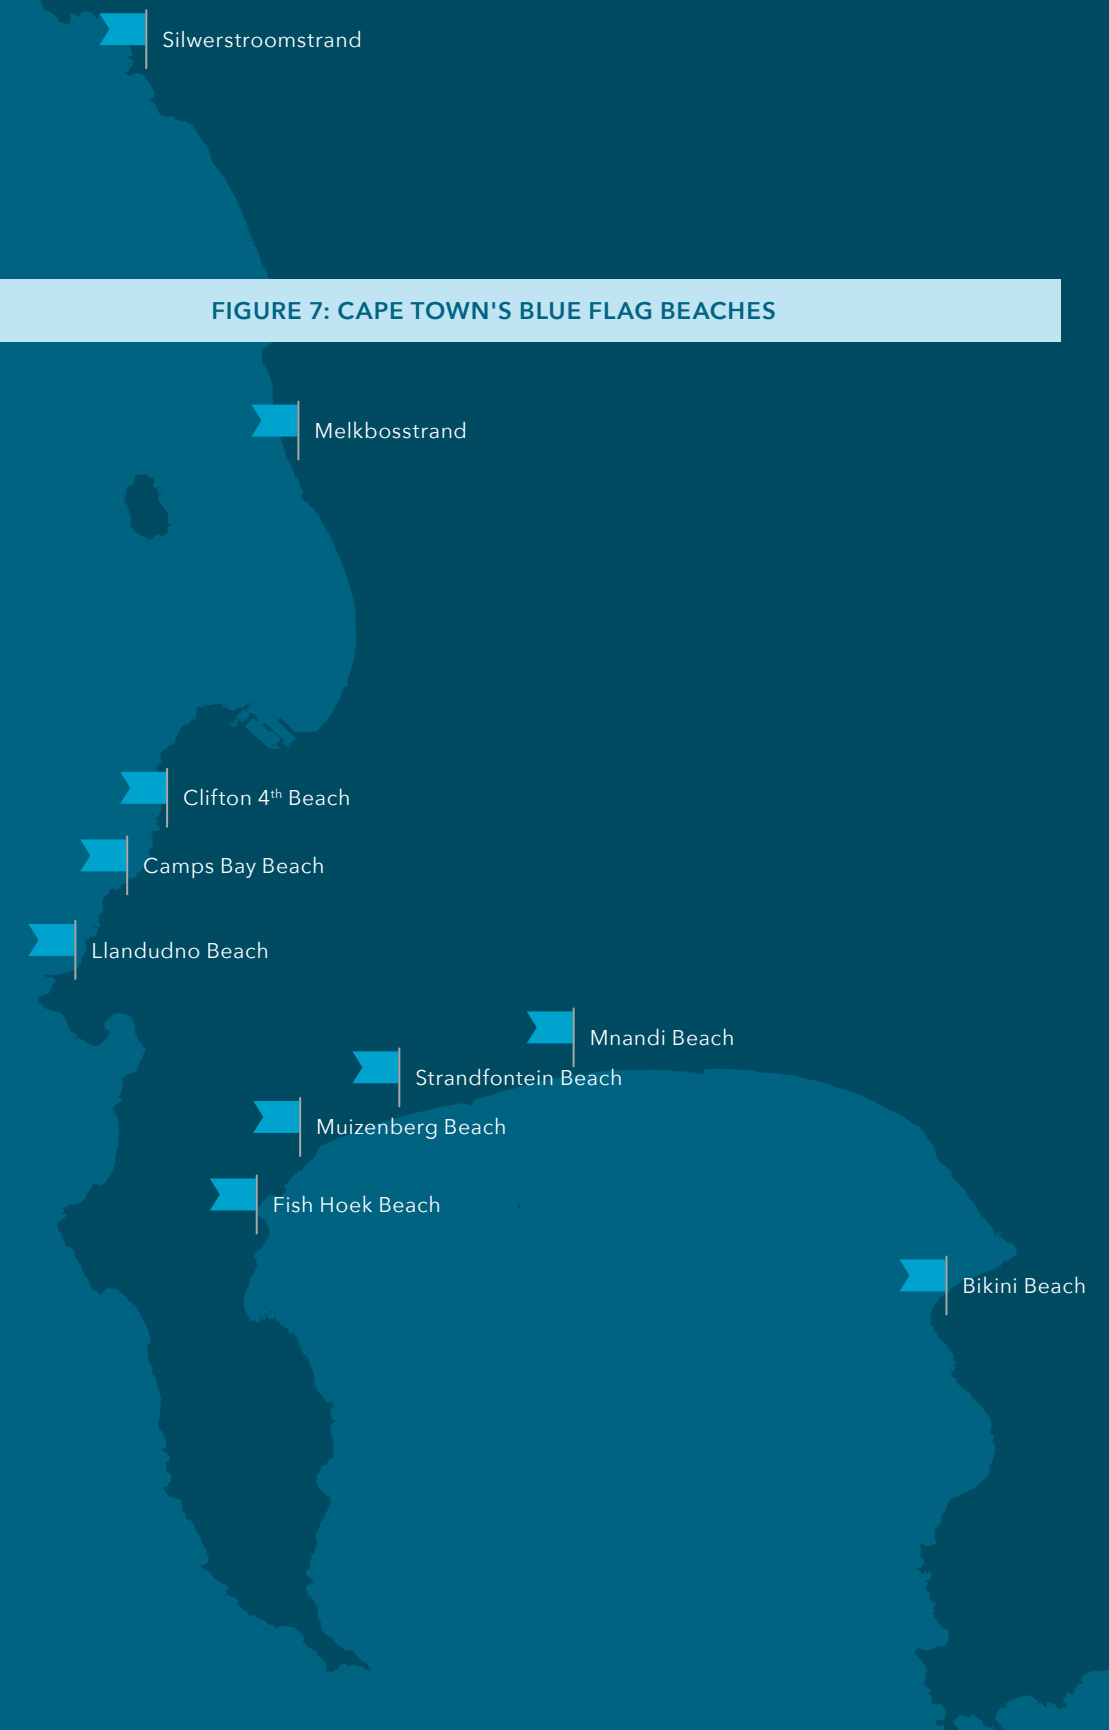
FIGURE 7: CAPE TOWN'S BLUE FLAG BEACHES

Despite the challenge of sewage spills, all Blue Flag beaches managed to maintain their status. The City currently has 10 Blue Flag beaches, with five each on the Atlantic and False Bay coastlines (Table 7 and Figure 7).
