This document sets out to validate the Large Soil Moisture Probe Temperature readings and counter readings (Counter readings have already been confirmed to meet requirements).

XP1=1<sup>st</sup> Cast Probe, XP2=2<sup>nd</sup> Open Probe

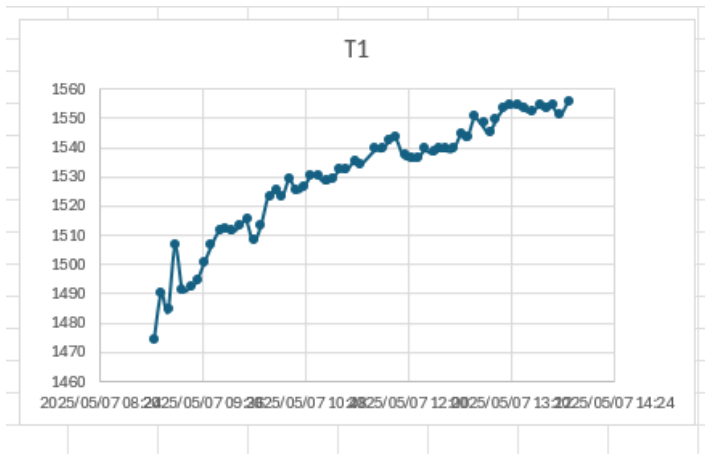
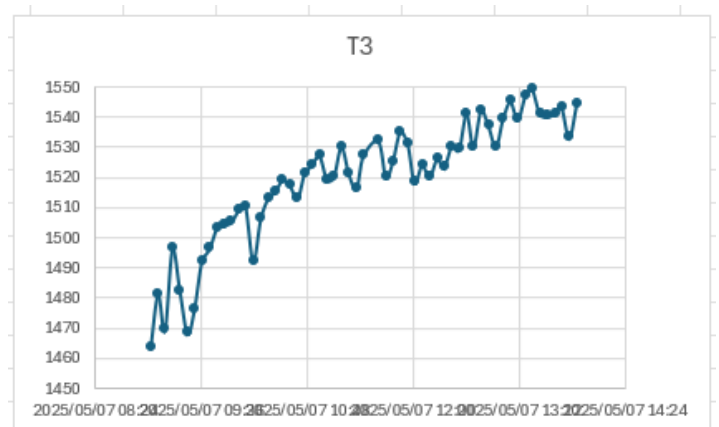
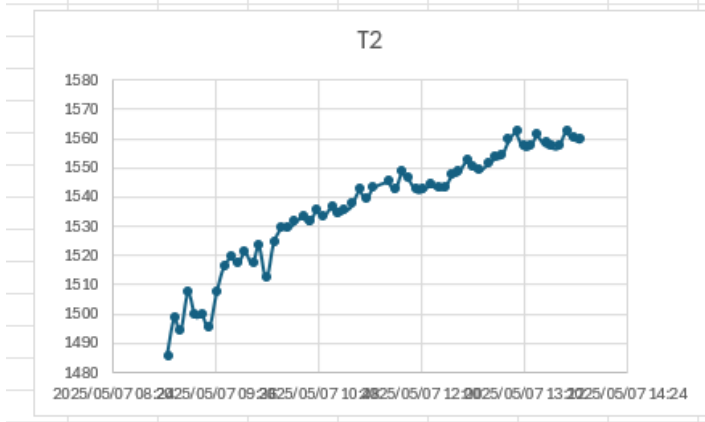
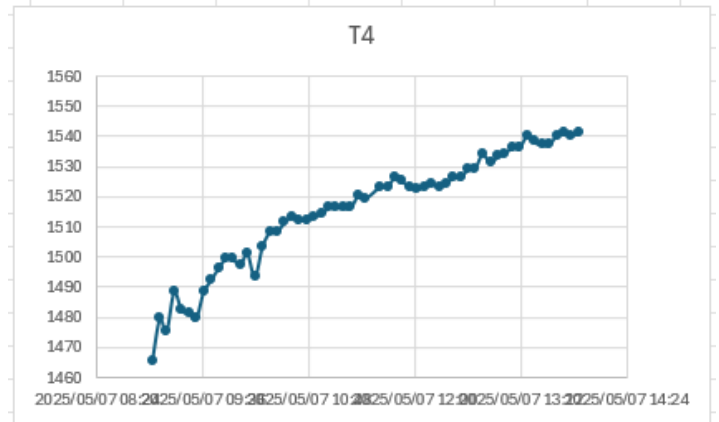
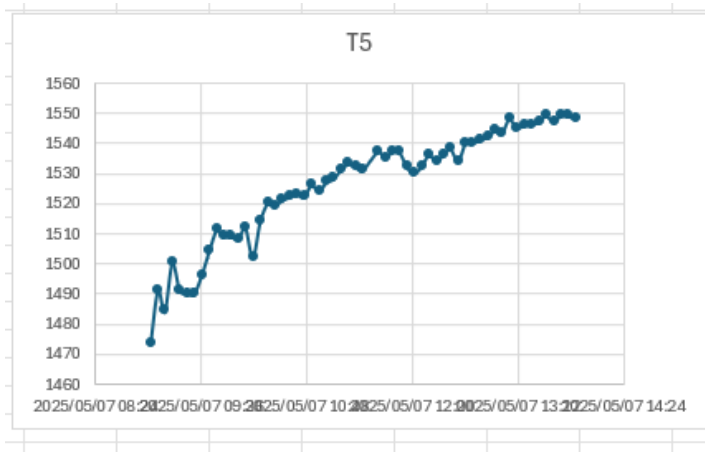
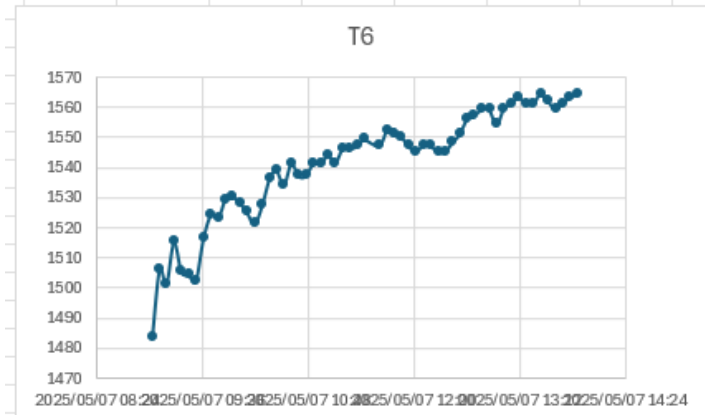
Below is a close-up of the above readings after being taken out of the fridge
