This document sets out to validate the Large Soil Moisture Probe Temperature readings and counter readings (Counter readings have already been confirmed to meet requirements).

XP1=1st Cast Probe, XP2=2nd Open Probe

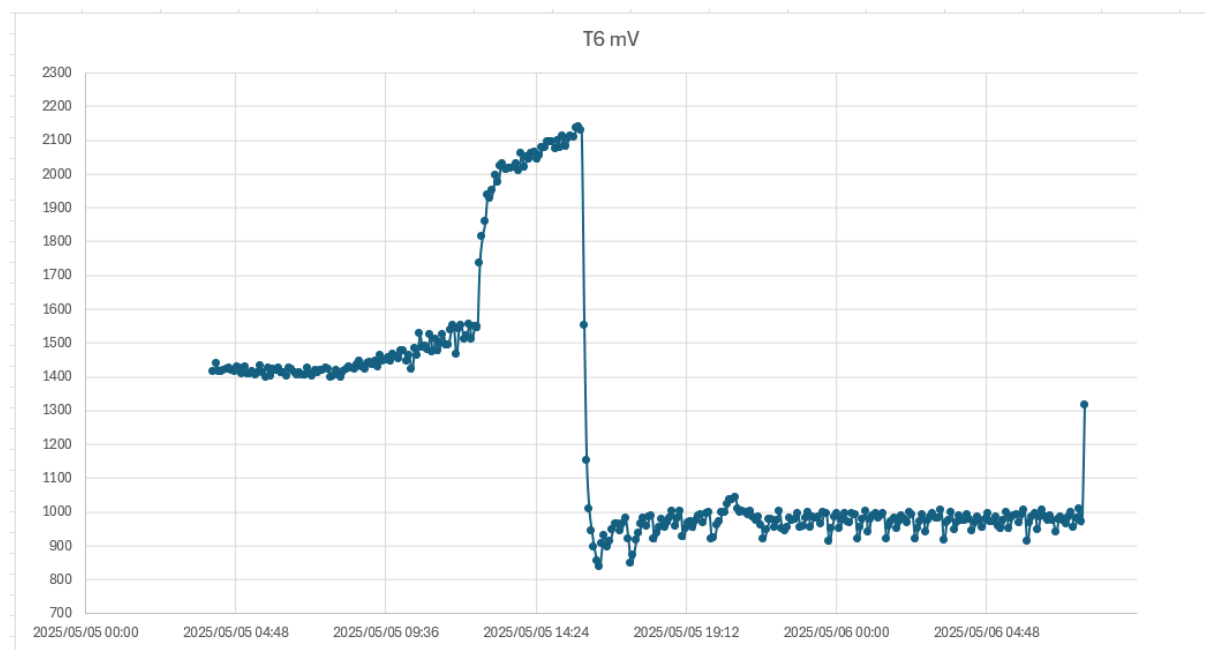
Plotted the graphs after swapping the sensors as described in the table above.

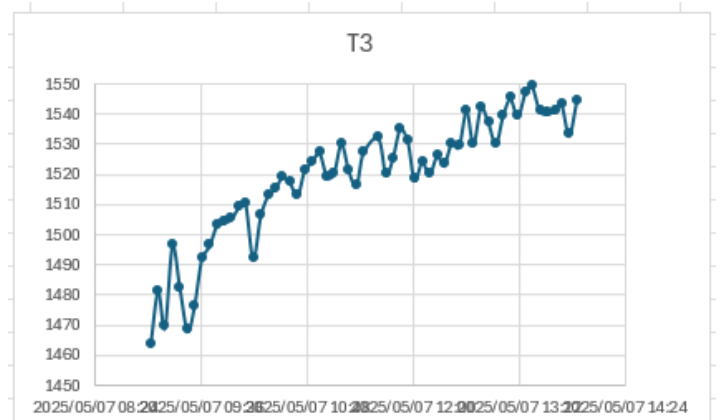
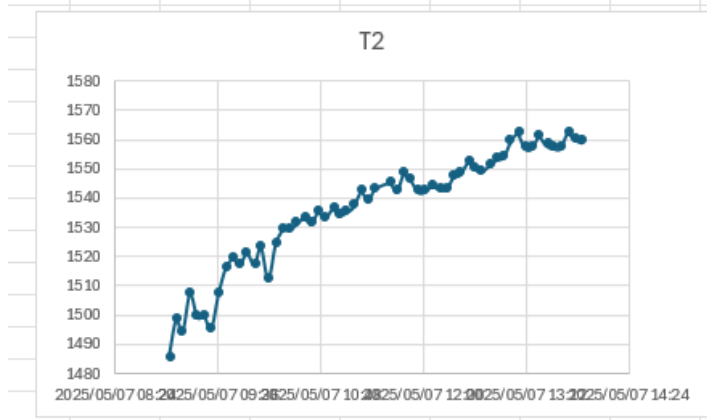
Below is a close-up of the above readings after being taken out of the fridge

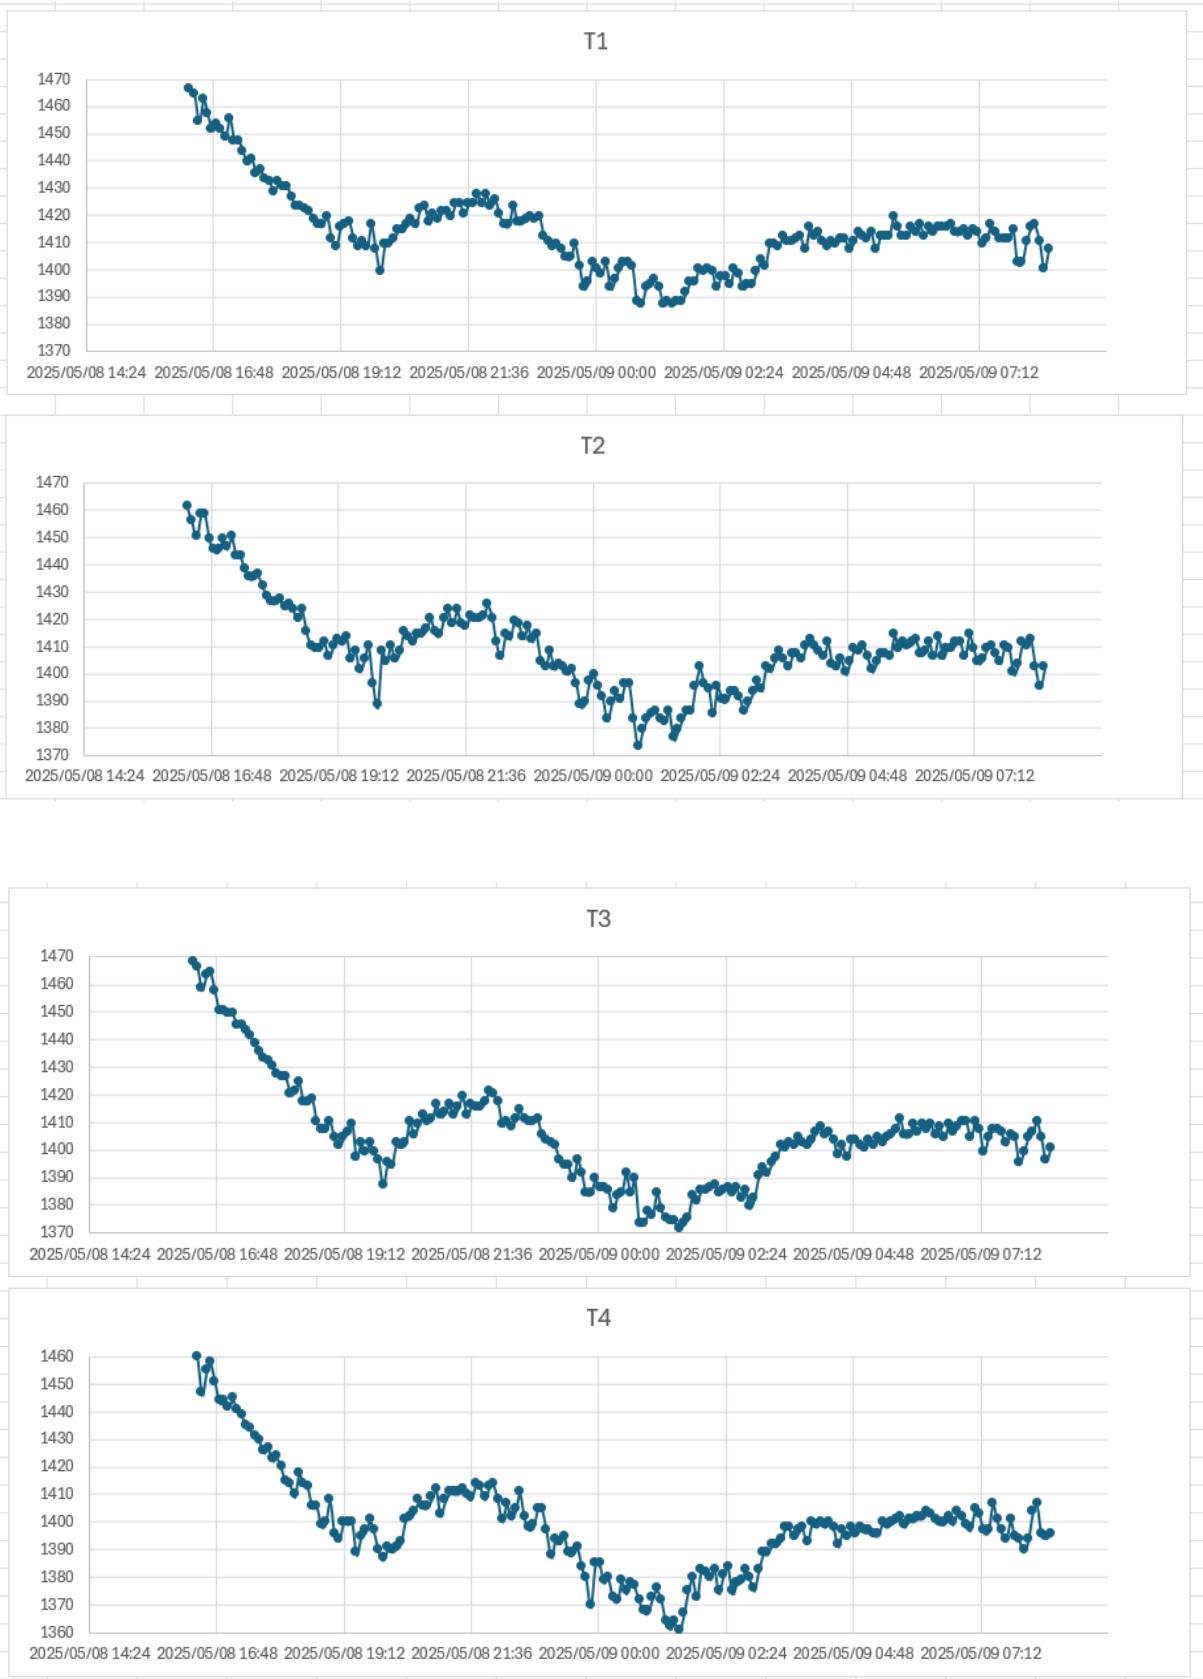
Data plotted for just the night portion below:

Observations: Temperature data oscillations have been removed. The data is now within the necessary specification for compliance with the requirements for the soil moisture probe.

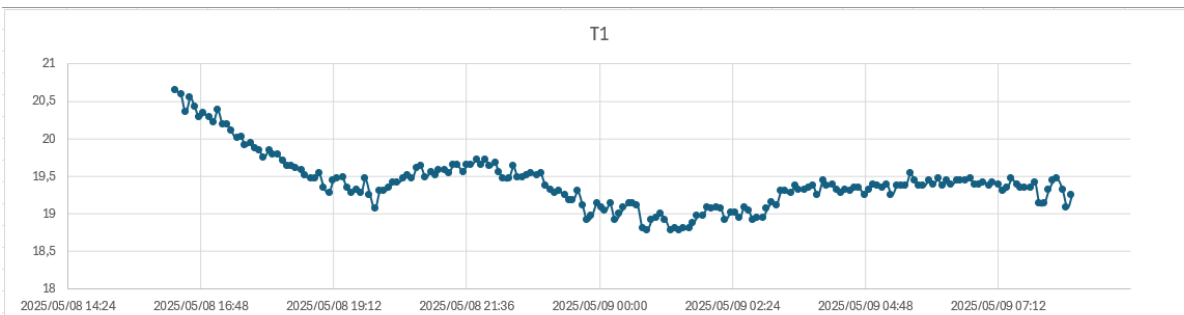
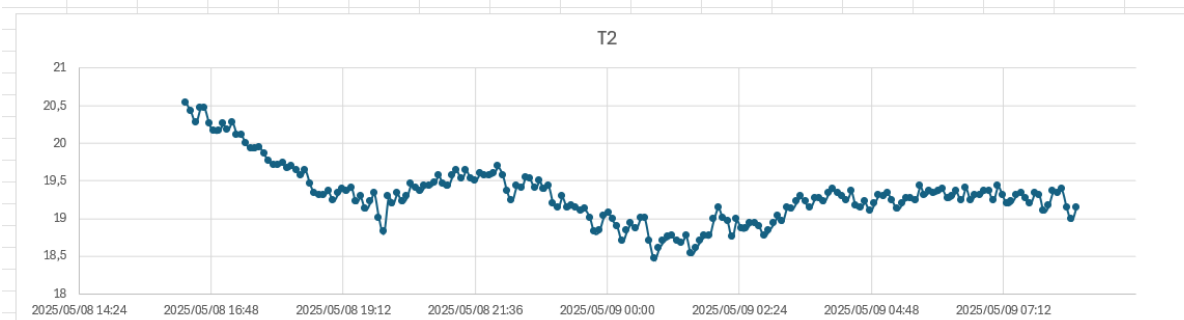
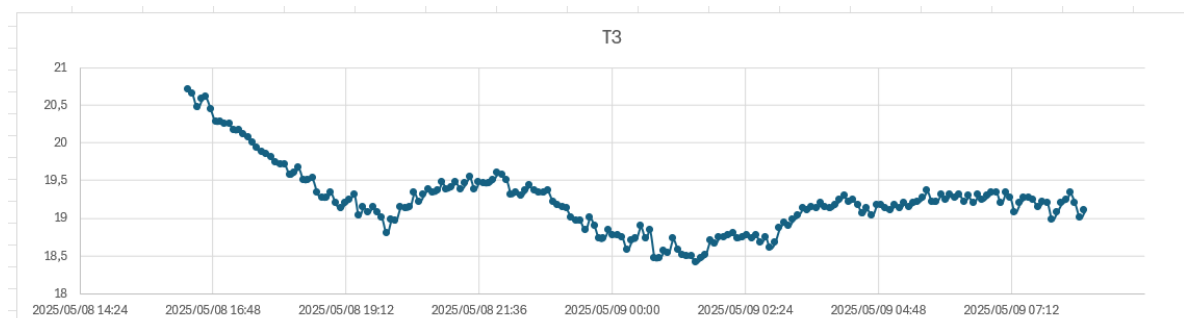
Values converted to temperatures:
