Installation tips for the Muller Pantera

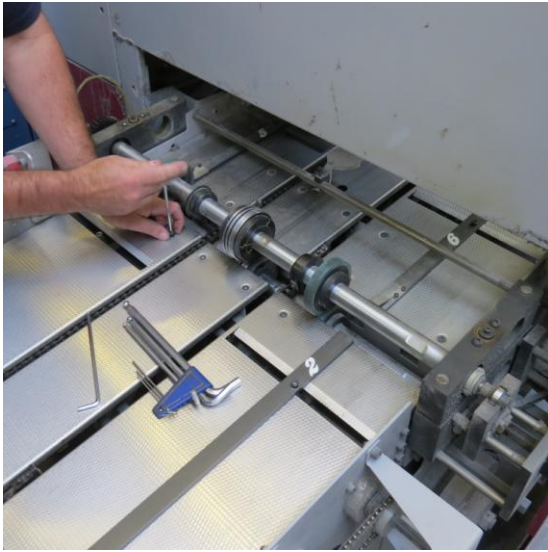
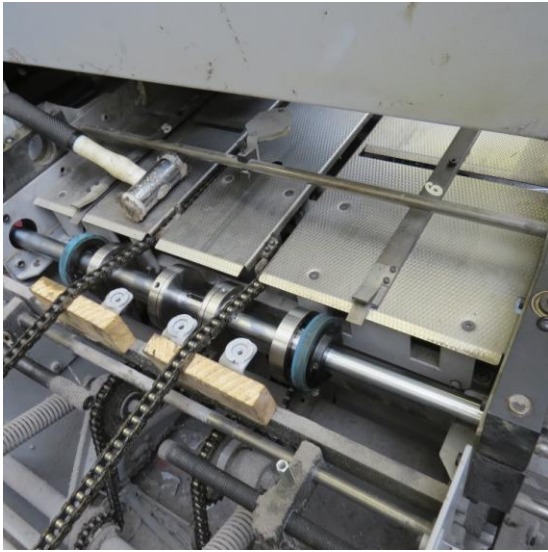
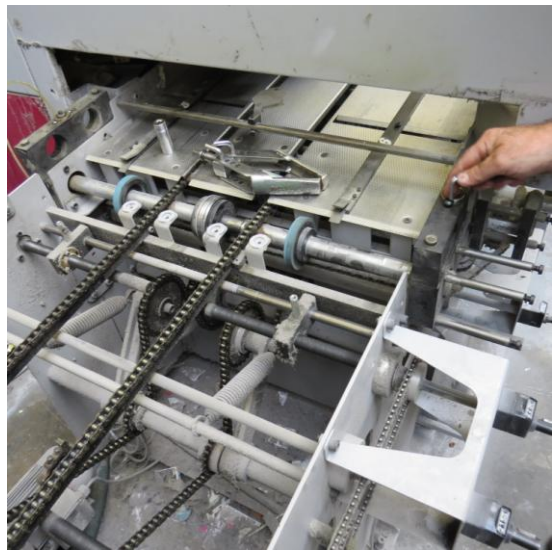
With the Nylon crease ribs locked into the crease units align the bottom shaft crease unit with the rear of the clamp and tighten the bottom fixing screws.

Place the nylon crease ribs inside the female channels.

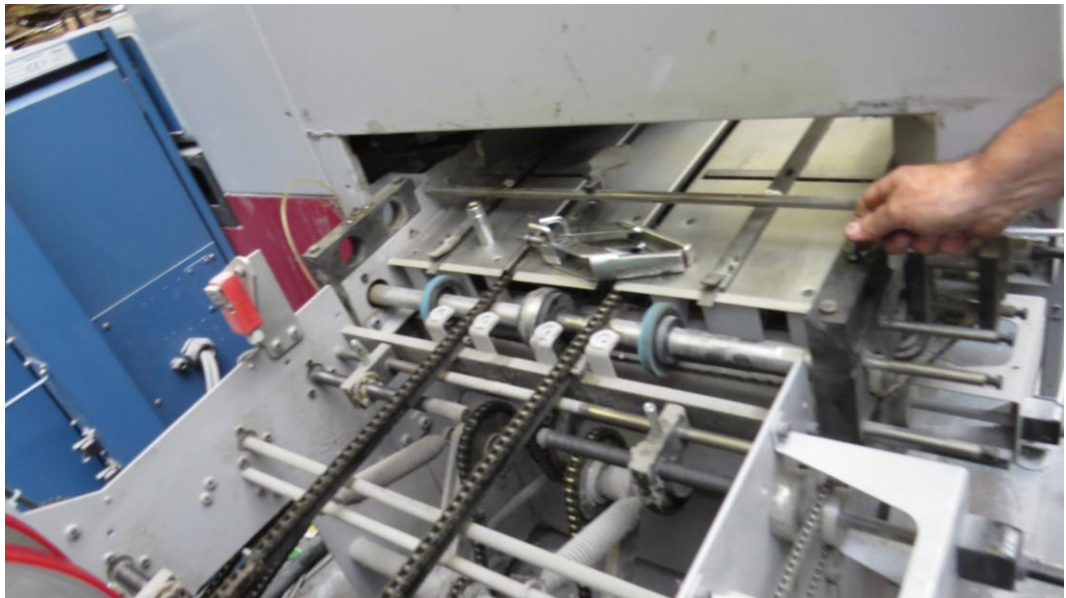
DO NOT TIGHTEN THE TOP CREASE UNITS.

Place a sheet of cover stock between the top and bottom crease units. Slowly run the machine until the top shaft fixing screws become accessible.

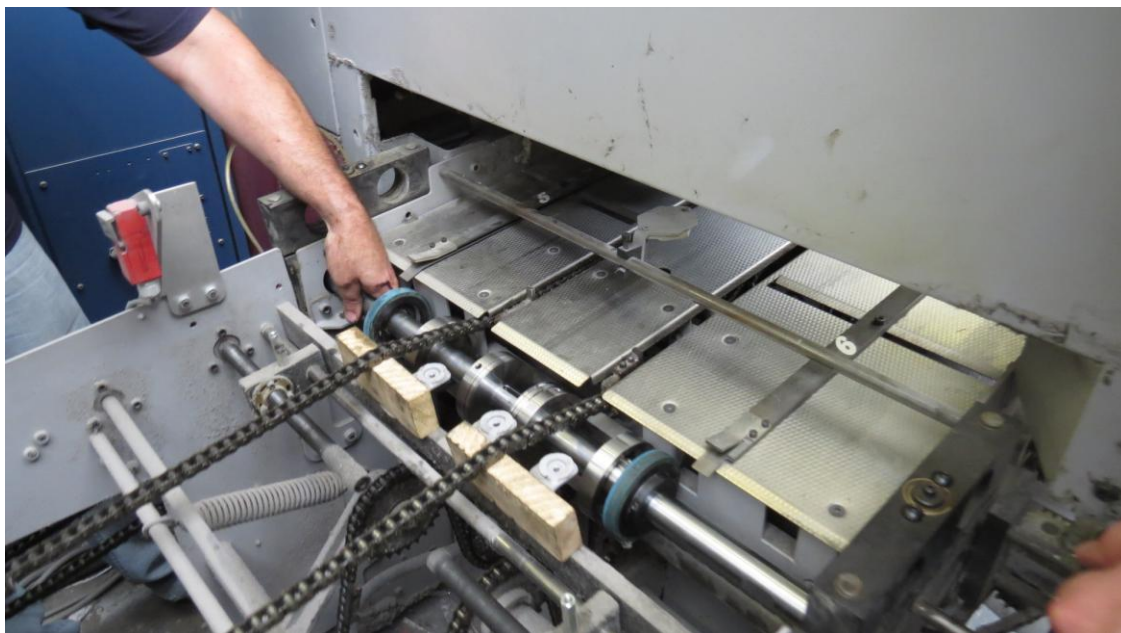
As the cover travels through the crease units the loosened top crease units will automatically centralise to the optimum creasing position.

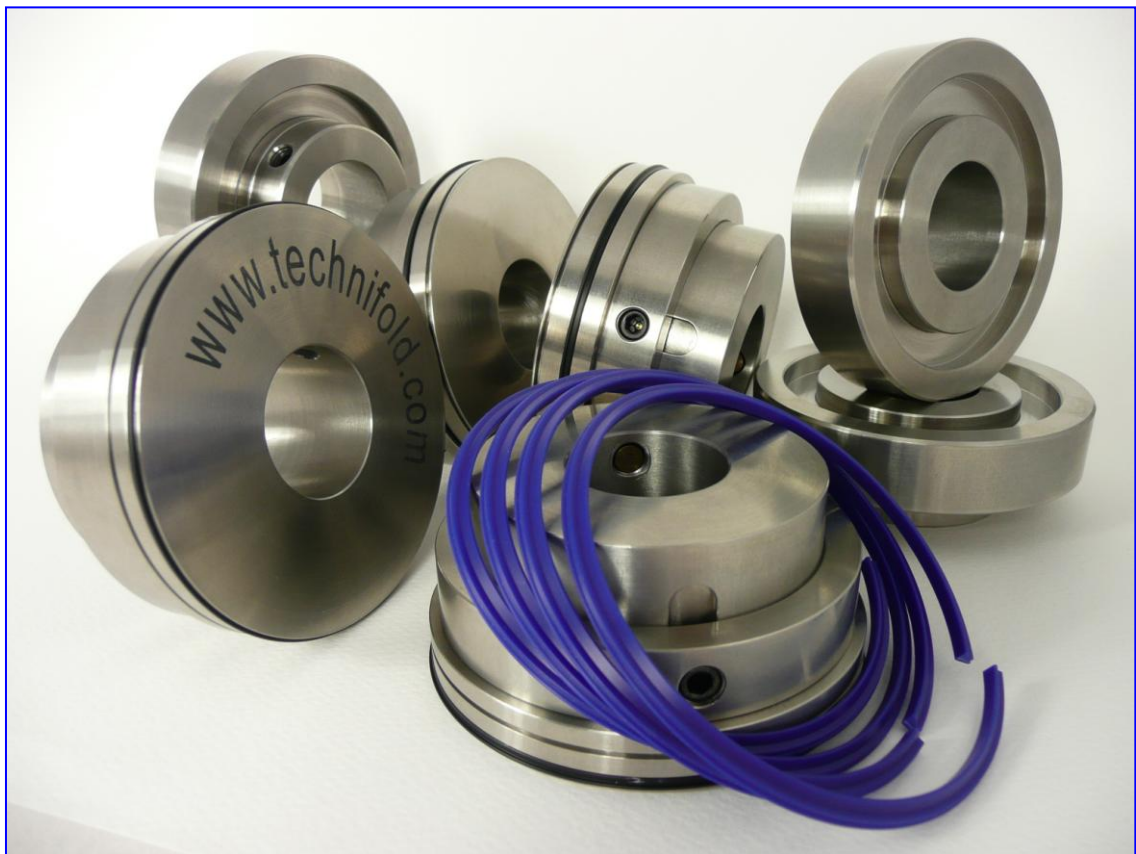
With the cover stock still positioned between the crease units tighten the top crease units.
