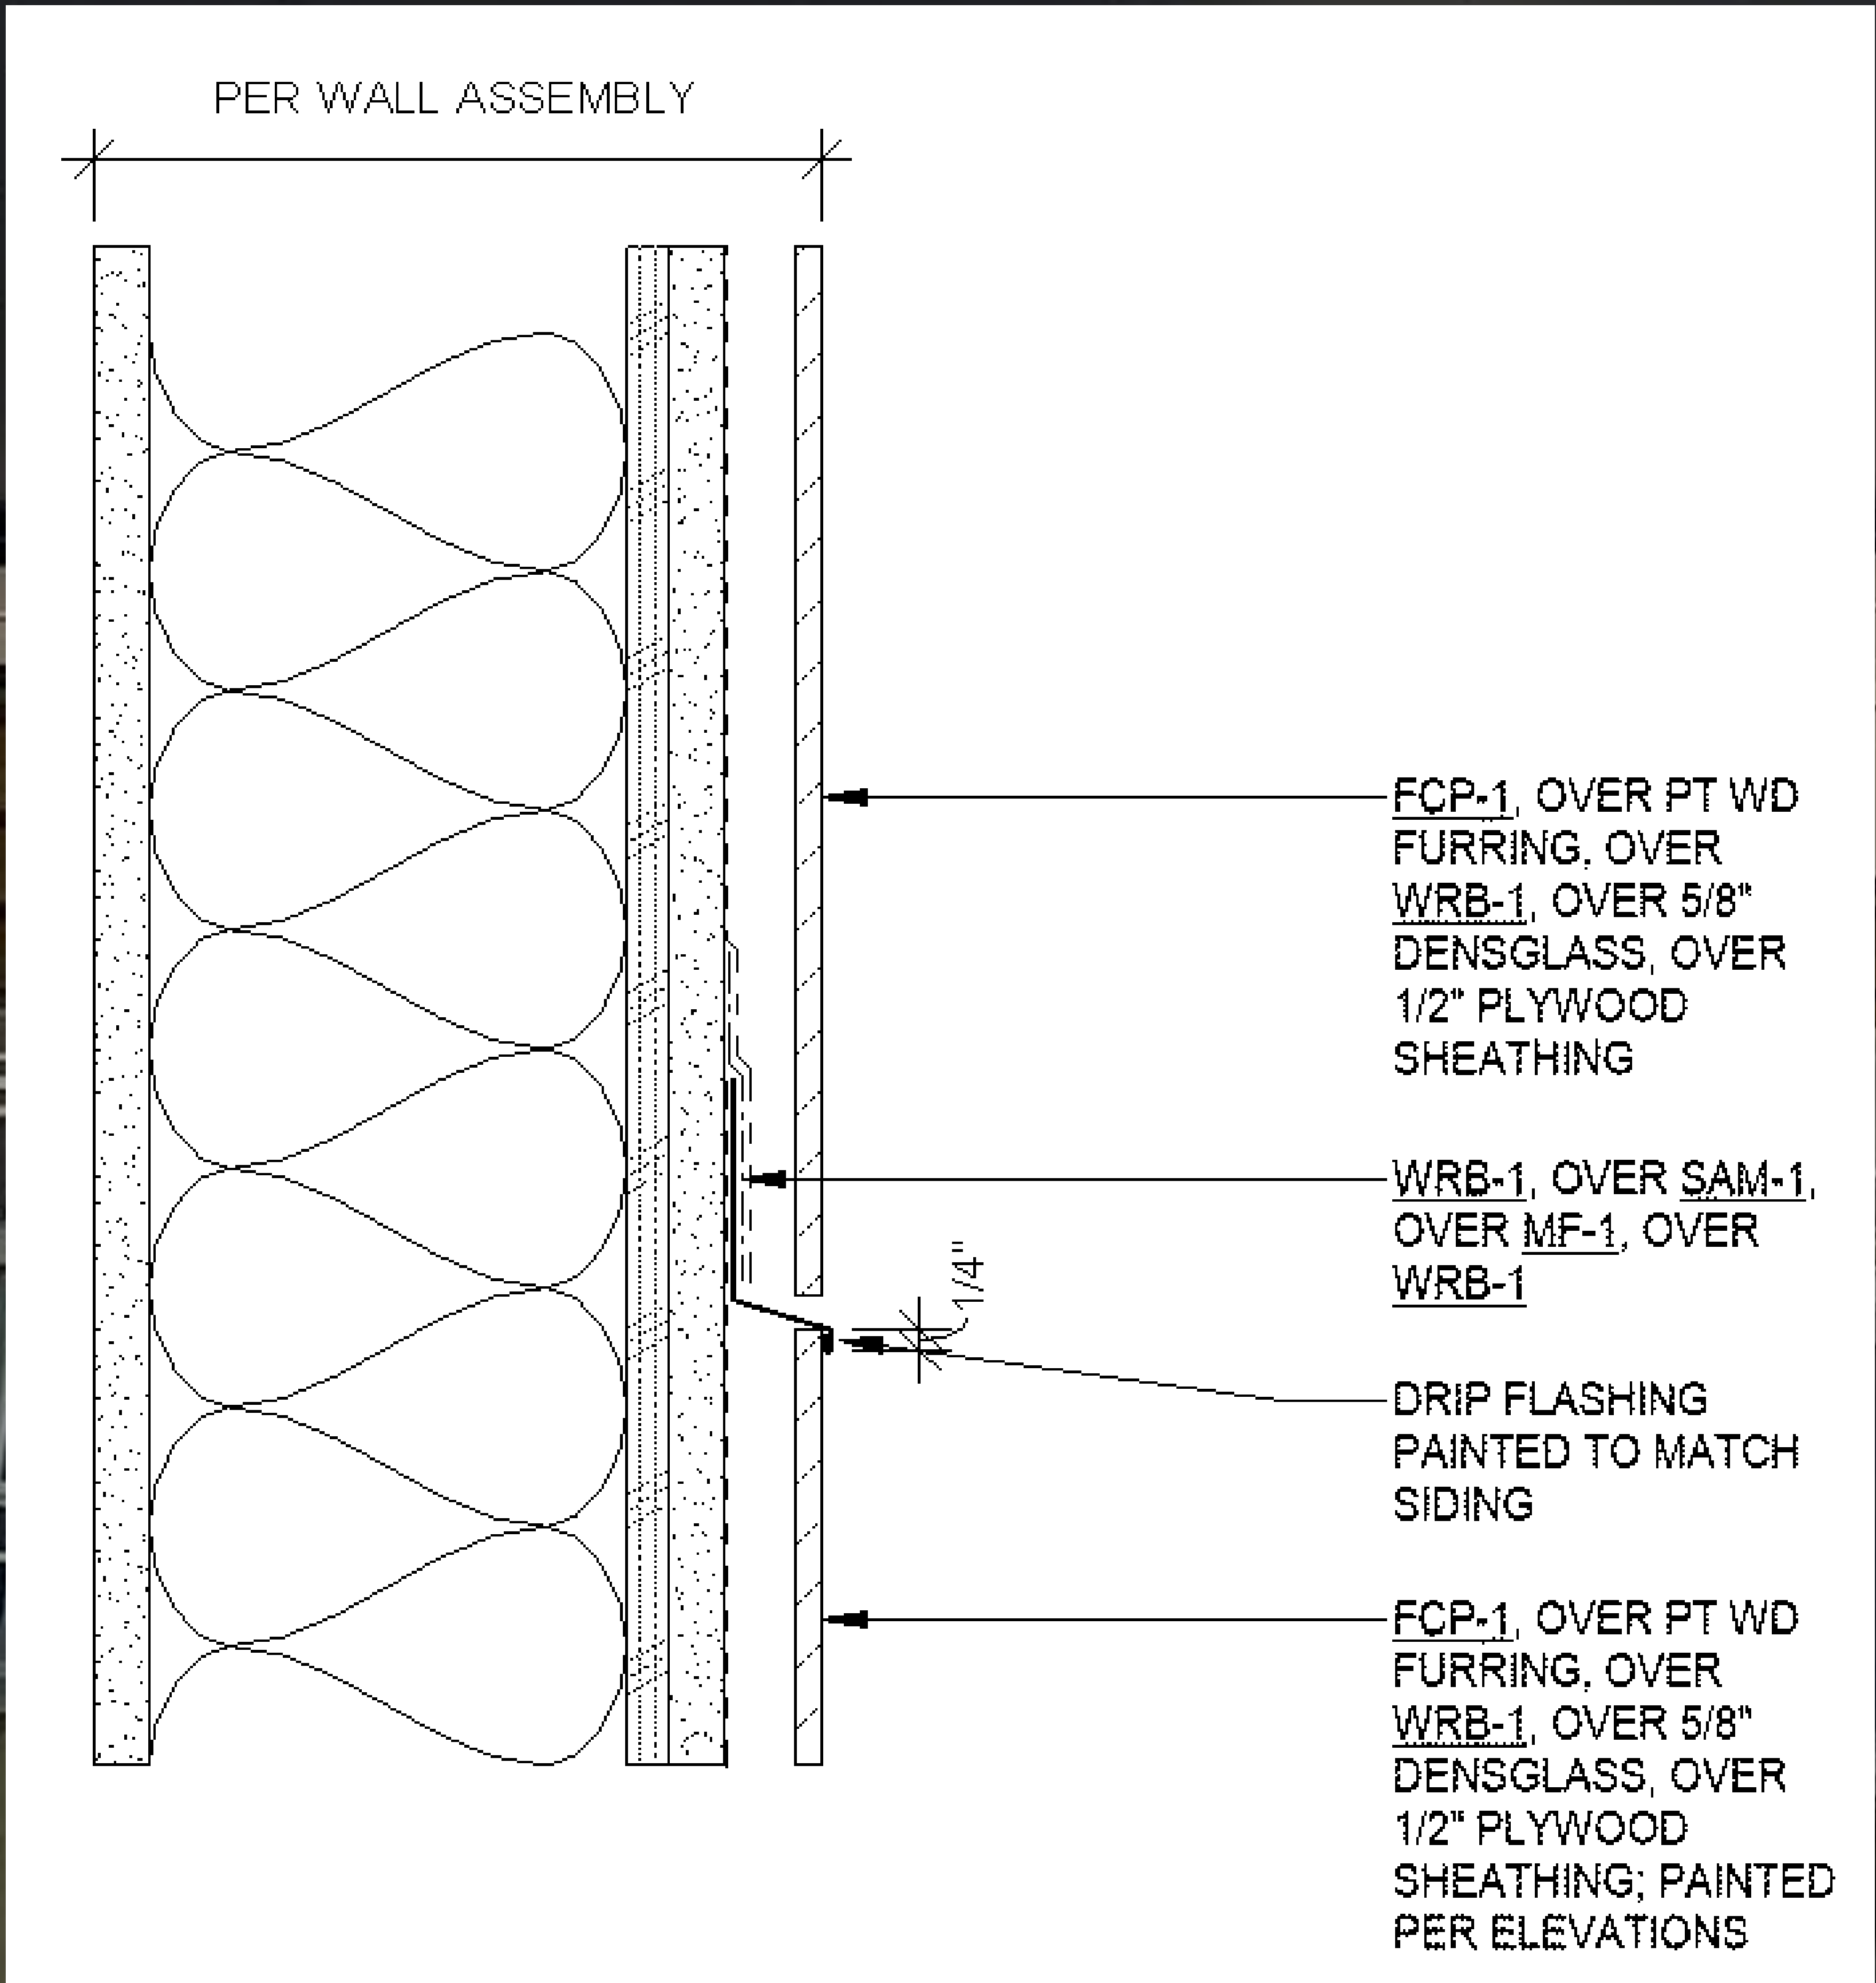
HORIZONTAL JOINT AT RECESSED WINDOW FACING COURTYARD ON BUILDING F HAS NO SILL FLASHING. SILL FLASHING IS REQUIRED AT ALL HORIZONTAL JOINTS. REMOVE SIDING AND INSTALL FLASHING.
