**“Report on Road Condition and Safety of Maruti  
Temple Road, Gangotri Layout, Mysuru”**

**BACHELOR OF ENGINEERING  
IN  
CIVIL ENGINEERING**

**DEPARTMENT OF CIVIL ENGINEERING  
July, 2023**

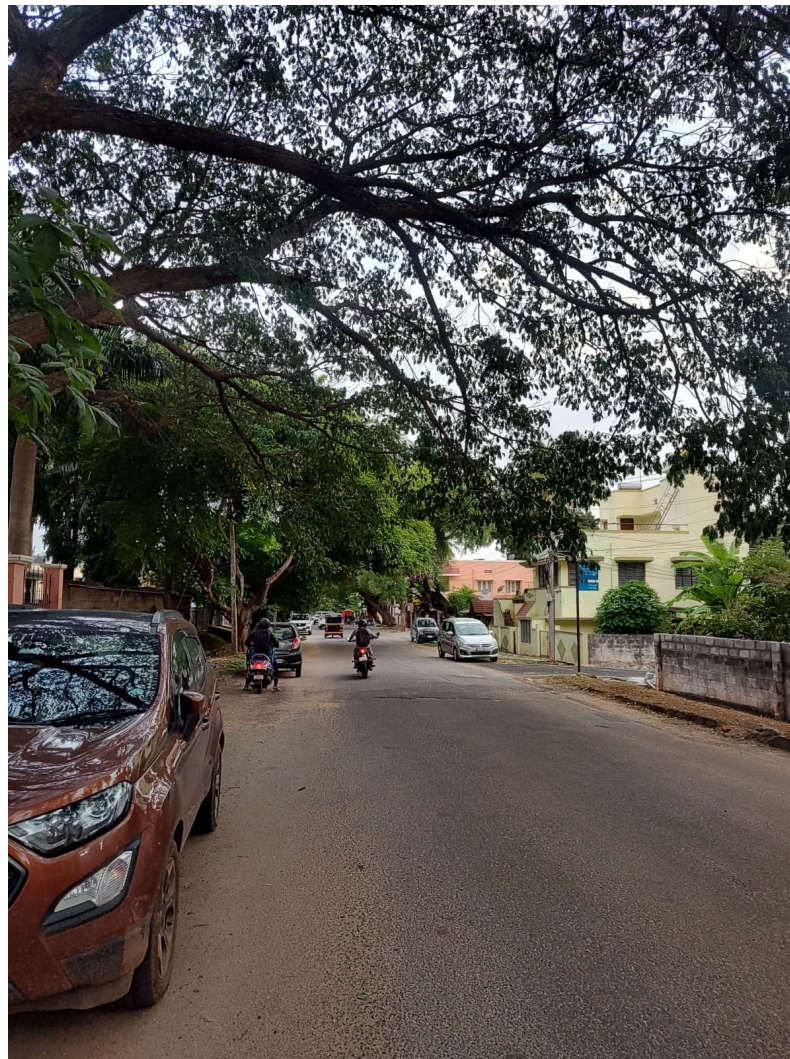
*Figure 1: Maruti Temple Road, Gangotri Layout, Mysuru*

Type of Road	: Residential road (ODR)
Location (Lat & Lon)	: (12.3071344, 76.6201587)
Lane width	: 3.75m
Road Width	: 7.5m
Road Length	: 630m
Kerb Width	: 1.2m
Max Permissible speed	: 40 kmph
Vehicle count	: Approx. 12 vehicles/min
Vehicle type	: LMVs and 2-wheelers

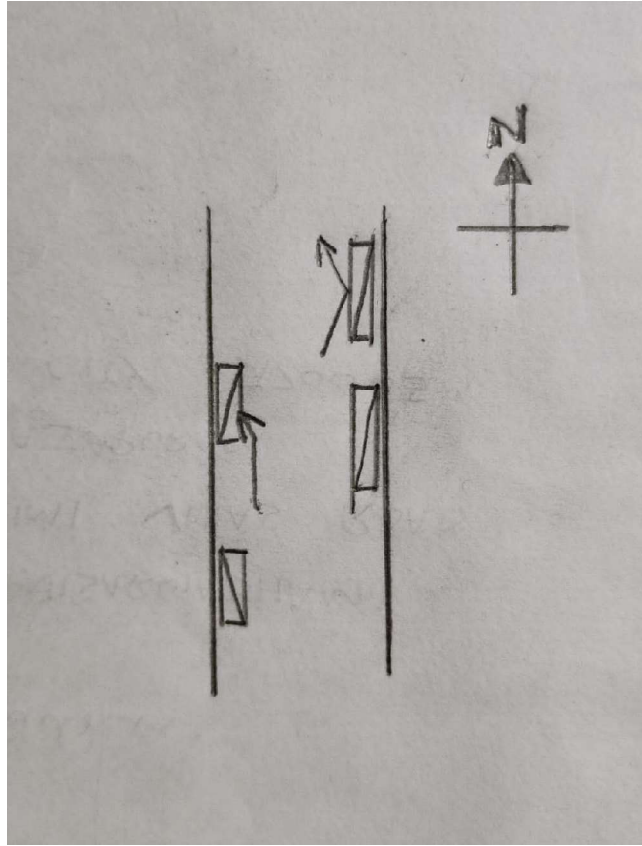
Figure 2: Collision Diagram

<b>Time</b>	<b>Date</b>	<b>Type of collision</b>	<b>Accident cause</b>	<b>Vehicles involved</b>
<b>17:15</b>	<b>15-01-2023</b>	<b>rear end collision</b>	<b>Reduced carriageway width due to parking</b>	<b>scooty v/s car</b>
<b>18:00</b>	<b>14-01-2023</b>	<b>rear end collision</b>	<b>Over speeding and carelessness of the rider</b>	<b>auto v/s car</b>
<b>21:15</b>	<b>19-01-2023</b>	<b>side swipe</b>	<b>Reduced visibility due to foliage</b>	<b>car V/s bike</b>
<b>08:30</b>	<b>25-01-2023</b>	<b>rear end collision</b>	<b>Water filled pothole impairing the driving ability</b>	<b>scooty v/s car</b>
<b>18:00</b>	<b>21-02-2023</b>	<b>Head on</b>	<b>Improper maintainence work</b>	<b>Car and kerb</b>

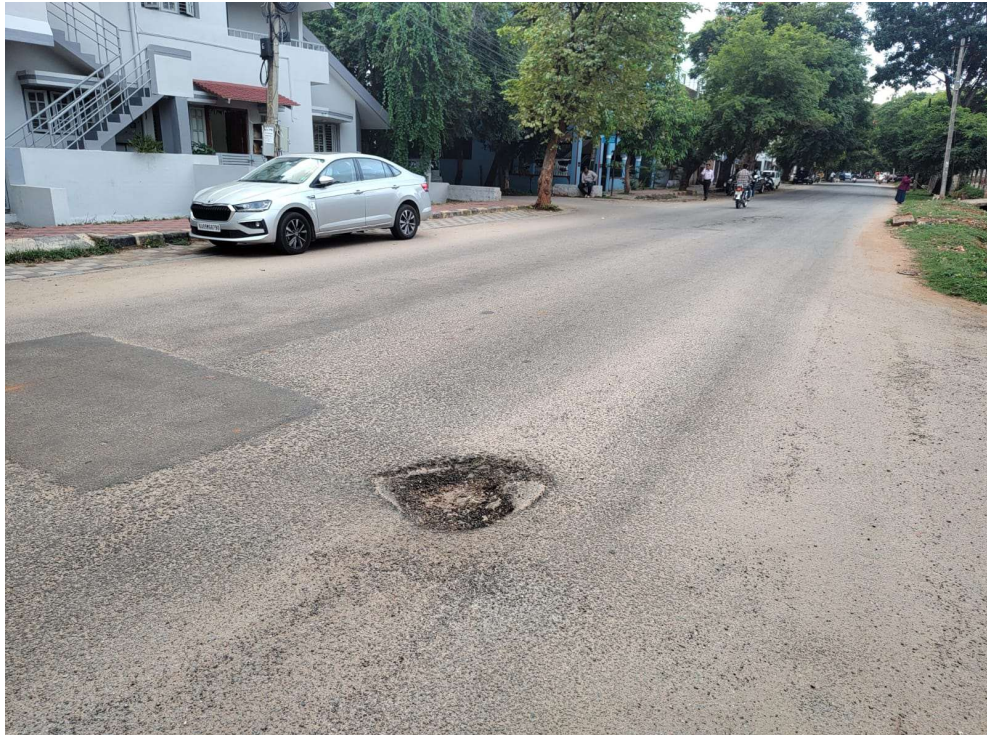
*Figure 5: Potholes*

The road in consideration is in a poor condition. It is filled with numerous potholes, making it challenging to navigate. The surface is uneven and rough, causing discomfort and potential damage to vehicles passing over it. The lack of proper maintenance is evident, with cracks and patches scattered along its length. The road's deteriorating condition poses a risk to the safety of drivers, cyclists, and pedestrians alike. It is evident that immediate attention and repair are required to restore the road to a safer and more functional state. The current state of the road is not only inconvenient but also hazardous, warranting urgent action from the relevant authorities.

### **1. Potholes fillings :**

- a) Conduct regular inspections, promptly repairing any identified potholes to prevent further deterioration and minimize the risk of accidents.
- b) Improve road markings, signage, and public awareness to alert drivers to the presence of potholes and encourage cautious driving, reducing the likelihood of accidents.

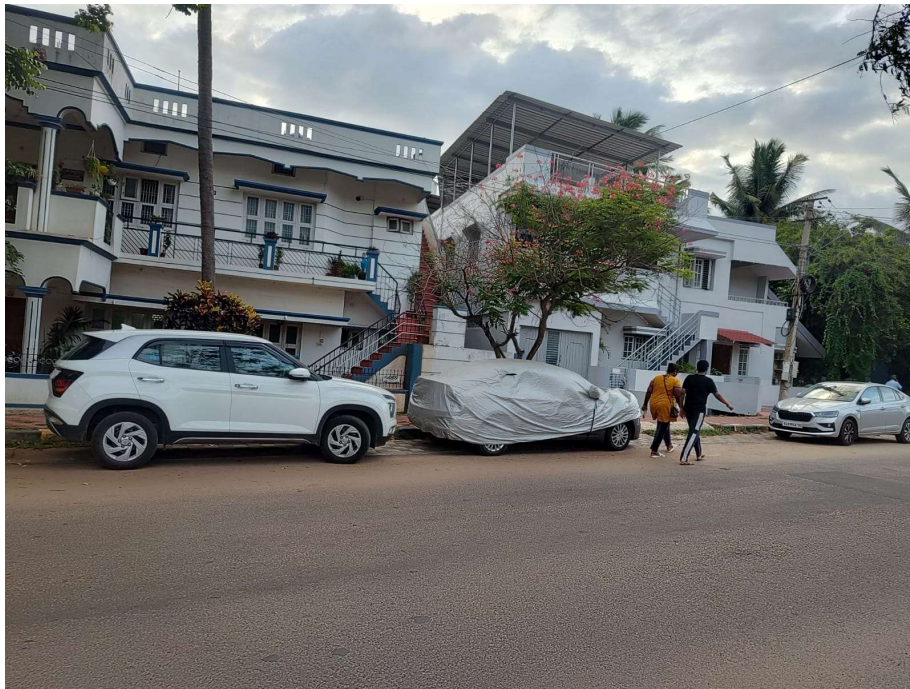
*Figure 6: Parking of Residential Vehicles, thereby reducing effective road width*

Residential parking on either side of the road can contribute to accidents and safety concerns. When cars are parked along the curb, it narrows the available space for moving vehicles, creating congestion and reducing visibility for drivers. This limited space can lead to conflicts between vehicles trying to pass each other, especially in narrow residential streets. It becomes challenging to anticipate oncoming traffic or pedestrians, increasing the risk of collisions. Additionally, parked cars may obstruct the line of sight at intersections, making it difficult for drivers to see approaching vehicles or pedestrians. Addressing the issue of residential parking and implementing effective parking management strategies is crucial to ensure safer road conditions and reduce the potential for accidents.

### **2. Prohibition of parking of residential vehicles :**

- a) Implement designated parking areas: Provide designated parking spaces or parking lots within residential areas where residents can park their vehicles safely. This helps reduce the need for parking on the roadside, minimizing obstructions and improving visibility for drivers, thus reducing the risk of accidents.
- b) Strict enforcement and penalties: Enforce strict regulations against parking residential vehicles on the road and implement penalties for violations. This discourages residents from parking their vehicles in prohibited areas and encourages them to utilize designated parking spaces. Effective enforcement mechanisms, such as ticketing and towing, can deter illegal parking and ensure compliance with parking regulations, thereby enhancing road safety.

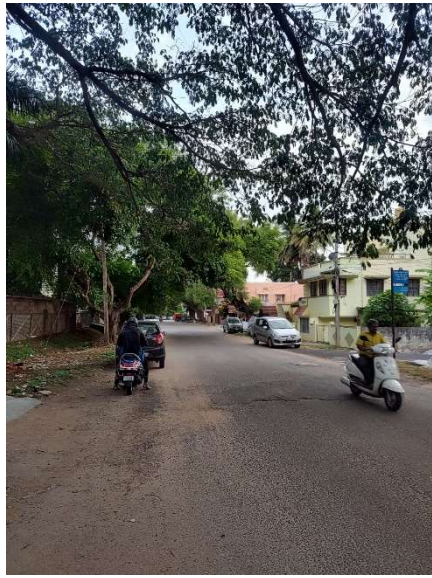
*Figure 7: Foliage obstructing the SSD*

Low visibility caused by overgrown vegetation can contribute to accidents and road hazards. When trees, shrubs, or other vegetation obstruct the view of drivers, it becomes difficult to see oncoming traffic, pedestrians, or potential hazards ahead. This lack of visibility increases the risk of collisions, especially at intersections or curves where quick reactions are crucial. Moreover, overhanging branches or foliage may obstruct road signs, making it challenging for drivers to navigate safely. Regular maintenance and trimming of vegetation along roadsides are essential to ensure clear visibility and prevent accidents caused by poor sightlines.

### **3. Maintenance of vegetation on kerb :**

To prevent accidents due to non-maintenance of vegetation on the curb, the following measures are recommended:

- a) Regular trimming and pruning: Implement a proactive maintenance schedule for trimming and pruning vegetation along the curb. Regularly trim overhanging branches and cut back vegetation that obstructs visibility for drivers. This will help improve sightlines and ensure clear visibility of oncoming traffic, pedestrians, and road signs.

- b) Adequate clearance zones: Establish and enforce clearance zones between the curb and vegetation. Ensure that there is sufficient space between the edge of the road and the vegetation to prevent any encroachment onto the roadway. This will allow for unobstructed movement of vehicles and reduce the risk of accidents caused by vegetation blocking the line of sight.

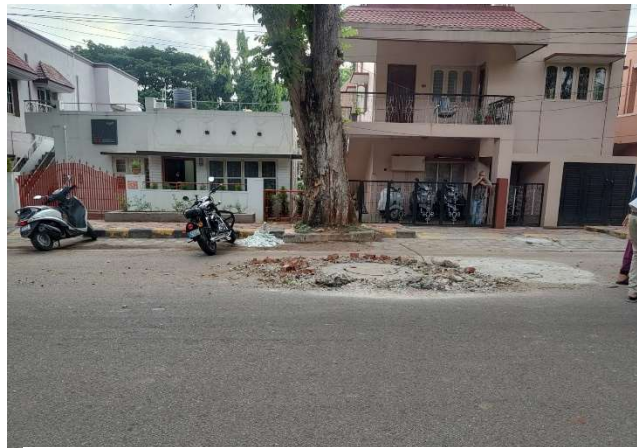
*Figure 8: Incomplete Maintenance*

Incomplete maintenance of roads can contribute to accidents and pose significant safety risks. When roads are not properly maintained, potholes, cracks, and uneven surfaces can develop, creating hazards for drivers. These road imperfections can cause loss of control, tire damage, and accidents, particularly for vehicles traveling at higher speeds. Inadequate maintenance can also lead to faded road markings, making it difficult for drivers to navigate and increasing the risk of lane departures or confusion at intersections. To ensure road safety, it is crucial for authorities to prioritize regular and thorough maintenance, including timely repairs, resurfacing, and repainting of road markings, to prevent accidents caused by neglected road conditions.

## **5. Proper execution of maintenance works :**

To prevent accidents due to the lack of proper execution of maintenance works, the following measures are recommended:

- a) **Regular Inspection and Monitoring:** Conduct regular inspections and monitoring of maintenance works to ensure that they are executed correctly and meet the required standards. This includes assessing the quality of repairs, resurfacing, and other maintenance activities. Timely identification of any deficiencies or errors can help prevent accidents resulting from inadequate maintenance.
- b) **Quality Assurance and Supervision:** Implement strict quality assurance measures and effective supervision throughout the maintenance process. This involves having qualified personnel oversee the execution of maintenance works to ensure compliance with specifications and safety guidelines. Adequate supervision helps identify and rectify any substandard or incomplete work, reducing the chances of accidents caused by poor execution.

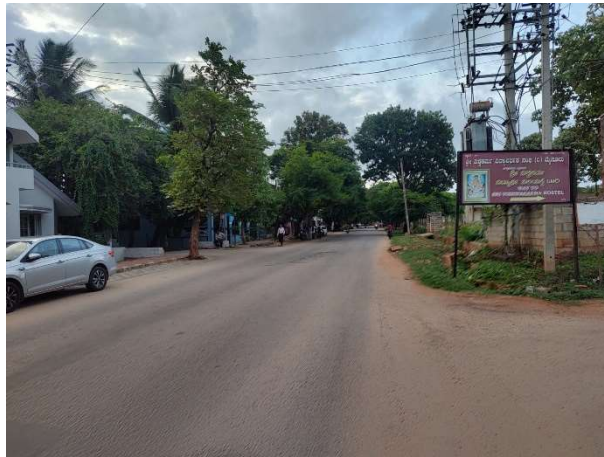
*Figure 9: Absence of Road Markings*

The absence of road markings can significantly contribute to accidents and compromise road safety. Road markings, such as lane dividers, crosswalks, and directional arrows, provide important visual cues for drivers, aiding in navigation and traffic flow. When these markings are missing or faded, it can lead to confusion and uncertainty among drivers, increasing the risk of collisions and lane encroachments. The absence of clear markings at intersections can result in right-of-way violations and potential accidents. To mitigate these risks, it is essential for road authorities to ensure the regular maintenance and repainting of road markings, providing clear guidance to drivers and enhancing overall road safety.

## **6. Providing of road markings :**

To prevent accidents due to the lack of road markings, the following measures are recommended:

- a) **Regular Inspection and Maintenance:** Conduct regular inspections of road markings to identify faded or missing markings. Implement a maintenance schedule to ensure timely repainting and restoration of road markings. This includes lane dividers, crosswalks, stop lines, and other relevant markings. Proactive maintenance will enhance visibility and

provide clear guidance to drivers, reducing the risk of accidents caused by confusion or improper lane usage.

- b) Enhanced Visibility Measures: Implement measures to enhance the visibility of road markings, especially in low-light conditions or adverse weather. This can include using reflective or high-contrast paint for road markings, installing raised pavement markers or reflectors, and ensuring proper lighting at intersections. Enhanced visibility will help drivers easily distinguish road markings, promoting safer driving behavior and reducing the chances of accidents related to unclear or faded markings.
