**Functional Testing Specification**

**LOU-GED-DS200TCEAG1B**

**Test procedure for a DS200TCEAG1B card**

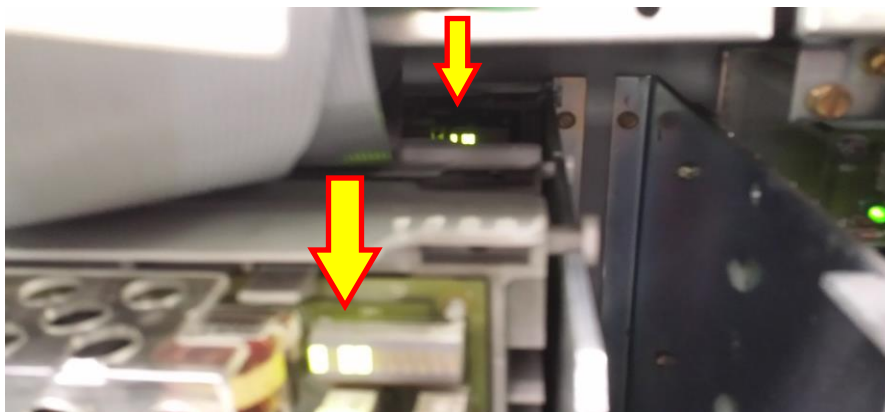
- 6.3.2.11** Verify TCEA board is still synchronized with the others in the panel by the BAR GRAPH LEDS match with all 3 TCEA's. This is important to verify.
