PCB Report – LAB 15

Professor Version of Board 2

The purpose of this lab is to test Professor version of board 2 which is designed with good practice and bad practice like adding decoupling capacitor and its placement, return plane and return path.

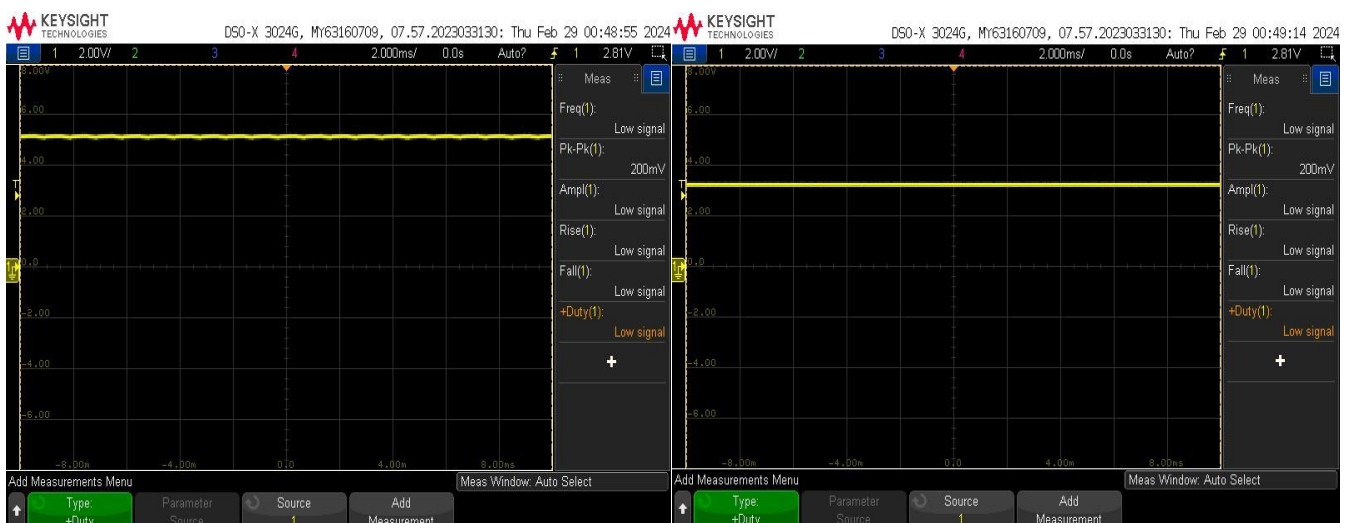
1. Power supply:

Captured and verified 5V coming from power jack and converted to 3.3V from LDO.

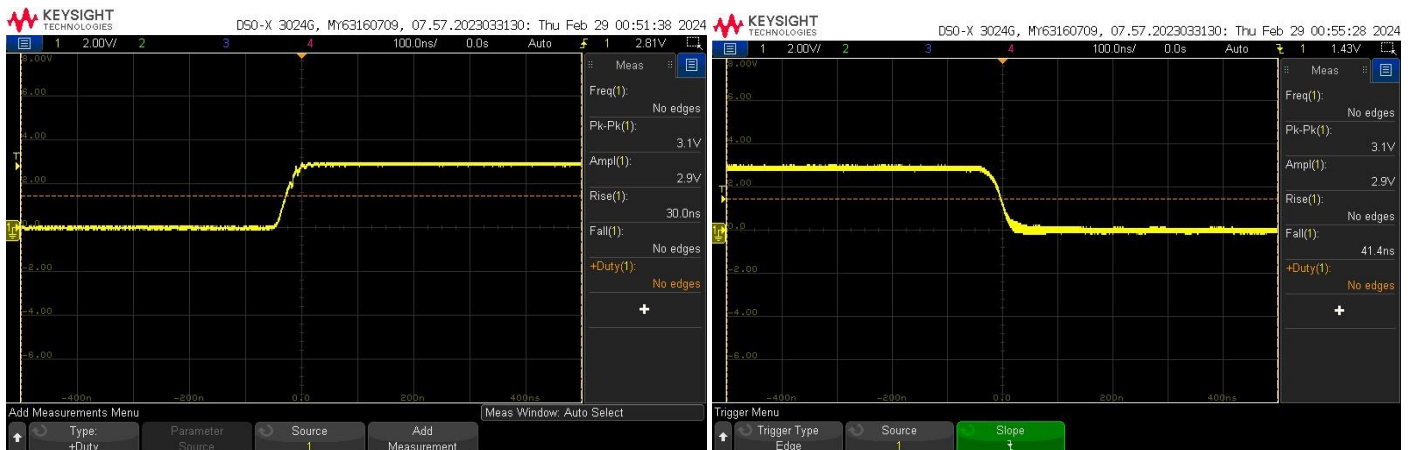
3. Rise time and fall time:

As per datasheet rise and fall time is estimated as 15ns for this LMC 555 timer. But rise time of 30ns and fall time of 41ns observed due to load at the output.

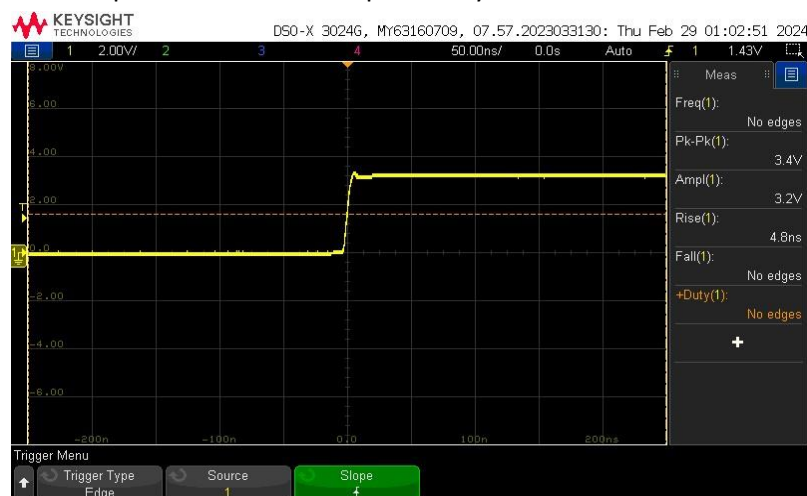
4. Output from bad practice hex inverter part of layout:

Measured rise time of 4.8ns from the triggered-out pin of inverter. In datasheet it mentioned that the transition time will be typically 8ns.

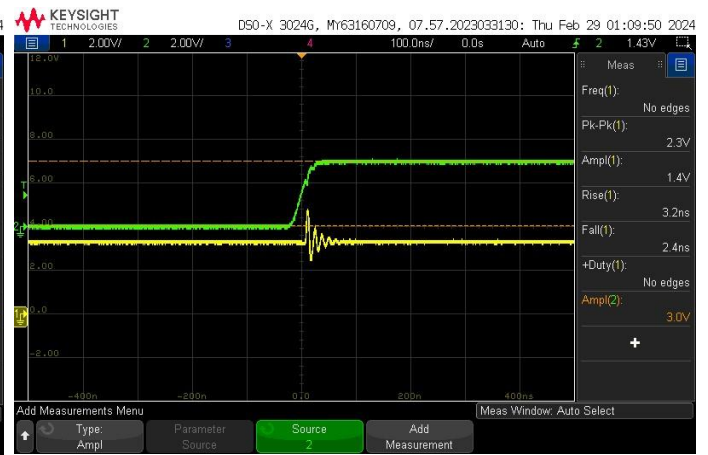
The output on the left is from quiet low and amplitude of 1.5V noise is seen because of ground debounce, which is due to common return path and lack of return plane. The right-side output is from quiet high and the amplitude of 1.4V noise observed at the switching point because of power rail noise, which in turn due to placement of decoupling capacitor for away from the IC package VCC pin.

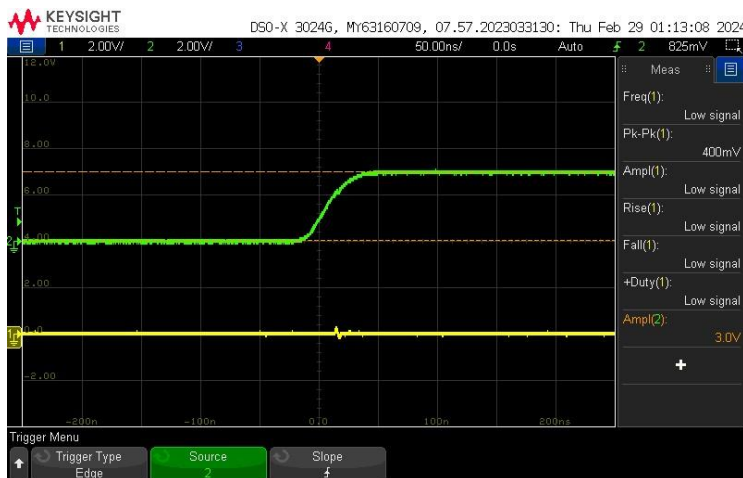
The image on the left (quiet low) shows that there is not noise seen in Volts range due to ground bounce, because of separate path and return plane is implementation. The Image on

the right (quiet low) shows that there is still 1V noise to power rail, where decoupling capacitor is placed far and induced more noise from the inductance of the rail.

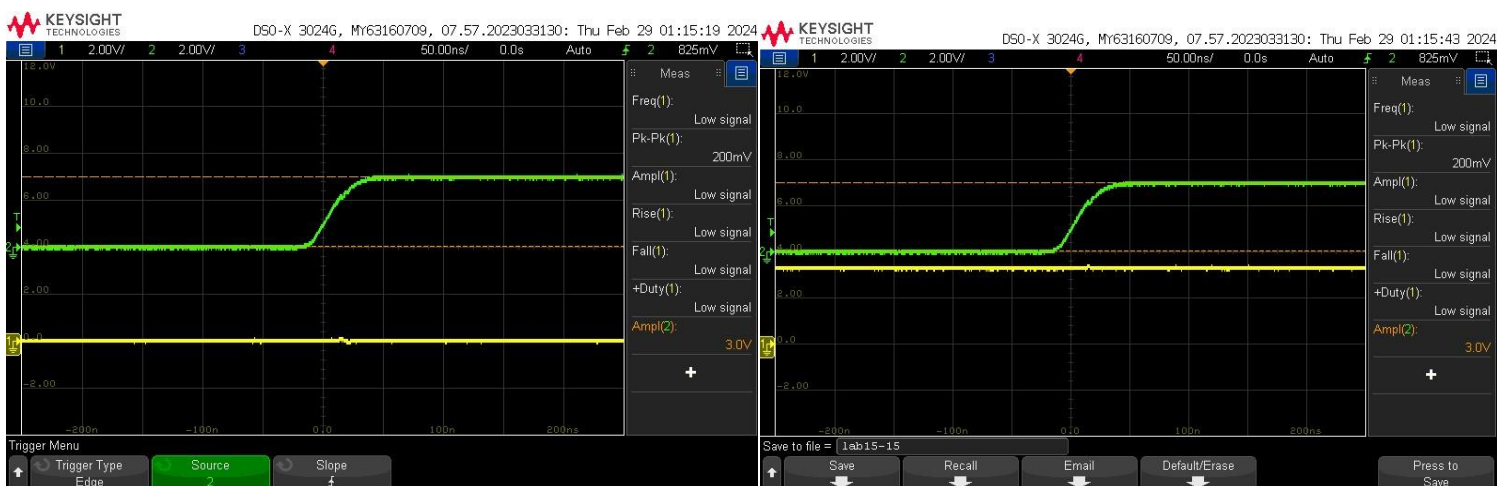
Here we can see that there is no noise seen in Volts range from both quiet low and quiet high pins, because we took every measure to reduce noise by placing decoupling capacitor close, separate return path and return plane.

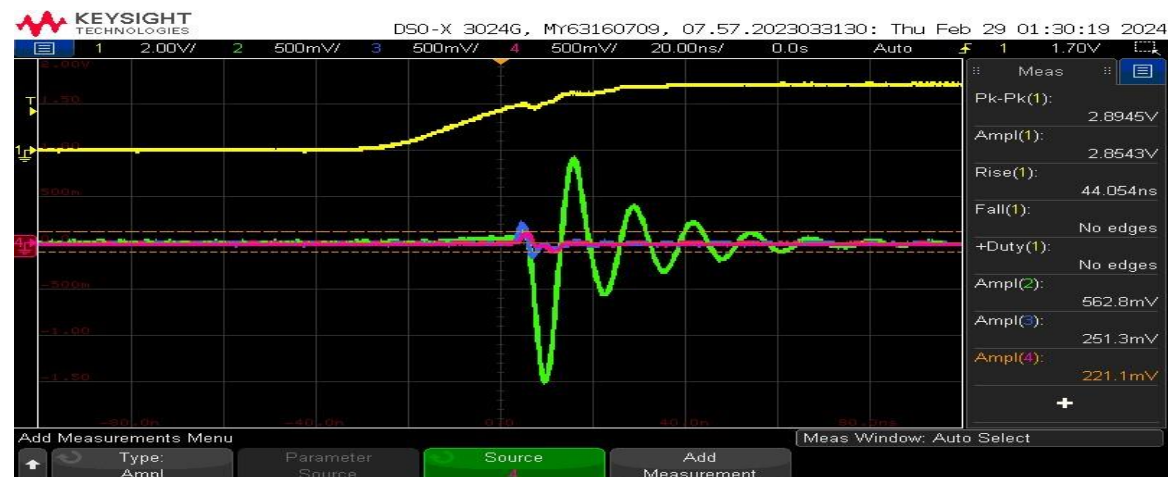
7. Quiet Low output from all bad and good parts of the layout:

Green (bad part), Blue (good but far decoupling capacitor) and pink (good part) signals clearly shows that how the noise reduced in the ground plane with good practices.
