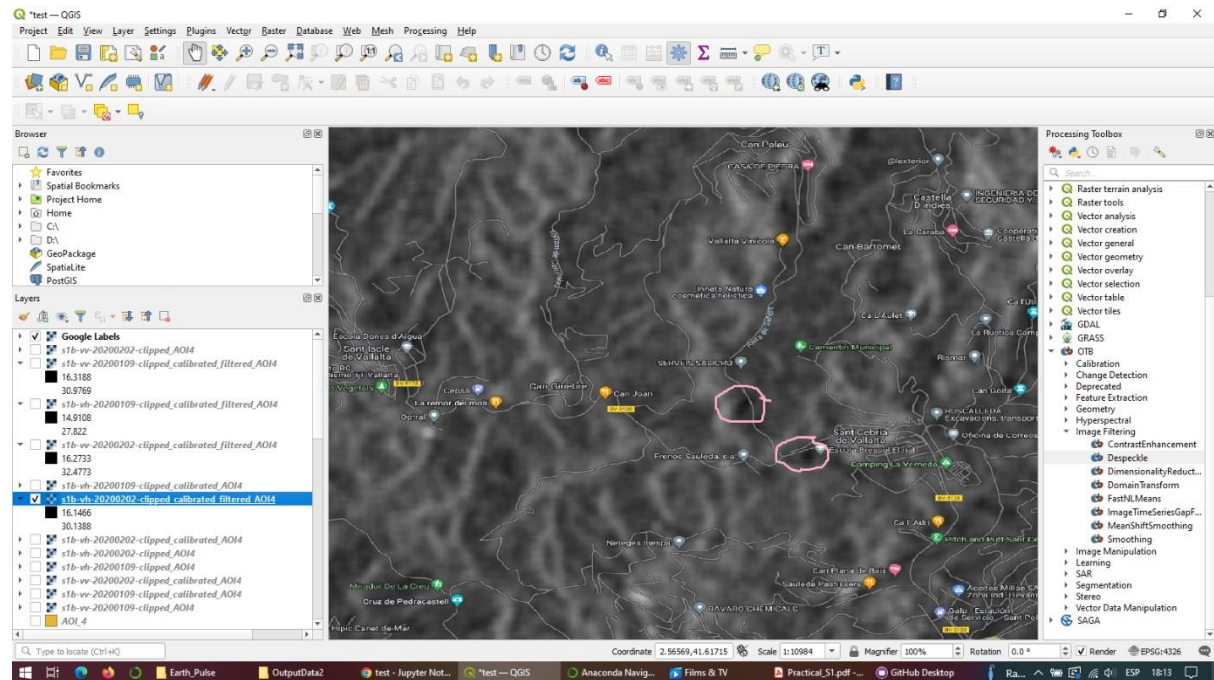
In this image we can see that the road BV-5128 is affected by the Gloria as the VH image polarisation from Sentinel-1 shows at 2nd February 2020 (after the effect).

Both polarisations have been studied VH and VV and images from before and after the Gloria have been checked.

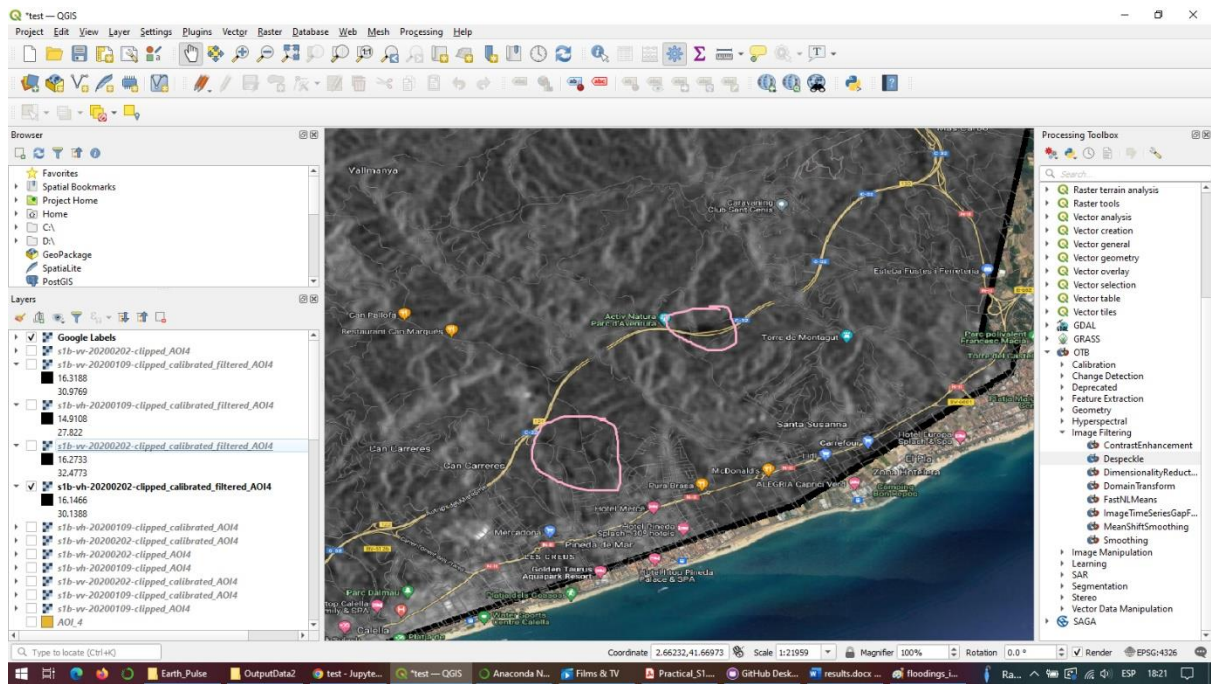
This last image represents floodings in areas close from Pineda de Mar and C-32.
