CASE STUDY: DEFORMATION MONITORING AT CANOPY OF STAVROS NIARCHOS FOUNDATION CULTURAL CENTER

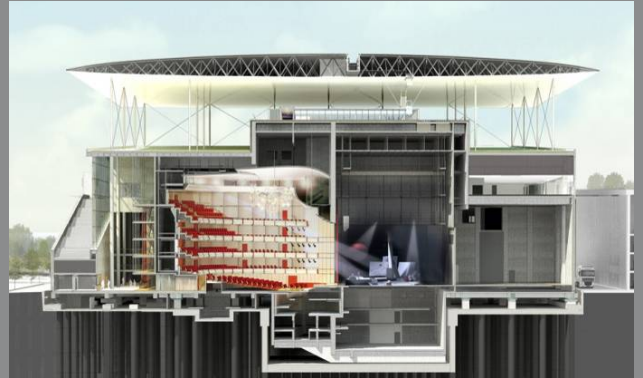
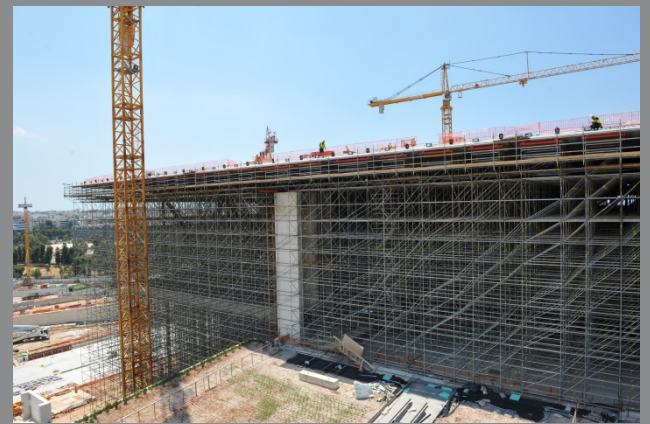
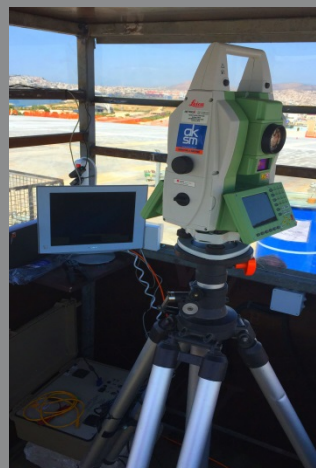
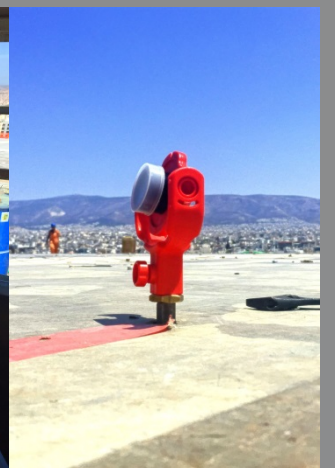
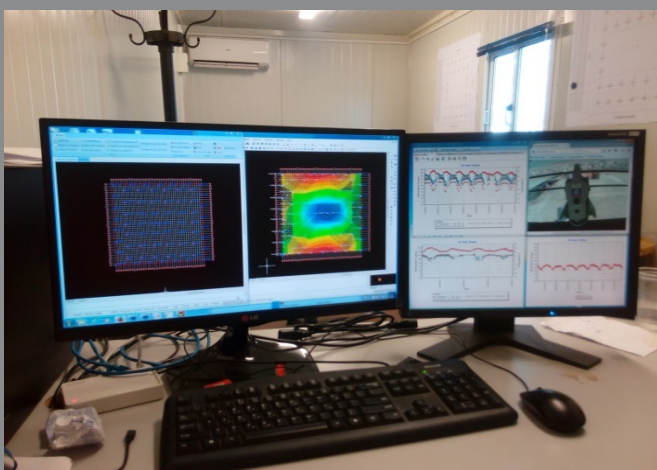
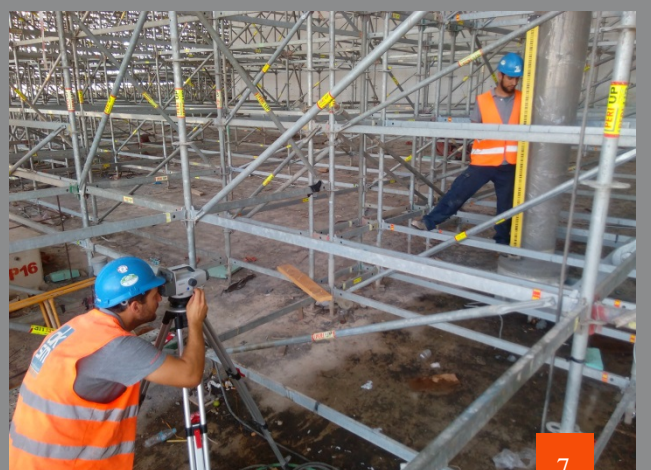
- Uplift values were reordered through on LVDT indicator instolled on the column head.
- Deformation values on the column base were calculated on a daily basis through high accuracy levelling.
- Deformation on the Canopy's surface were calculated through monitoring prisms installed on the casted surface (preinstalled couplers on skins) and a Robotic high accuracy station (Leica TS -30).
- Collected every 2 hours data were post processed through a SQL Based Database for monitoring data analysis. (Terramove).

- adjusted values
- deformation diagrams (D_x , D_y , D_z)
- deformation contours,

the deformation behavior of the structure were analyzed on a 24h basis, monthly basis, 3 months basis, etc.
