BARNSTON VILLAGE CONSERVATION AREA APPRAISAL AND MANAGEMENT PLAN

PART 1 - CONSERVATION AREA APPRAISAL

Prepared for Wirral Council by Donald Insall Associates Ltd, 2007 – Wirral Council 2009

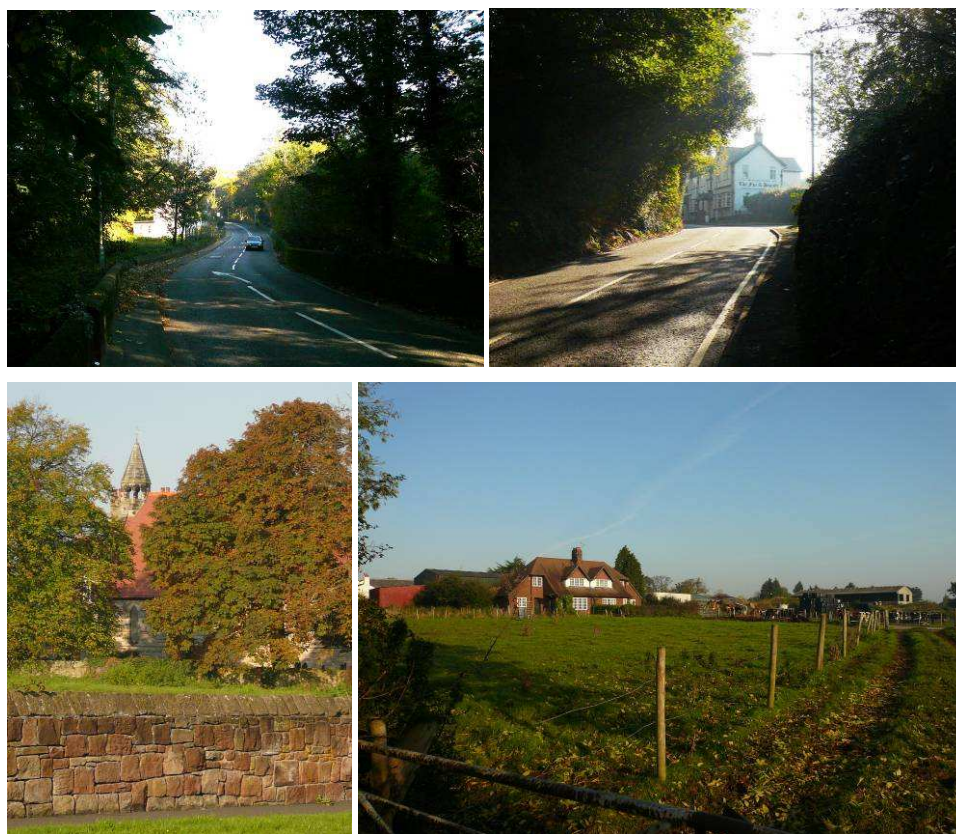
(Top left) View towards no. 109 / 111 Barnston Road; (top right) View from Barnston Dale up towards the Fox and Hounds; (bottom left) Glimpse view towards the Church from entering the conservation area from the south-east along Barnston Road; (bottom right) View towards 136 / 138 Barnston Road on entering the conservation area from the south-east

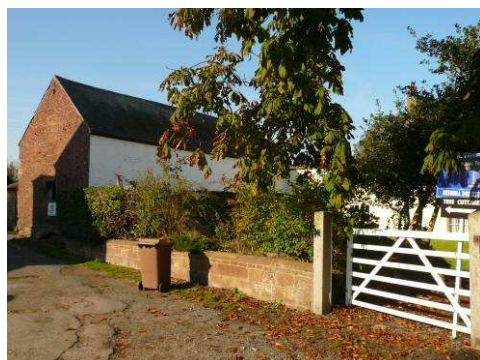
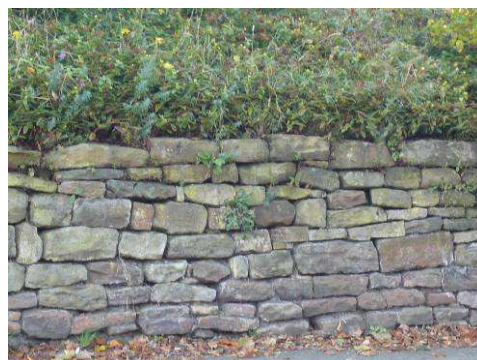
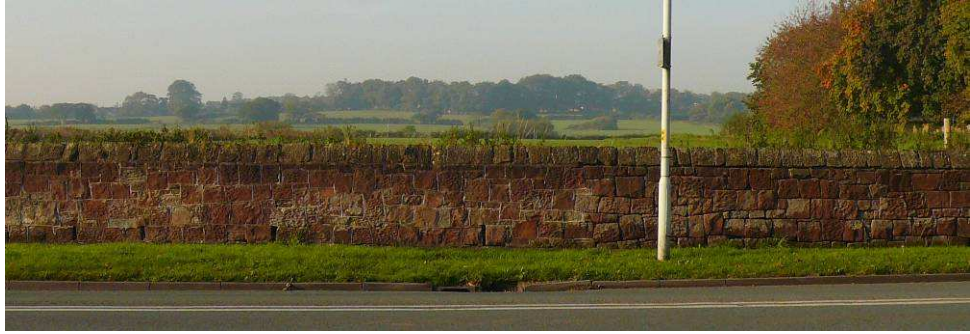
- 4.3.3 Boundary walls within the conservation area are a key part of its visual character. Most walls are constructed of local red sandstone. These walls are used around both agricultural and domestic properties. These vary slightly in construction and design, but are all of coursed rubble, with very little dressing or squaring-off of stones. In some instances walls have capping stones of a simple shape, in others they larger heavier stones capping the wall. Some walls appear to be of a dry-stone construction, apparently without mortar.
- 4.3.2 In some instances, walls perform a retaining function, such as when Barnston Road winds down into Barnston Dale. Buildings can also form a boundary to the road as on the Storeton Lane defile towards its junction with Barnston Road.

Stone boundary walls in the conservation area.

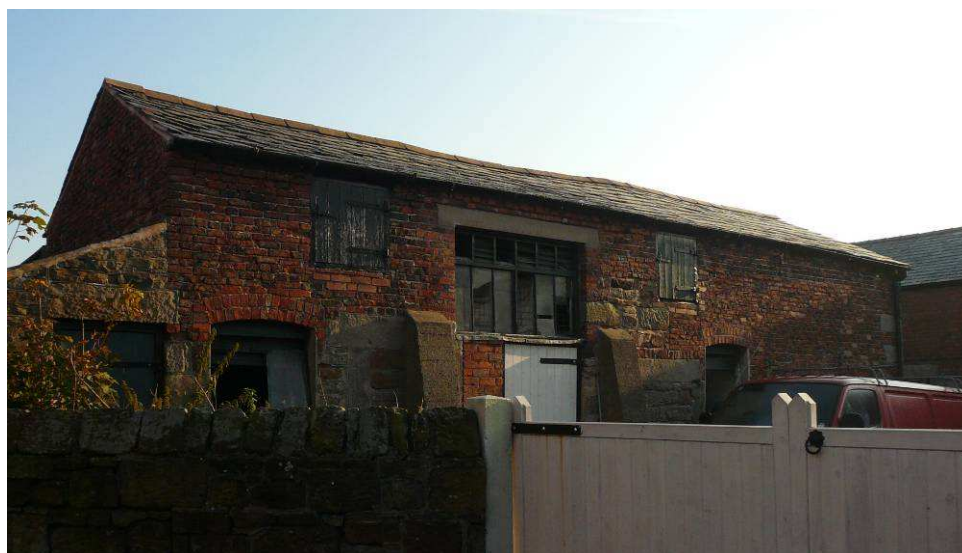
- Agricultural buildings – constructed from locally sourced materials of brick and stone with slate roofs and often extended or altered in an ‘ad-hoc’ manner. Forms are simple and rectilinear and the buildings have relatively low pitched roofs. Openings are generally small and the buildings have a ‘robust’ character.

Agricultural building in the conservation area

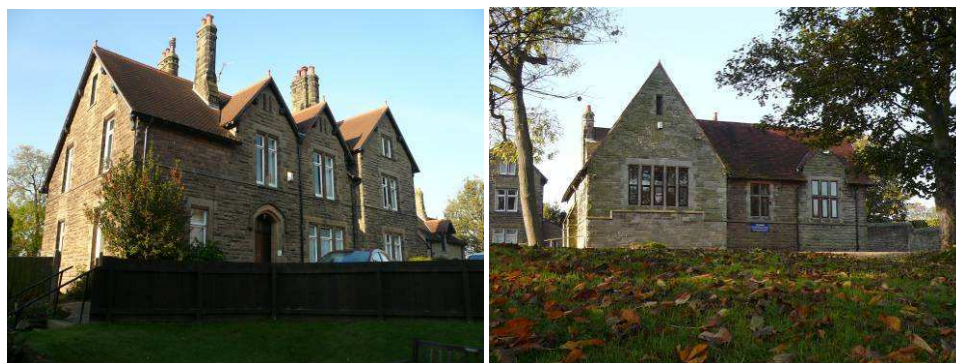
- Vernacular Revival / Gothic – Buildings with details derived from other traditional building types. Influences include Gothic, Jacobean, Elizabethan and Medieval building periods. In contrast to the traditional agricultural buildings, roofs are more steeply pitched and elevations are relatively detailed. Plan forms are generally more complex. Gables are used regularly as features in the design of buildings, and like openings, are shaped to reflect the style of the building. Chimneys are typically more prominent on buildings of these styles. Buildings in this category include the church, vicarage and village hall.

Buildings of a Vernacular Revival / Gothic influence in the conservation area

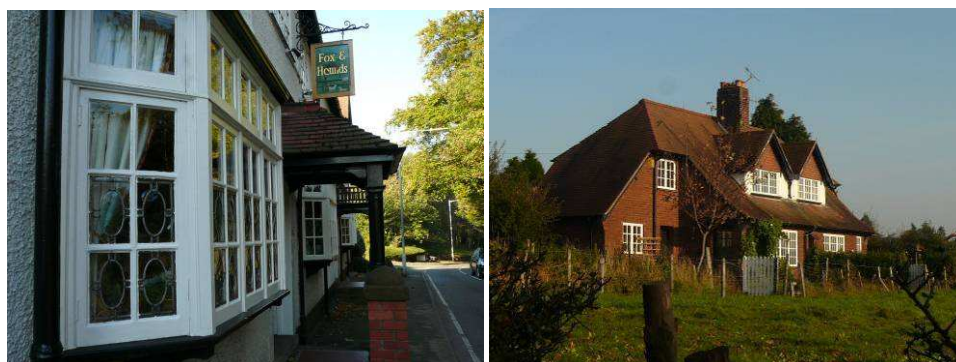
- Arts and Crafts – buildings with particular attention to detail and using elements of traditional craftsmanship in their decoration. The Fox and Hounds Public House has decorative leading to its window panes, some decorative timberwork and oriel windows. All these features are reminiscent of Arts and Crafts buildings, although it is simpler in its level of decoration. Similarly, no. 136 / 138 Barnston Road, is an attractive semi-detached building, drawing its form from Arts and Crafts houses built a couple of decades earlier. However, its level of decoration is noticeably simpler. The design and good maintenance of the building possibly indicates that it may be, or may have been an estate cottage.

Buildings within the conservation area with details / form originating in the Arts and Crafts style.

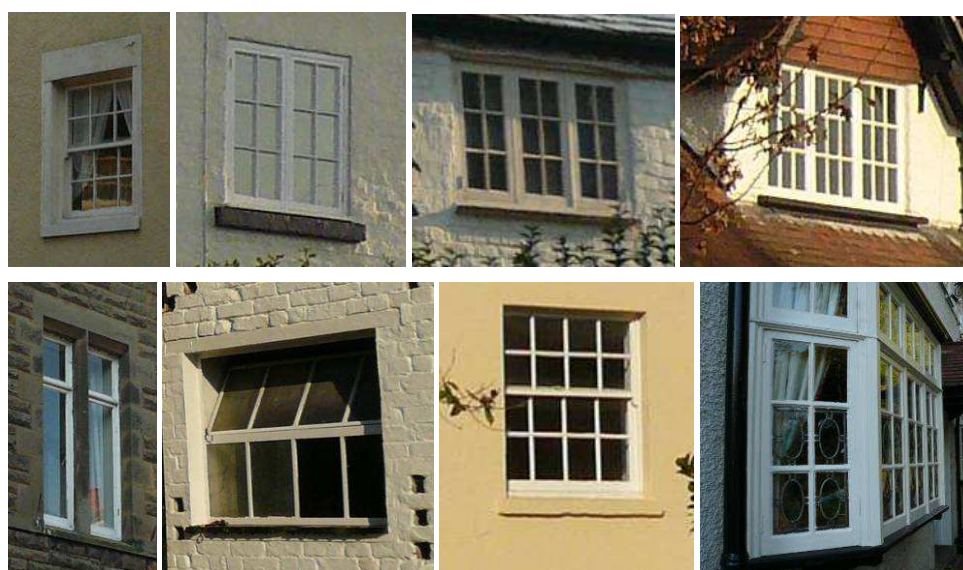
- Painted timber vertically sliding, multi-paned sashes – seen on the higher status houses. A few of these are arch-headed.
- Painted timber, multi-paned casements – on most low key houses and many agricultural buildings. These are likely to have been horizontal sliding sashes originally.
- Metal multi-paned windows on agricultural buildings with inward-opening upper panes.
- Decorative windows, often with leaded lights.

Windows in the conservation area

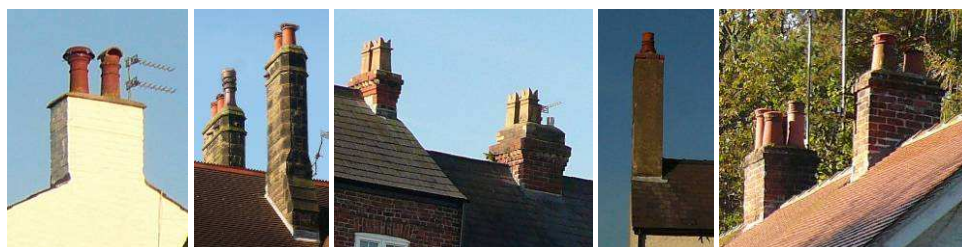
- 5.4.5 **Chimneys** play a part in the visual composition of most buildings, although they are typically of a simple rectilinear design, with little in the way of projections. Only a few buildings have tall, visually dominant chimneys; these buildings tend to be of a higher status. Terracotta or buff clay pots of varied design are generally seen on top of most stacks.

Chimneys within the conservation area.

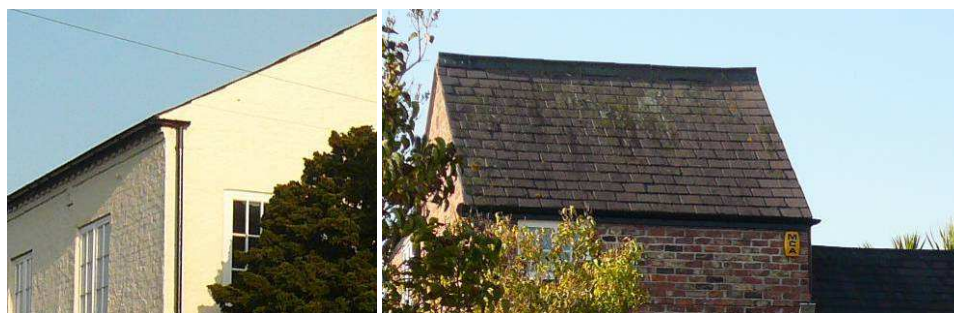
- 5.4.6 **Roof details** to almost all buildings within the conservation area are, or once would have been, very simple. There are few barge board or parapets on gables. Eaves have little in the way of an overhang and any detail is provided by 1 or 2 courses of projecting / dentilled brickwork. Ridges are generally unadorned.

Roof details in the conservation area

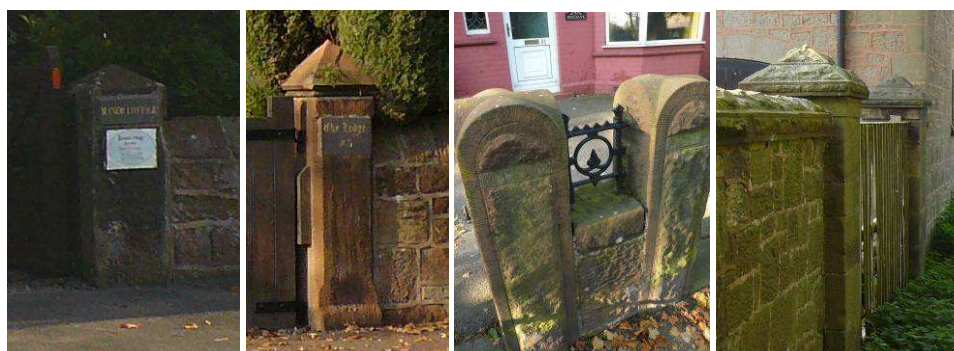
- 5.4.7 **Gateposts** are either of a simple timber construction (to farm buildings) or of a large, simple / unornamented sandstone shape. Both are of an agricultural character.

Stone gate posts with the conservation area

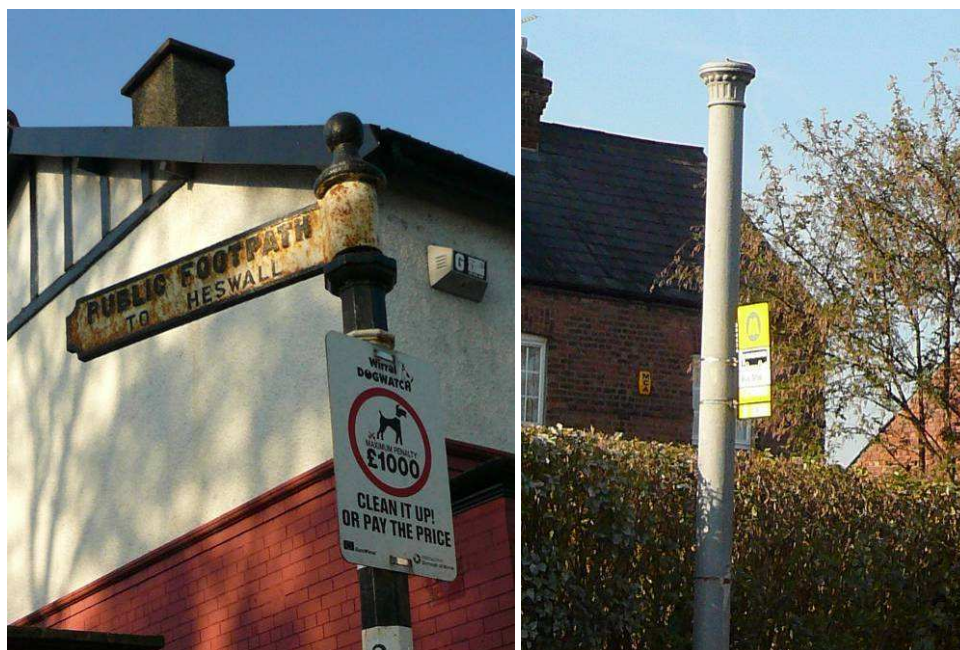
- 5.4.8 **Public realm features** within the village are relatively simple and often of a traditional form. There are a few examples of historic public realm features such as signs, posts and gates constructed of, or at least made to appear to be of either cast or wrought iron. Whilst generally more modern, simple timber signs and posts are appropriate within the conservation area and can enhance its appearance

Cast iron sign and post.

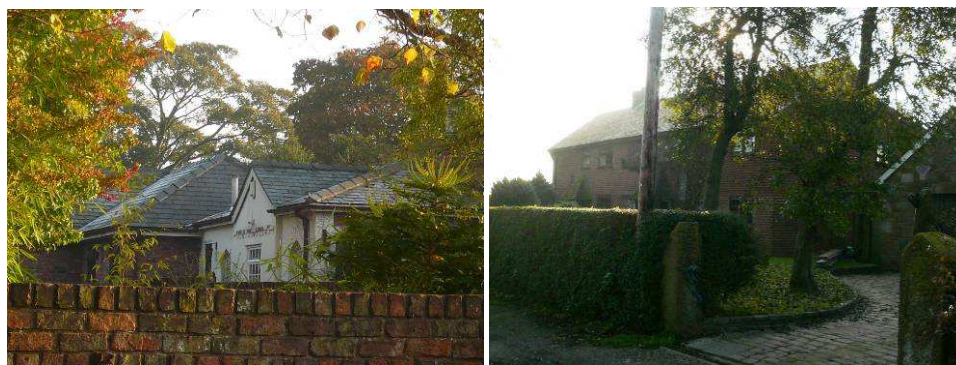
6.2.1 There have been very few buildings built since the middle of the 20th century. A relatively small number of barns have been constructed next to older farmsteads. The few modern houses (132/134 Barnston Road and a new building forming part of 'The Cottage' on the eastern side of the road) are set well back from the road and of inauspicious materials and forms. In such low numbers these modern buildings have a neutral affect on the historic character of the conservation area.

Modern buildings within the conservation area

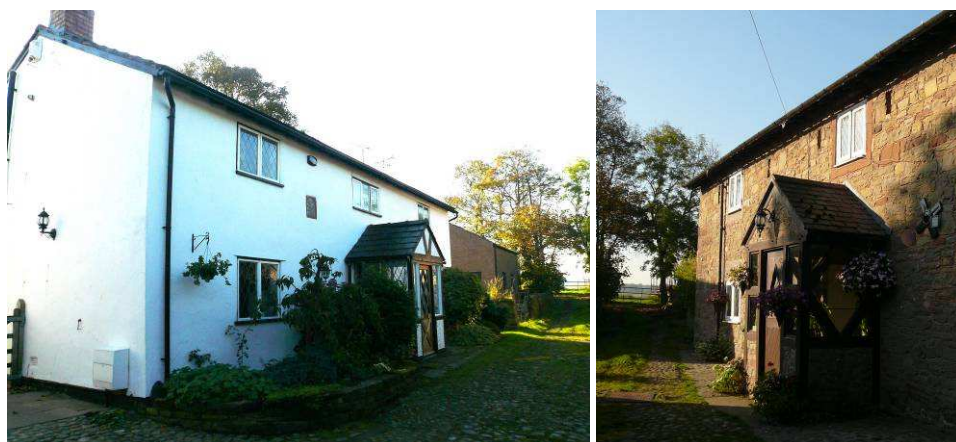
Extensions within the conservation area. The left hand photo shows a cottage that has been extended in recent years by about 50%. The modern render over both the older and modern parts confuses the original form. The right hand photo illustrates how an attractive porch added to the front of a building (together with other changes) can have an adverse effect on its original agricultural character.

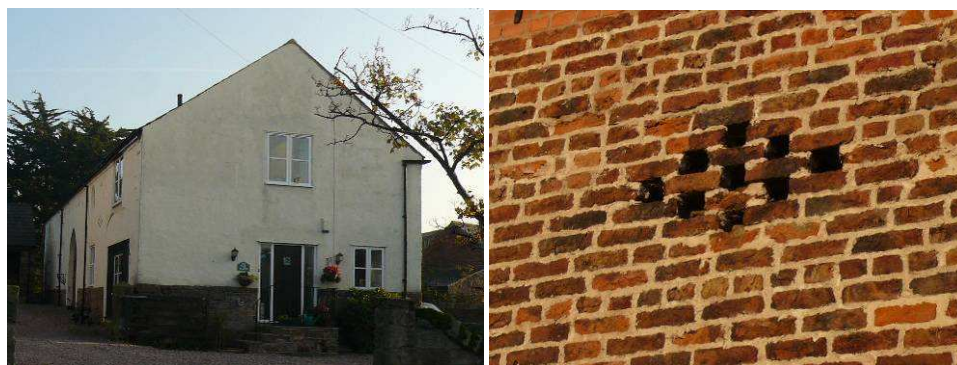
To the south-west and north-west elevations of Barn House, most of the building's agricultural character was apparently lost during conversion. The domestic nature of the windows and doors together with the render finish to the walls disguise its original appearance. To the south-east the barn's largely blank brick / stone elevation retains the legibility of the original form, although the building's appearance is marred by obtrusive modern pointing.

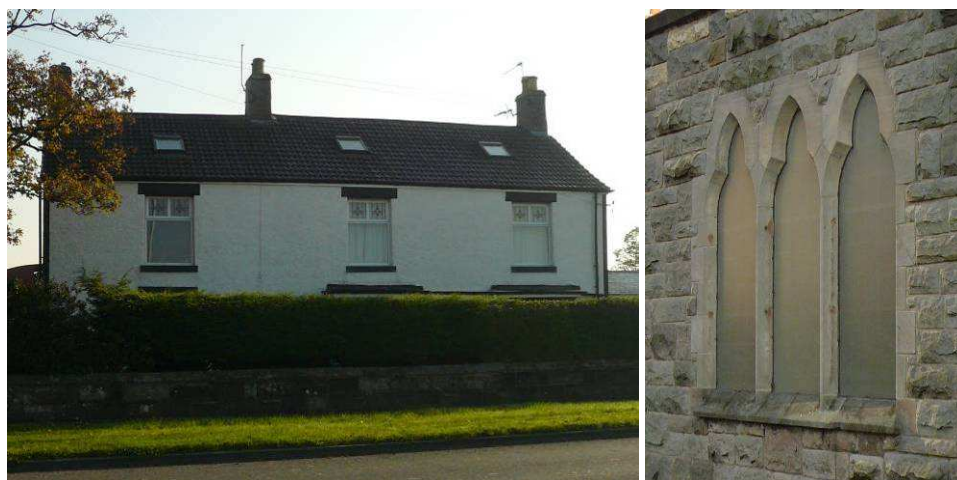
(left) Changes to the windows and roof covering adversely affect the building's character and its contribution to the conservation area. (right) Although probably necessary to prevent damage by vandals, the application of perspex over the leaded lights of Christ Church's windows makes it impossible to appreciate their intricacy from the outside.

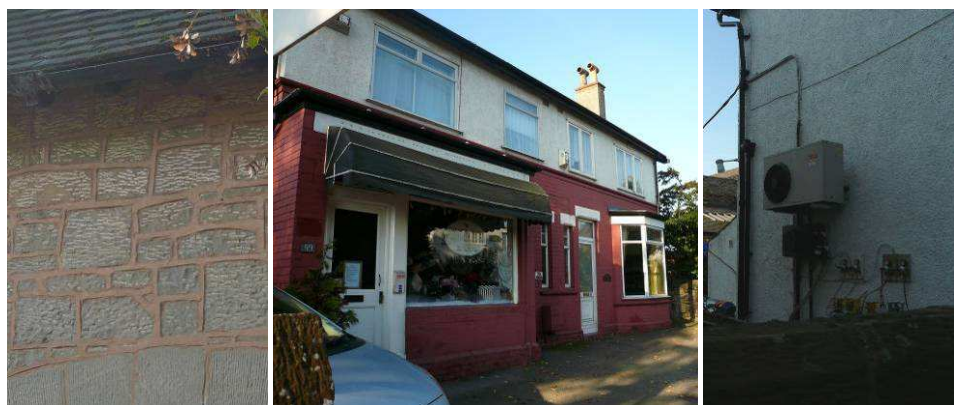
Management issues with the conservation area: (left) obtrusive modern pointing over the face of stonework. Artificial colorants are also used giving it an unnatural colour; (middle) Painted brickwork and inappropriate modern windows; (right) An air conditioning unit mounted in an obtrusive position on the Fox and Hounds.

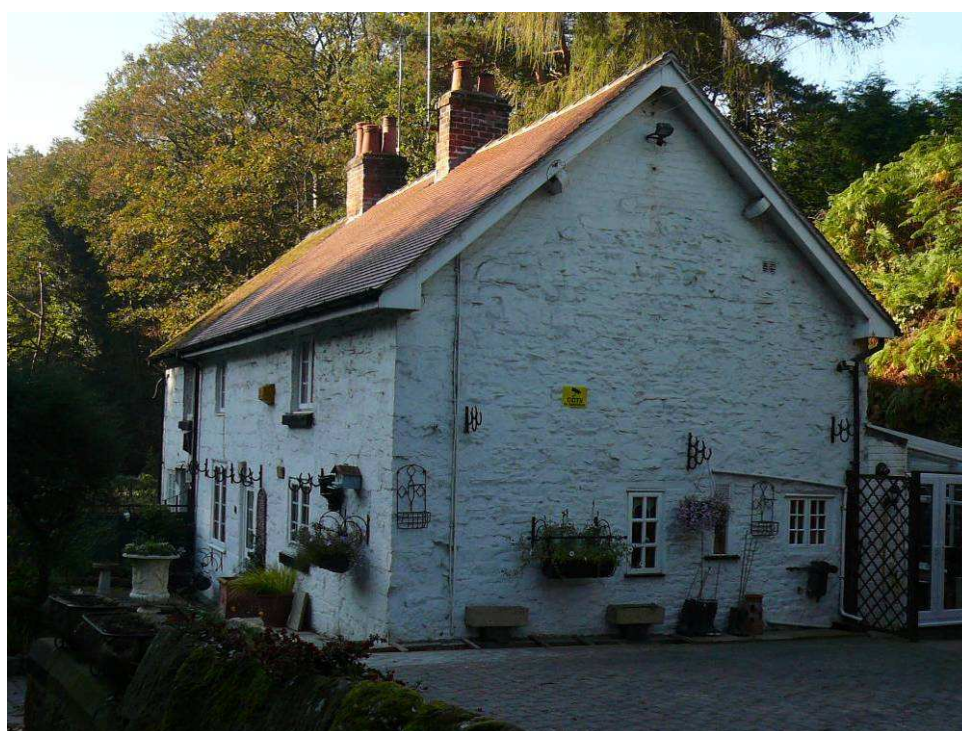
A particularly historic house that has unfortunately had a number of modern alteration carried out, including the installation of UPVC windows and boxed soffits. These changes particularly jar with the original character of the building.

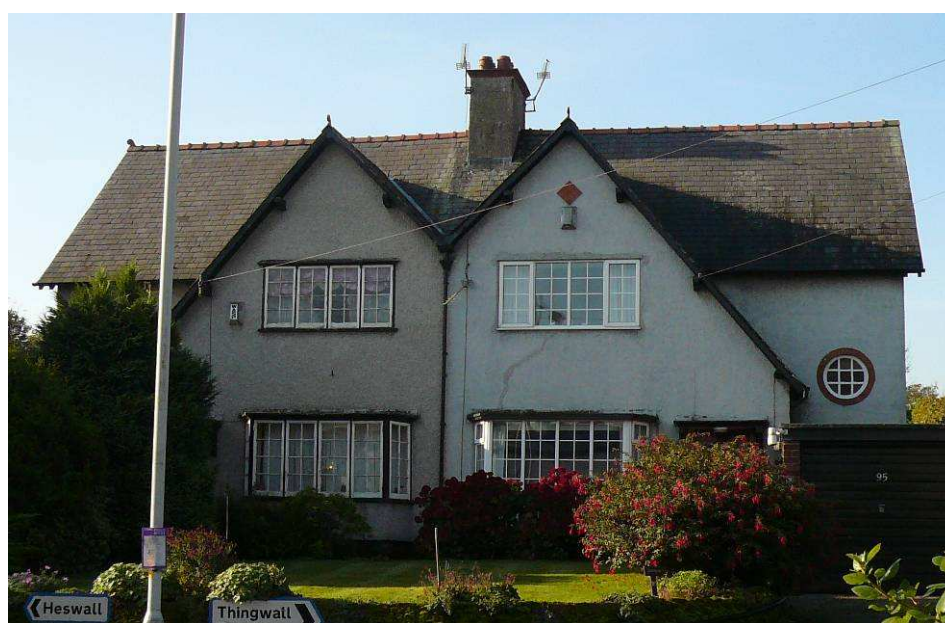
- 6.4.2 The foremost alteration to historic fabric within the conservation area is the replacement of original doors and windows. These alterations are often well intentioned – to improve the thermal or acoustic performance or to reduce maintenance requirements for instance. However, the visual effect of the replacement windows, particularly on the architecturally simple buildings, is immense. The original sash windows would have had very slim profiles, giving an elegant appearance. In contrast, a UPVC or aluminium replacement, particularly when holding a thick double glazed unit, has

considerably thicker framing elements, which are more obtrusive visually and will let much less light into the building.

Replacement windows within the conservation area: this photo illustrates that even though UPVC windows can be manufactured to approximately the same form as an original casement, they are of a lesser quality visually. In this instance the opening lights require much larger frames than the fixed ones and the intermediate mullions (painted black on the originals) are lost. The glazing beads are within the double glazed unit, instead of forming an integral part of the casement. This is immediately apparent and this adversely affects the visual character of the window.
