# ROCK PARK CONSERVATION AREA APPRAISAL AND MANAGEMENT PLAN

## PART 1 - CONSERVATION AREA APPRAISAL

Prepared for Wirral Council by Donald Insall Associates Ltd, 2007 – Wirral Council 2009

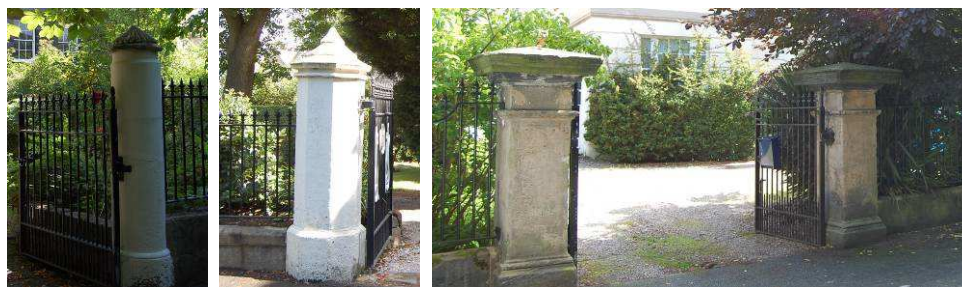
replacements sympathetic to the character of the area. There are a number of different shapes of gateposts, often repeated elsewhere in the area, possibly signifying the original owner or developer of the land. All gateposts to villas are of a relatively consistent height, but their plan forms include circles, octagons and squares. Most plinth walls are low and of a simple form. The majority are of sandstone but some are of brick with a rendered finish. Railings have recently been reinstated to almost all of these walls. These are thought to be approximately to the original design, but are constructed from steel.

*Original gatepost and boundary wall treatments*

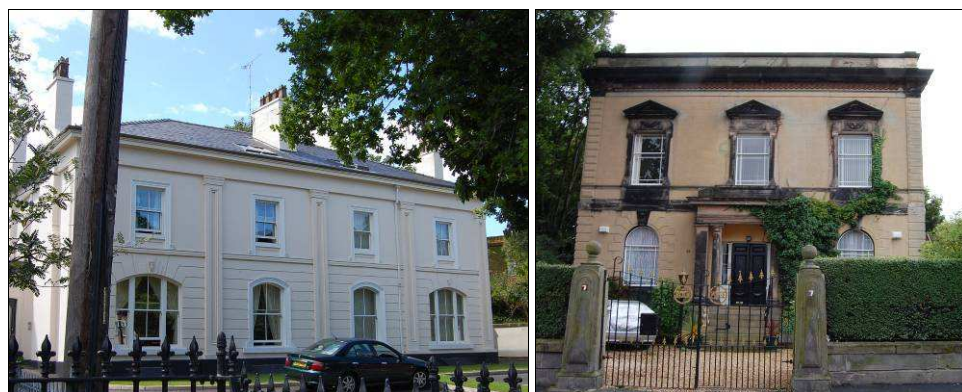
- Classical / Italianate –These buildings are proportioned loosely according to classical rules and adopt features such as cornices, quoins, pilasters and ground floor rustication. Many of the buildings have an Italianate character created through particularly projecting cornices at eaves level and in their detail around openings. Most roof pitches are relatively low and occasionally behind a parapet. All windows are sash windows and openings are positioned in a regular rhythm across the façade.

*Buildings of a classical or Italianate influence*

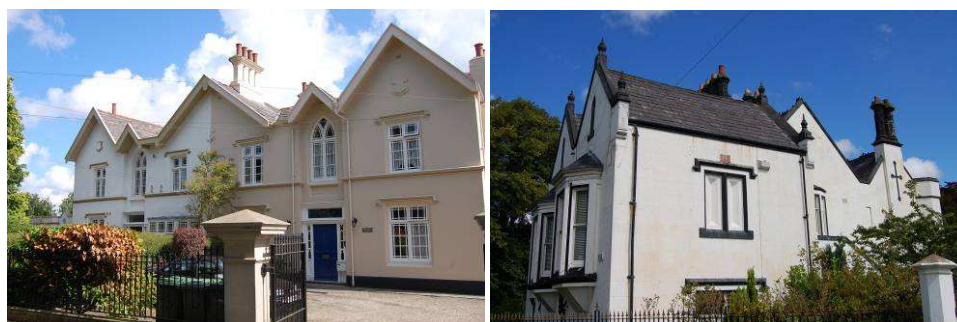
*Buildings of a vernacular revival or gothic influence*

- Vernacular Revival / Gothic – Buildings with details derived from other traditional building types. Influences include Gothic, Jacobean, Elizabethan and Medieval building periods. In contrast to the Classical / Italianate buildings, roofs are more steeply pitched and elevations have fewer formal proportions and design rules used. Plan forms are generally more complex and buildings are less likely to be symmetrical. Gables are used regularly as features in the design of buildings, and like openings, are shaped to reflect the style of the building. Chimneys are typically more prominent on buildings of these styles.

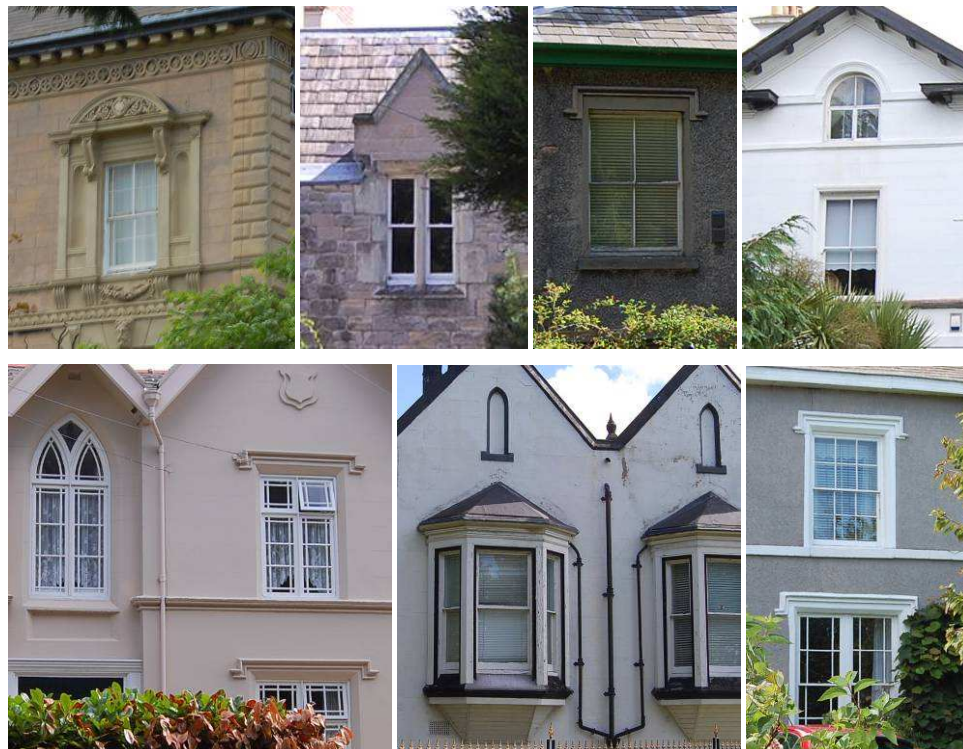
- 5.4.1 **Windows** within the Rock Park houses seem to have all originally have been vertically sliding sashes at the time of the buildings' construction. The style and configuration of these windows varies according to the decoration and form of the building. All sashes would have had been sub-divided with glazing bars. The most simple of sashes are split into two parts by a vertical glazing bar, but perhaps the most common configuration is 6 over 6 format (or 3 over 6 / 6 over 9 formats for smaller / larger windows). The use of thin margin lights down the sides of the sashes is an elegant and fairly unusual detail which is seen in Rock Park.

*Windows in the conservation area*

- 5.4.2 Many of the sash windows are grouped together in twos or threes. In the case of tri-partite windows, the two side windows are generally narrower. In a number of instances the head of windows are arched.

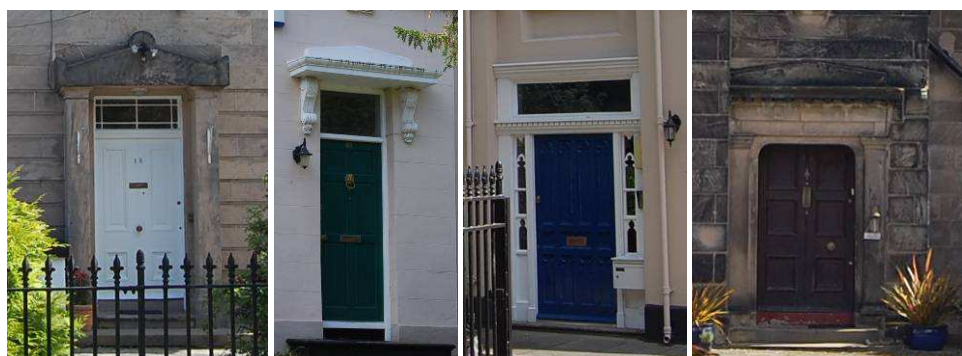
- 5.4.4 **Doors** themselves within the conservation area are often not highly apparent from the road, being either recessed from the building frontage or on a side elevation. The door surrounds and entranceways are generally celebrated architecturally, however, with carved stone canopies, porches and surrounds.

*Doors within the conservation area*

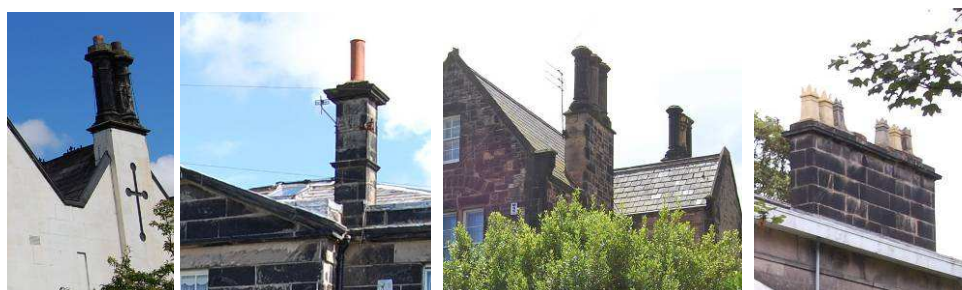
- 5.4.5 **Chimneys** play a part in the visual composition of most buildings, although they are typically of a simple rectilinear design. A few buildings have more ornate or visually dominant chimneys; these buildings generally have a more gothic inspired design. These chimneys have separated flues for approximately the final 1 metre of their height, built in a circular or octagonal shape, before they rejoin at the top with a projecting moulding.

*Chimneys within the conservation area.*

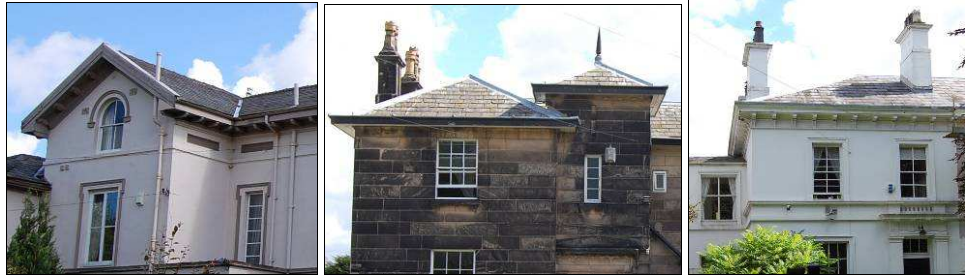
- 5.4.6 As many of the lower storeys of the buildings are obscured, the **roof details** of the buildings in Rock Park are critical to their contribution to the character of the area, being often the most prominent feature. A few of the more

classical buildings have deep, ornate cornices, but otherwise simple roof forms. Where buildings have gables facing onto the street, the verge projects and they are generally supported on a number of brackets. These brackets are often a feature along the eaves of building, also to form dentils in the cornice.

*Roof details in the conservation area*

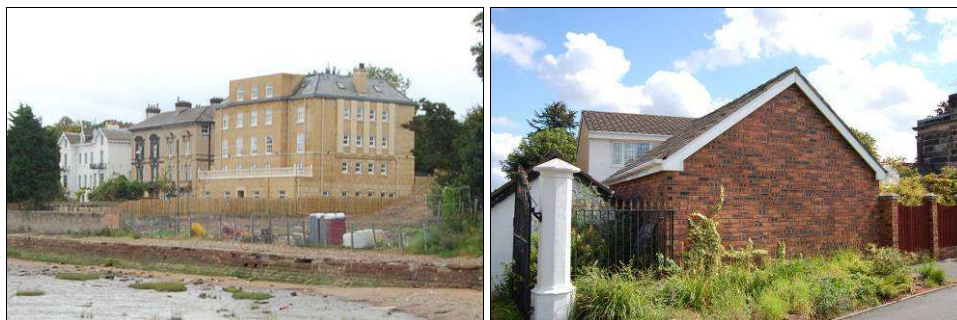
*Development in the conservation area which is detrimental to its character or to the setting of its listed buildings: (left) new flats adjacent to 1 Rock Park; (right) Nova House on Rock Park Road*

6.2.3 Nova House, on Rock Park Road, however, has a detrimental effect on the setting of both adjacent listed buildings and the character of the conservation area as a whole. Particularly obtrusive are the elements of the site along its road facing boundary: a garage is cited immediately adjacent to the road and is constructed of basic readily available materials to a fairly standard design without reference to the special characteristics of the conservation area. The garage has a direct and adverse effect on the visual relationship between the two neighbouring listed buildings. The fence along the front boundary is also of a basic construction and it detracts from the quality and appearance of the streetscene as a whole. The house itself is of an entirely incongruous scale to the rest of the conservation area and built of inappropriate standardised materials, however, it is slightly set back from the road and the building line, which means that there is the potential for its detrimental visual impact to be lessened by good landscaping in the future.

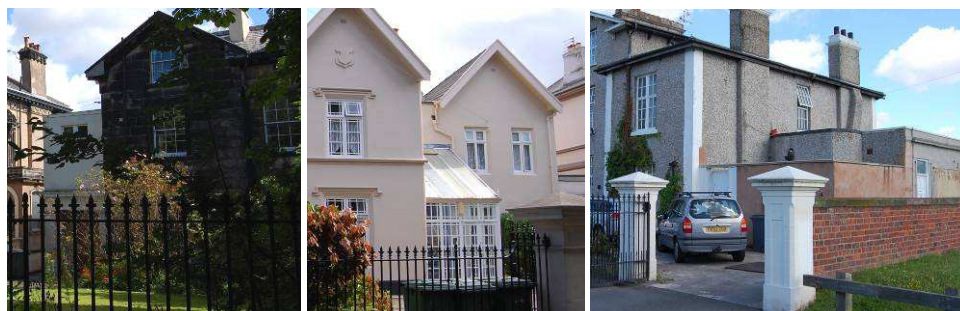
- 6.3.1 There are relatively few extensions within the conservation area of a significant size. Most extensions have been to the rear or sides of houses to provide ancillary accommodation such as porches. In many cases extensions have involved the alteration of existing outriggers and therefore have not substantially changed the form of the building. The most unsympathetic of extensions are likely to be those that confuse the original form of the building and lessen the overall perception of quality. Good extensions would either use the materials and detailing of the original building or be of a modern design and construction that is of a high quality but adequately contrasting to the original.

*Extensions within the conservation area. The first two images show extensions of a similar form to elements of the original building, but lacking the quality of detailing, the third shows very poor quality and highly visible single storey additions.*

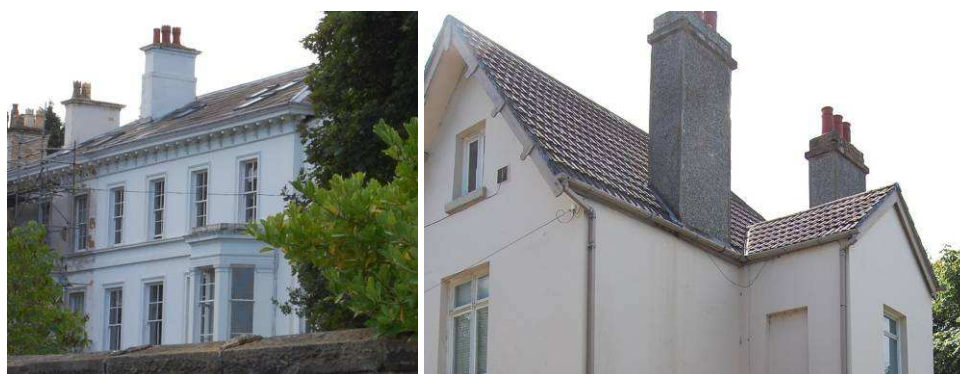
- The insertion of new or alteration to existing openings
- Replacing original windows, within modern designs and materials such as UPVC
- The replacement of doors
- The replacement of slate roof coverings with modern tiles
- Rendering or painting over originally exposed stonework
- Poor quality repairs, particularly where using a change of material
- The installation of rooflights
- Changes to chimneys

*Unsympathetic alterations within the conservation area: (left) rooflights inserted into the roof slopes; (right) concrete pantiles*

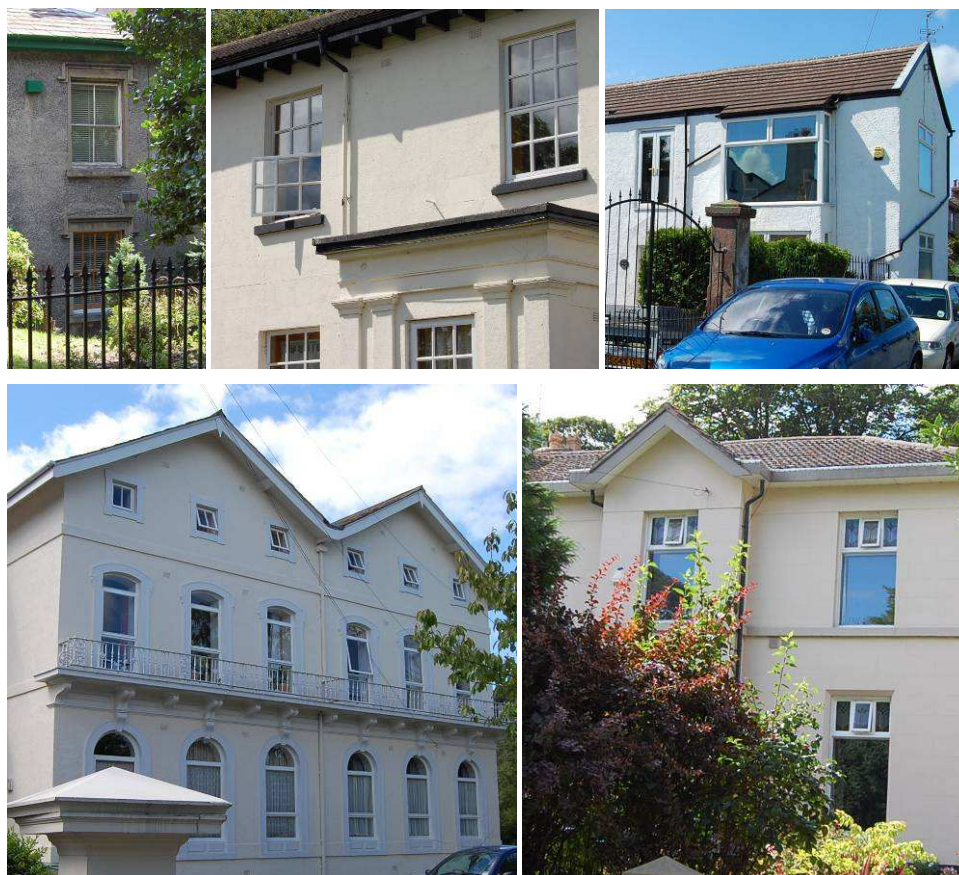
6.4.2 The foremost alteration to historic fabric within the conservation area is the replacement of original doors and windows. These alterations are often well intentioned – to improve the thermal or acoustic performance or to reduce maintenance requirements for instance, but the visual effect, particularly on the architecturally simple buildings is immense. The original sash windows would have had very slim profiles, giving an elegant appearance. In contrast, a UPVC or aluminium replacement, particularly when holding a thick double glazed unit, has considerably thicker framing elements, which are more obtrusive visually and will let much less light into the building. To exacerbate this problem, it appears as though many of the buildings' sash windows were replaced with casements (albeit of a relatively sensitive design) many decades ago, confusing the original design intention of the building.

6.4.3 The reconfiguration of opening panes (particularly when replacing sashes with top-hung casements) dramatically changes the architectural character of the building. Where windows are replaced in timber, these can also

adversely affect the appearance of the building where the original detailing is not followed and often the quality of the timber is far substandard to the original, giving it a short lifespan. There are a few instances where secondary glazing has been used in the village (e.g. in the village hall), which will always produce a more satisfactory visual result than a double glazed equivalent. The use of UPVC windows is more prevalent amongst, although not restricted to, the unlisted buildings.

*Replacement windows within the conservation area: (top left) an example of an instance of two different configurations of sash window within a building. It is not clear which is original and either may be appropriate but together they are detrimental to the rhythm of the façade. The bottom windows is an example of a stained finish which is inappropriate to the character of the building; (top centre) the detrimental impact of casement windows feigning to be sashes; (top right) large picture windows which result in an historic building appearing to be modern; (bottom left) illustrating the way that modern windows can adversely affect the overall perception of quality to a façade; (bottom right) modern casements again changing the character of the building.*

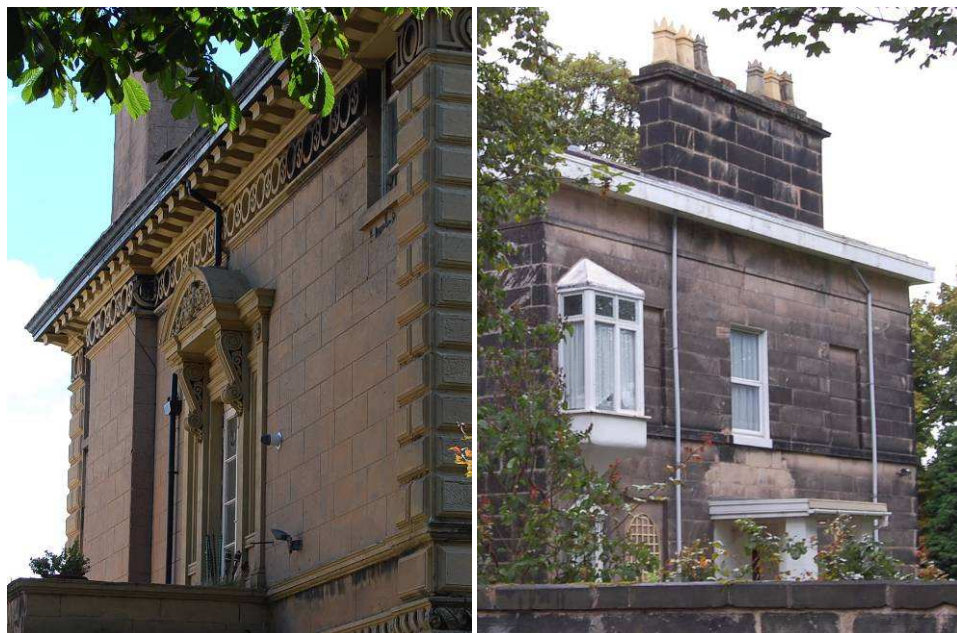
- 6.4.4 There are a number of instances where new openings have been inserted into the walls of historic buildings. The carefully elevations of the buildings are generally particularly well proportion and as a result any new opening upsets the balance rhythm and geometry of the existing fenestration or may change the character of an intentionally plain façade. The effect of inserting a new opening through existing fabric where it penetrates through details such as cornices is particularly great.

*Photographs illustrating the detrimental impact of inserting new openings. The left-hand example shows a small window penetrating through the decorative cornice, the right shows an oriel window (possibly older) and a modern canopy that have unbalanced and changed the architectural quality of the façade. Both of these facades are particularly prominent.*

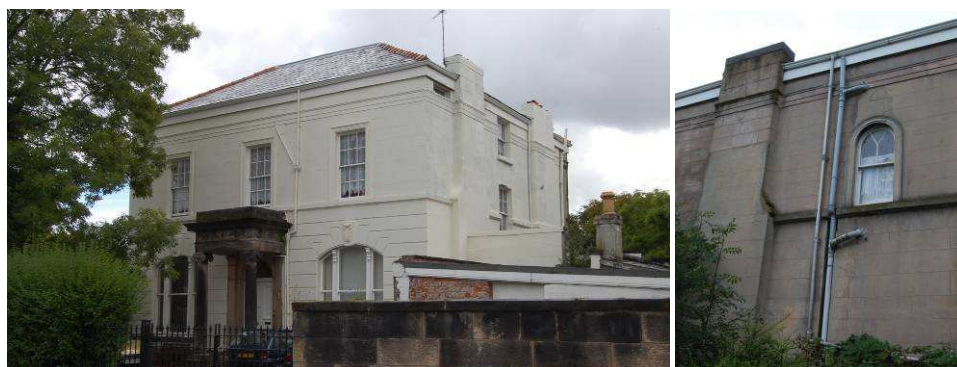
6.4.5 There are a number of further issues, which do not involve the loss or damage to historic fabric but have a detrimental affect on the appearance of the conservation area. All of these matters could be changed without or with little cost, therefore can be considered management issues. These include:

- The installation of service fixings and fixtures such as rainwater and waste pipes in prominent positions
- The repainting of facades in inappropriate colours
- Changes to the landscape setting, for example large areas of hard landscaping for car parking.
- The installation of satellite dishes and aerials.
- Bins stored in front gardens, presumably due to a lack of facilities at the rear.

*Management issues: (left) a recently painted façade; (right) waste and soil vent pipes, together with a modern fascia treatment.*

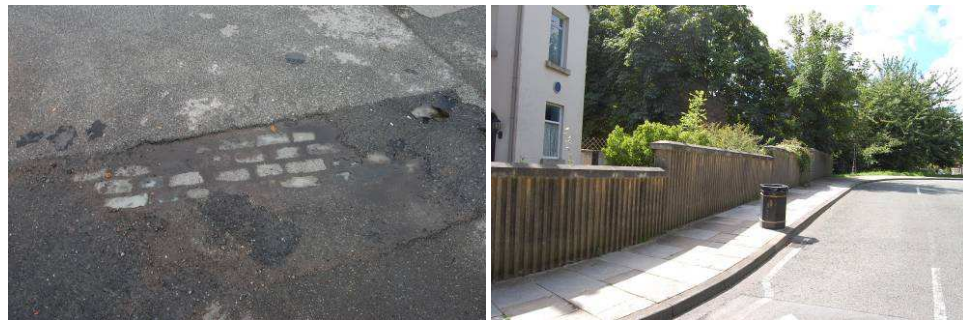
- 6.5.1 Many of the roads (most notably Rock Park itself) do not have pavements, however, where pavements exist, they are of modern materials, such as concrete slabs, with the exception of some stone kerbs. Roads are all tarmaced, although there are some areas of granite setts showing through around the junction of Bedford Road East and Rock Lane East. Although these surfaces are generally fit for purpose, they are not of a quality that corresponds to that of the listed buildings.

*(left) granite setts beneath tarmac; (right) modern concrete slab pavements with concrete walling, presumably constructed at the time of the by-pass*

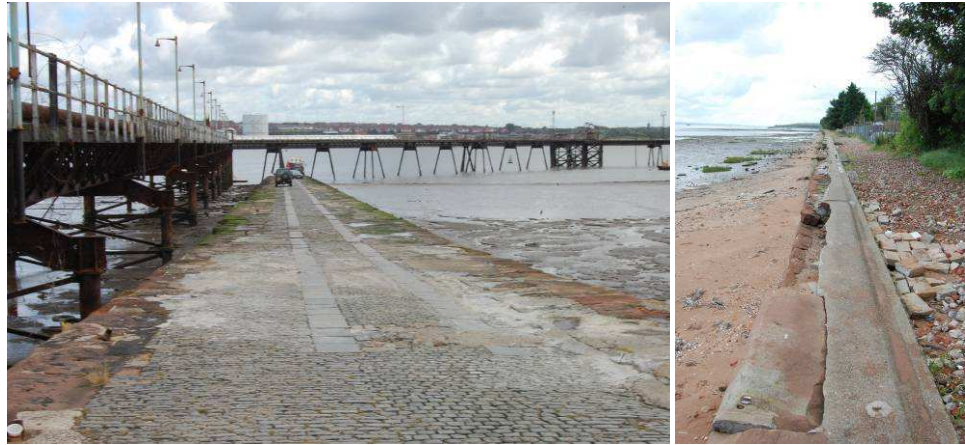
- 6.5.3 The jetty, pier and esplanade are all historic features of great tourist potential but in an unsafe condition. Despite their appearance, considerable amounts of historic fabric remain, but are being lost due to erosion, vandalism and poor maintenance.

*The jetty, pier and Esplanade*
