Backgrounds at sPHENIX

John Haggerty*

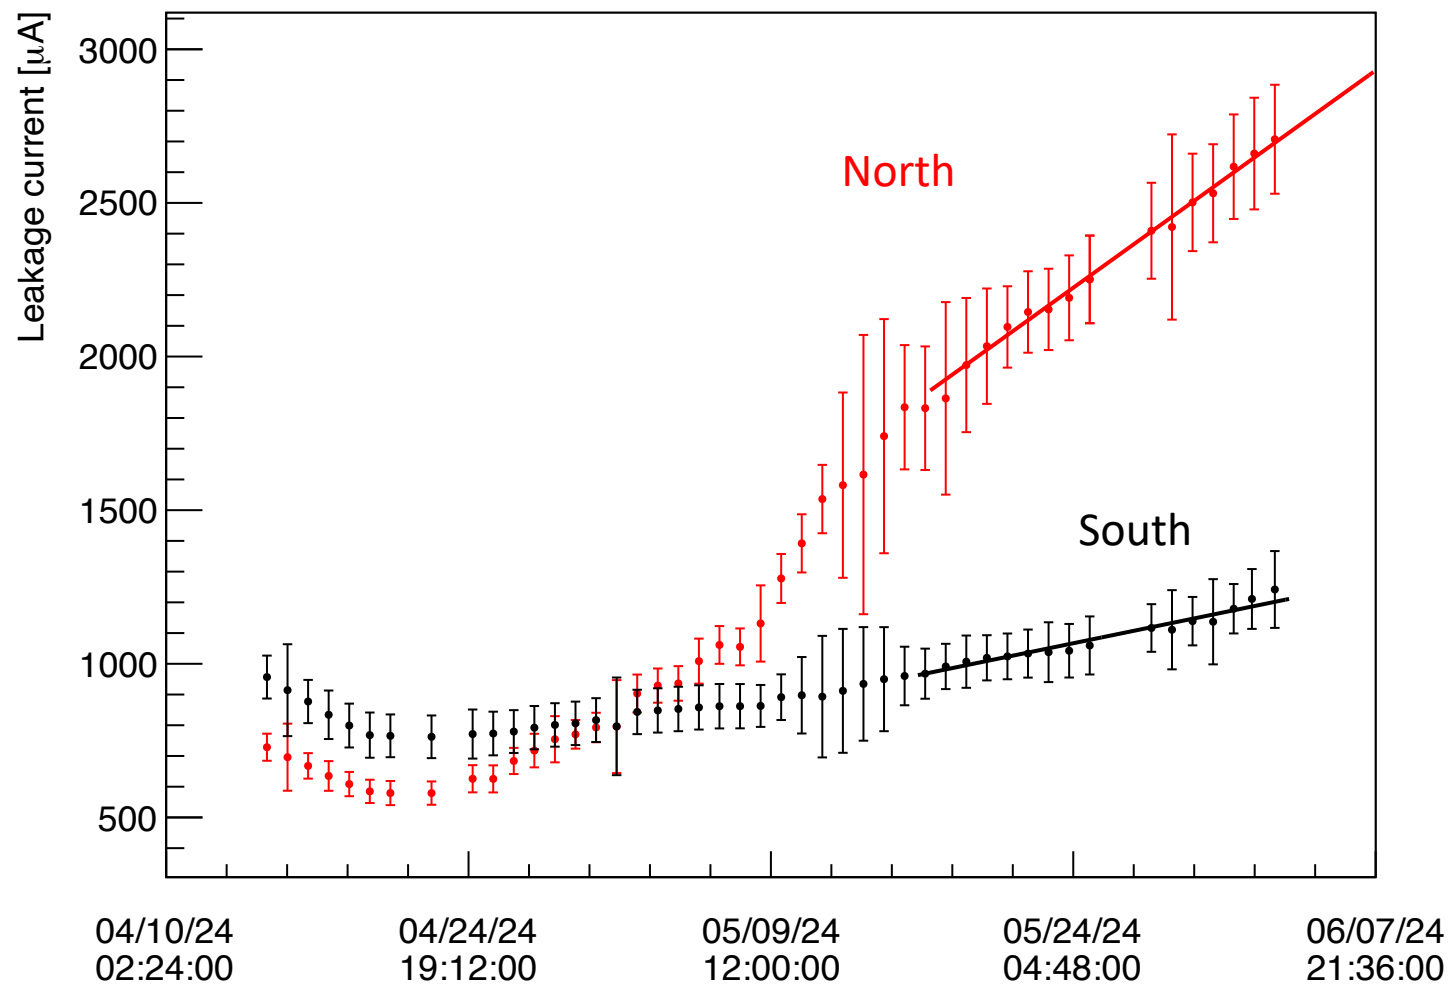
sPHENIX EMCAL SiPM leakage currents IB5

- The photodetectors on the calorimeters are little dosimeters (3mm x 3mm)
 - 100k in a cylinder about 90 cm in radius
 - Increased leakage current with rad damage, making them noisier
 - Damage known to be mainly from ~ 1 MeV neutrons
 - We supply 64 towers (256 SiPM's) with a supply up to 100 mA
 - Initial currents were 0.1 mA before 2023, 1 mA at the beginning of 2024

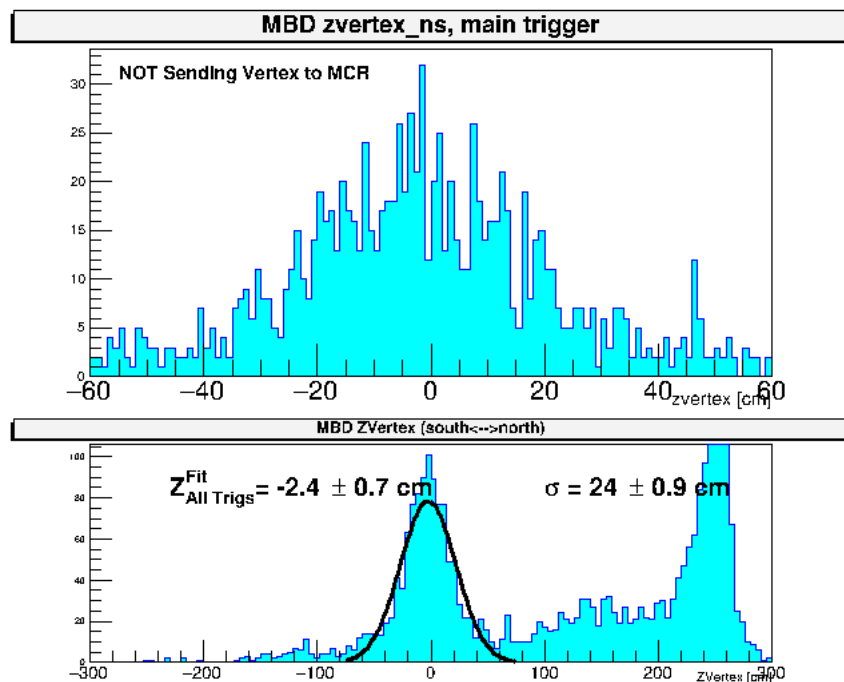
Run #44622 Events: 5394 Date: Tue Jun 4 06:00:11 2024

- The MBD is small (30 cm diameter with a 10 cm hole) and right outside the beam pipe
- We sometimes see a spurious vertex distribution which comes from particles parallel to the beam pipe which go through both MBD's
- More aggressive collimation generally eliminates them
 - ...but Angelika can tell you more

June 4: Before and After MCR intervention

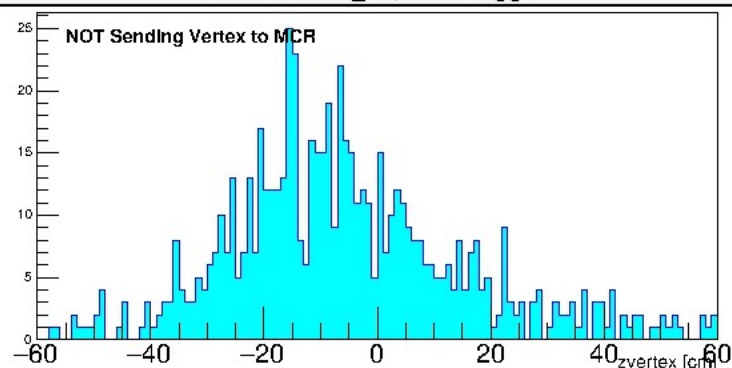
Run #44695 Events: 2211 Date: Wed Jun 5 00:54:16 202

June 5: Before and After MCR intervention

MBD zvertex_ns, main trigger

MBD ZVertex (south<-->north)

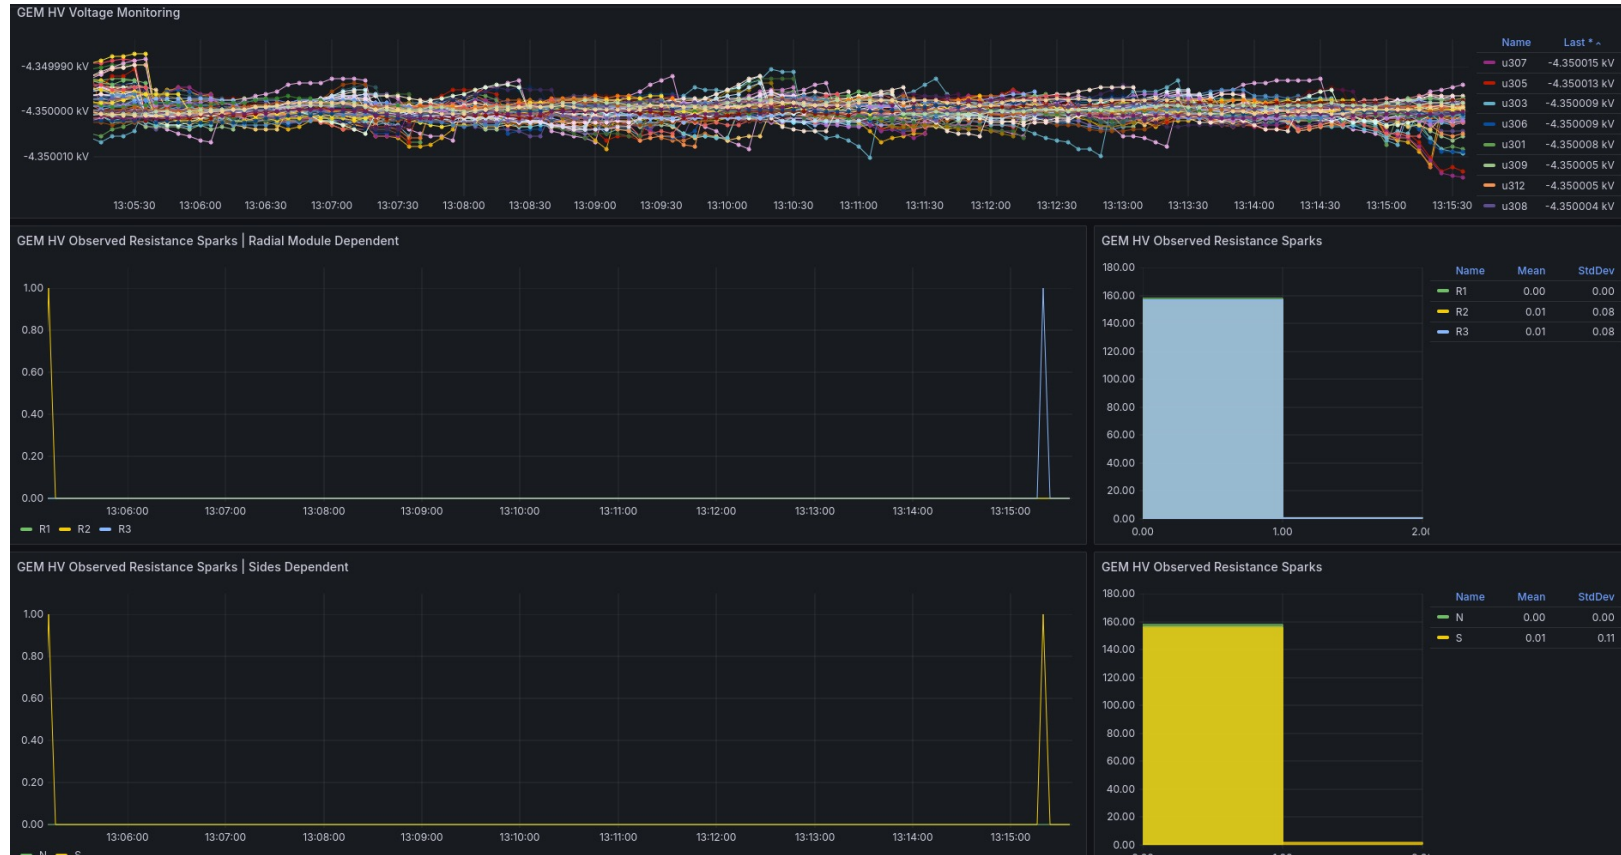
Sparks detected without beam

- Few sparks detected during testing Feb-April
- Still true now without beam (this was 10 minutes with 1 spark on Tuesday)
