Detection of Manufacturing Flaws in Ceramic Matrix Composites using Machining Force Signatures

Julian de Leon* and Nathan Machak[†]
San Diego State University, San Diego, CA, 92182

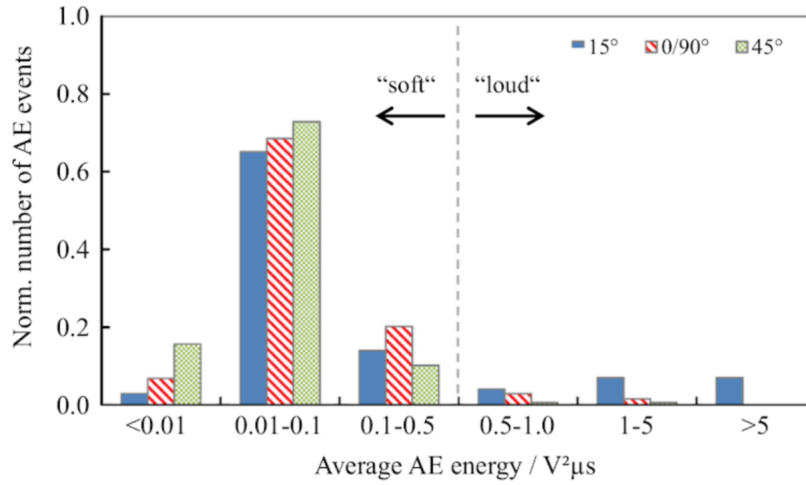
Fig. 2 Histogram of acoustic emission events for the different fiber orientations

After filtering and analyzing the recorded data, it was determined the different energy levels could be related to different types of damage occurring during the test and the number of AE events varied due to the fiber orientation, as seen in Fig. 2.

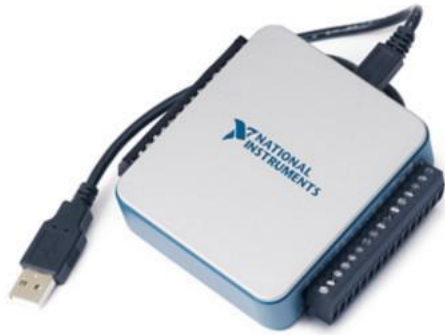
Fig. 7 National Instruments 6003 USB

The National Instruments series 6003 USB data acquisition device was used for this project to collect data from each load cell and import it to the computer, where the data could undergo post processing. The NI 6003 has a high sample rate of 100 KS/s, which is important for this project, because a high resolution will be needed for testing.

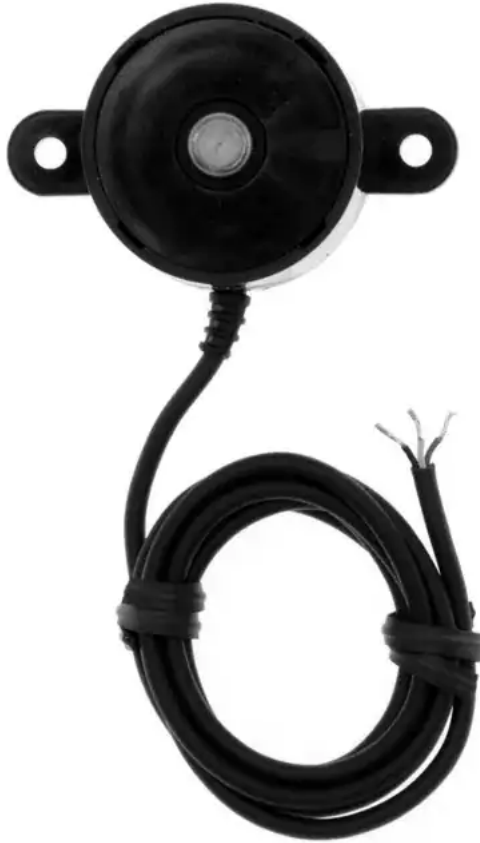
Fig. 8 TE Connectivity Compression Load Cells

The two types of load cells that were used in the rig are compression type load cells and bar load cells. The compression type load cells that were used had a load capacity of 25 lb and are used to measure the normal force during drilling. Because three were used this gave the rig a total limit on the normal drilling force of 75 lb. The compression load cells also have a built in amplifier, which allows them to output a big enough voltage for the NI 6003 to be able to pick it up.

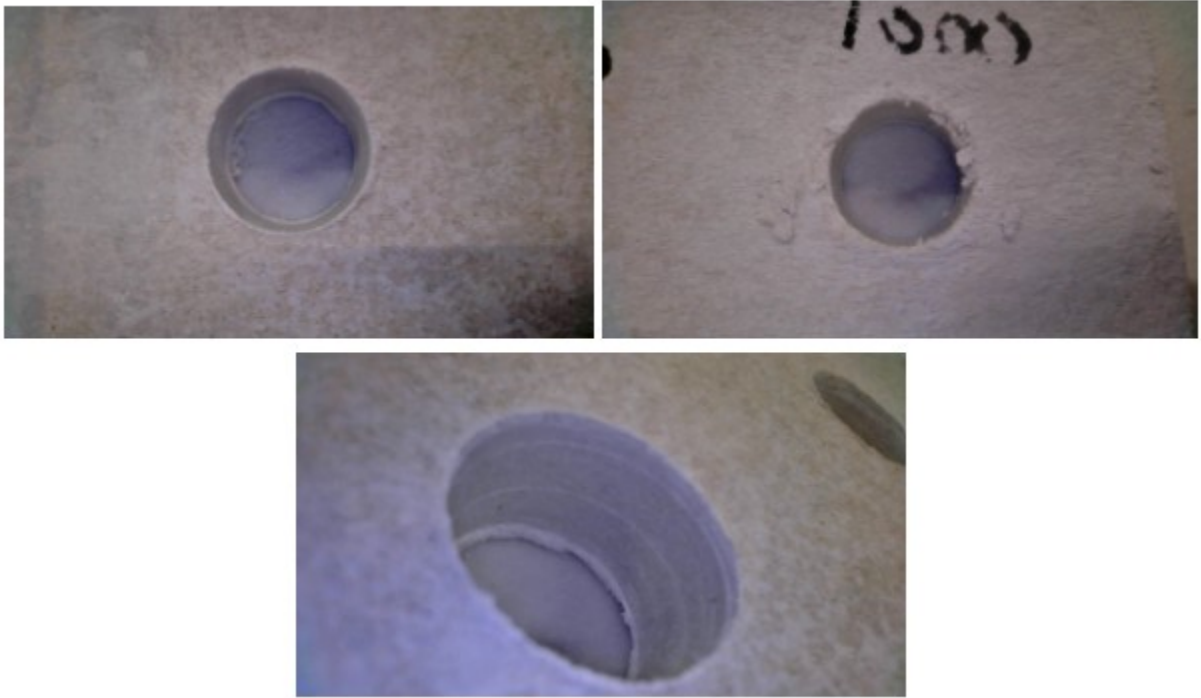
Fig. 10 Top View (Top Left), Bottom View (Top Right), Side View (Bottom) at 1000 RPM, 3 in/min

In Table 1, the different combinations can be seen. For the preliminary tests, there was 1 hole drilled per combination. After each hole was drilled, each one was examined to inspect how the Hardie Board had been affected by the spindle speed and feed rate. It was quickly noted that a spindle speed of 750 rpm would not be sufficient as a testing parameter as each hole that had been drilled with this speed did not seem to cut as efficiently as the higher spindle speeds. The next increments tested utilized spindle speeds of 1000 rpm and 1250 rpm. These speeds were combined with the same feed rates as the 750 rpm tests. The last tests were run at a spindle speed of 1500 rpm. By the time all the previous tests had been run, it was decided that a feed rate higher than 3 in/min would be excessive. Therefore, for the runs set at 1500 RPM, tests were conducted with feed rates of 3 in/min or lower. After the testing for each section was completed and the quality of the drilled holes were checked, it was decided that the pairing of a spindle speed of 1000 RPM and a feed rate of 3 in/min would be the parameters used for the Hardie Board testing. This was chosen because it provided the best visual results of the combination. With these parameters, the inside of the drilled hole showed each layer of the Hardie Board, and cut without excessive force that would punch a hole and blow through the back of the test sample. One of the drilled holes can be seen below in Fig. 10.

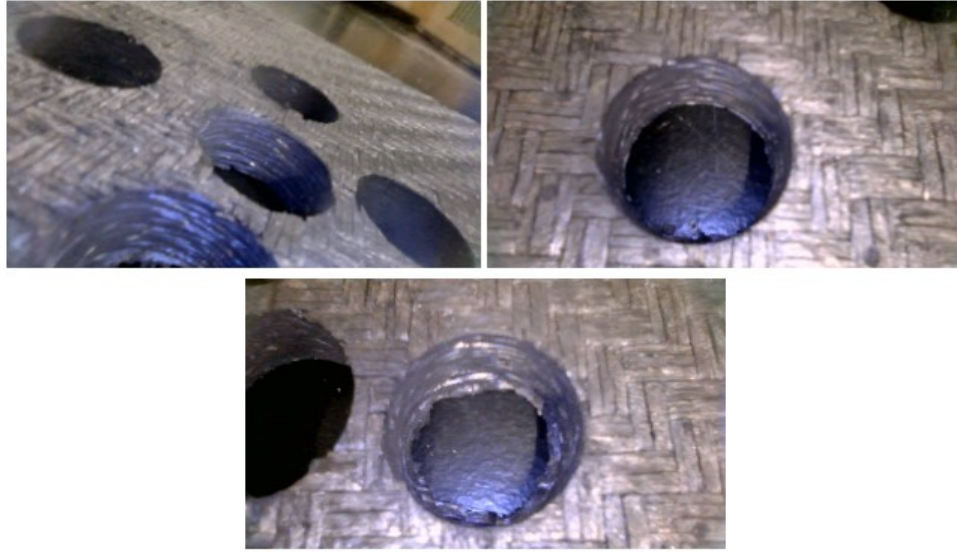
Fig. 18 Holes drilled into unbonded Carbon/Carbon Sample

To begin the experiments, it was a similar process to the Hardie Board in which a spindle speed and feed rate needed to be found. Given the small amount of carbon/carbon available, the results needed to be found relatively quickly. After several runs, the spindle speed and feed rate combination that would be used for the tests were 1000 RPM at 1 in/min. The slower feed rate was due to the fact that the carbon/carbon was more brittle than the previously used Hardie Board. Just as a sacrificial piece had been used for the Hardie Board tests, one was also placed under the carbon/carbon samples. Similar to the problems with the Hardie Board, the plugs created by using a hole saw to cut these specimens would get stuck in the holes of the saw. The drills used for the carbon/carbon were also a finer grit hole saw, which meant that there was more frictional force during the cutting. This different hole saw drill bit would also pose a difficulty as it was much harder to remove the plugs created from drilling from the hole saw. As a result, the decision was made to change out the drill bit used every two holes. The first specimen used was the unbonded sample. This sample was able to be drilled five different times within the experimental rig. After this sample had been bonded the maximum number of times, it was time to move onto the bonded sample. In order to get the bonded sample to fit within the experimental rig, it was necessary to remove one of the stands that held the clamping system. This could potentially cause a problem as it resulted in one less secure point to hold down the test specimen. With the odd shape of the piece, it was only possible to drill three holes into this specimen. Some of the drilled specimens can be seen in Figs. (18) and (19).
