EARTHQUAKE MODELING PRE-READING

RMS® CCRA® Training Program

Classifying Structures for Earthquake – Learning Objectives

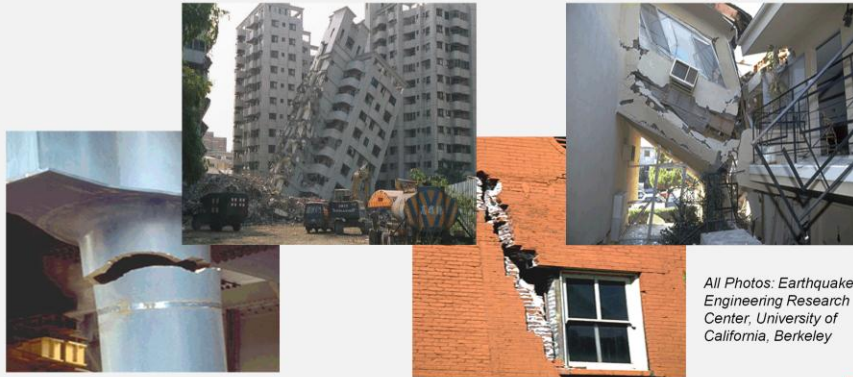
Shown here are different types of buildings (tall, masonry, wood, steel). The vulnerability for each of these structures is a function of ground motion characteristics as a result of earthquake waves traveling through the earth and impacting the site causing the structures to shake. Depending upon their construction, buildings will perform differently.

The top right figure shows the earthquake performance of a building with discontinuities, causing the damage seen at the top level. The next figure to the left shows a masonry building with a large crack around the window, which is a common failure mode for this type of building. The picture second from the left depicts a tall building that lost the first level causing it to collapse and tilt. This damage is related to the interaction between the structure and the soil it is built on. Joint failure is shown in the left-most picture for a structure built on columns. This was a common failure mode observed for similar structures in both the Kobe, Japan and Loma Prieta, California earthquakes.

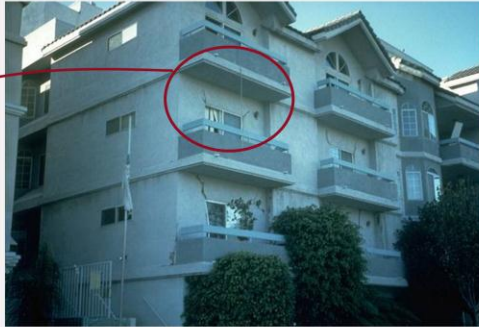
WOOD FRAME (ATC 1)

- Earthquake forces resisted by plywood/stucco/gypsum board shear walls
- Lateral loads transferred to foundation with anchor bolts through proper detailing of connections
- Common class for single and multi-family residential housing

Wood frame is widely used in residential single family and multi-family structures as well as for some commercial structures. Earthquake forces are dampened by shear walls through which lateral earthquake loads are transferred to the foundation of the structure if proper connections exist, such as anchor bolts. These types of structures generally are one to three stories. Building loads are light and the framing span is usually very short. Floor and roof framing consists of wood bracing with rafters that are placed about 24 inches apart.

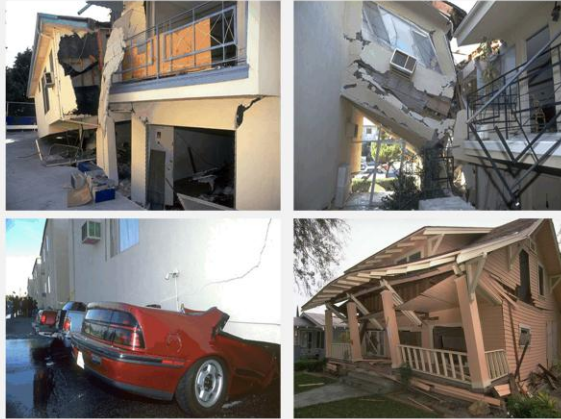
LEARNING FROM FAILURE – WOOD FRAME

This slide shows the performance of a wood frame building in an earthquake where damage occurred. Wood structures are very light from an earthquake perspective, and are thus an excellent material for low story earthquake exposed structures. However, if they are not built correctly they can be subject to severe damage.

Soft story, shape of the building, connections, and the soil and foundation underneath the structure are characteristics that have a significant impact on the structure's performance during an earthquake.

The photo on the upper right shows the impact of irregular shape configuration. There is a discontinuity between the upper and lower levels. This causes the structure to respond differently at each level, resulting in significant damage to the upper level of the building.

The upper left photo depicts foundation failure and sub-story failure.

The lower left photo is a classic example of soft story failure, which in this case is the failure of tuck-under parking, causing damage not only to the building but also to the cars parked underneath. Collapse is due to the discontinuity between the first floor structure and the building on top.

The photo on the lower right shows the failure where the connections of the roof to the vertical element (in this case columns) is not sufficient to transfer the loads properly during an earthquake from the roof, through the walls and/or columns, to the base of the structure.

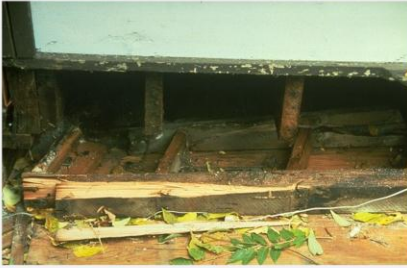
- Common in older wood frame houses with tall crawl spaces
- Crawl space walls (also known as cripple walls) connect the foundation to the floor joists
- Can fail under lateral loads, unless reinforced with plywood

Wood cripple wall failure in frame house –
1989 Loma Prieta Earthquake

One of the most important failure modes seen in older buildings is cripple walls, which are common in wood frame houses. Cripple walls connect the building foundation to the floor trusses. If these walls are not connected or reinforced properly to the floor system, then the motion of the structure during an earthquake will not be transferred properly to the foundation. The picture on the left shows the poor performance of a structure with a cripple wall in the Loma Prieta earthquake. This structure was moved off of its foundation because the cripple wall was not able to transfer the upper level forces to the foundation. How can this problem be fixed? It is necessary to provide reinforcement to the cripple wall or add rigidity to the wall to allow transfer of earthquake forces from the floor to the structure. In the figure on the right you will note a yellow element that depicts plywood panel. That is the type of element that will add to the vertical strength by improving the vertical rigidity, which allows continuous transfer of ground motion through the structure. Alternatively, if you use cripple wall bracing, then the building will experience similar transfer of ground motion to the structure during an earthquake.

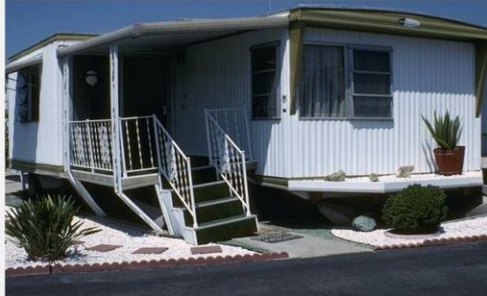
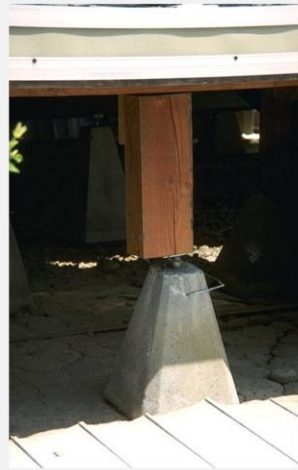
Mobile home damaged in 1994 Northridge Earthquake

Failure at pier supporting mobile home

Mobile homes are manufactured homes taken to the job site and placed on a foundation. The foundation is usually very simple with a limited connectivity between the home and foundation (as shown in the photo on the right). During an earthquake, the mobile homes are easily separated from the foundation and collapse.

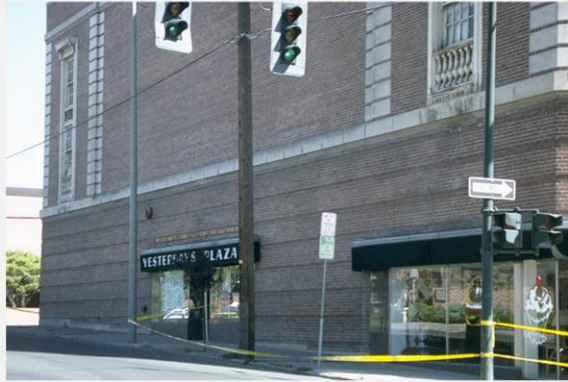
- Earthquake forces resisted by unreinforced masonry walls
- With frame (ATC 4) vs. without frame (ATC 3)

Unreinforced masonry walls may or may not have framing systems. In this photo, the perimeter of the building walls are unreinforced masonry (URM) and the interior is also masonry. The buildings are heavy, so there is more mass to experience larger shaking and a greater degree of damage will result if not properly built. Due to the large mass of the building, most of the earthquake forces are exerted from the roof to the foundation.

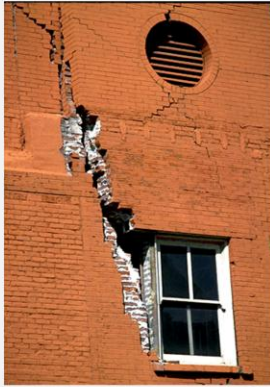
Massive crack in brick building, Northridge 1994

This slide shows the different failure modes of URM construction buildings. The figure on the left shows a massive crack due to the Northridge earthquake in 1994. The middle figure shows failure in a URM building during the Seattle-Olympia 2001 earthquake, which consists of a continuous crack in the wall. The figure on the right shows damage from the 1994 Northridge earthquake. The upper part of a brick wall moved in a different direction than the rest of the building and eventually crashed into the street.

While the three photos above show failure to different types of URM buildings in two separate events, the failure is due to the same problem related to URM walls not having sufficient confinement and reinforcement. The other issues are improper connections between the roof and the top of the wall, which can allow out-of-plane failure. In other words, the wall is allowed to move in a different direction from the roof during an event, causing the wall to fail and collapse as shown in the figure on the right.

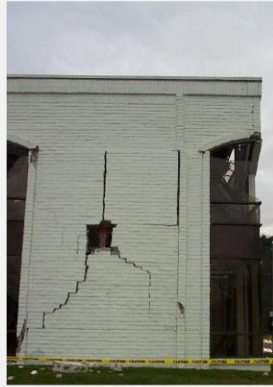
Seattle-Olympia 2001

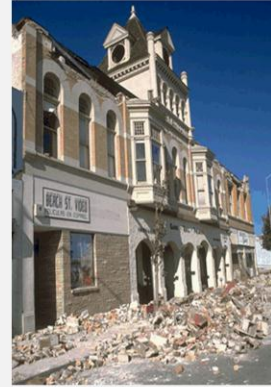
Upper part of brick wall fell down due to lack of proper connection with roof, Northridge 1994

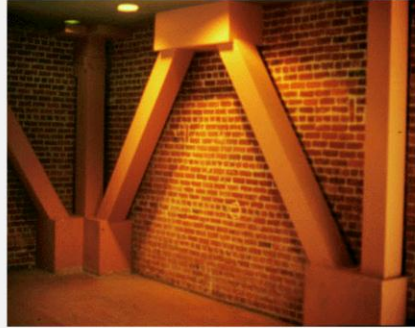
Many masonry buildings can be made more resistant to earthquakes by adding an internal frame, such as the one shown here, and bolting the walls to the frame.

This slide depicts one of the possible secondary construction modifiers – URM retrofit. By using the internal frame shown here, the design engineer is now allowing for the continuous transfer of earthquake loads via the lateral bracing from the roof through the walls and to the foundation. This shows one approach, which is to isolate the walls responsible for carrying the lateral forces. If this type of internal framing is implemented, then the URM retrofit modifier should reflect that structural credit.

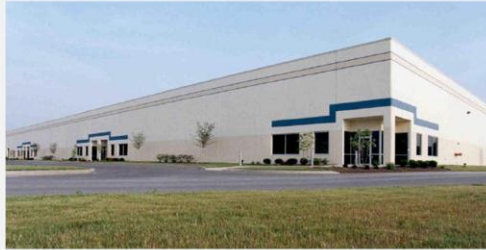
REINFORCED MASONRY SHEAR WALL (ATC 7 AND 8)

- Reinforced masonry provides the structure and the skin at the same time.
- Fire and sound resistance are built right into the wall.
- Vertical and horizontal reinforcement resist earthquake loads.

This slide shows a reinforced masonry (RM) building. The RM construction provides both reinforcement for the structure (thus improving the strength) and an outer surface covering (or skin) on the structure. Other advantages to reinforced masonry structures are their inherent sound and fire resistance. Finally, they provide both vertical and horizontal resistance to earthquake loads. The two pictures on the right show the failure modes of masonry walls. The cracks similar to those shown in the previous slides can be prevented by installing horizontal bars and vertical posts or reinforcement, shown as red lines in these figures. When these types of reinforcements are put in, together they increase rigidity, thus preventing the structure or material from moving. The confinement of the masonry diminishes or stops damage to the structure.

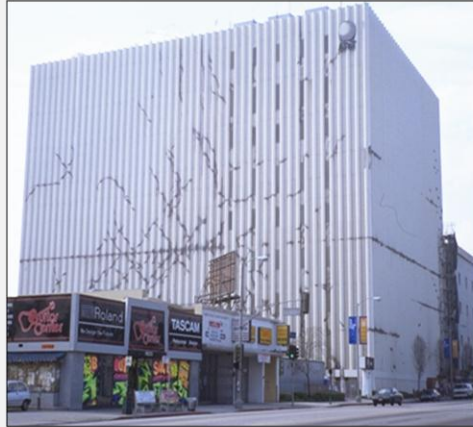
Earthquake forces are resisted by reinforced concrete (RC) shear walls.

In the next couple of slides we will focus on reinforced concrete shear wall structures with and without frames. Reinforced concrete buildings are usually constructed with a combination of shear wall, framing, and pre-cast concrete. This photo shows a shear wall building (ATC 6). In a shear wall building, lateral loads (which make up the majority of earthquake loads) are transferred from the shear wall to the floor and then to the foundation. These types of structures are very rigid and in terms of life safety, they perform very well. However, if the walls are not confined, they will experience damage. The picture above shows cracks in the walls that can be fixed, the integrity of the structure has not been damaged.

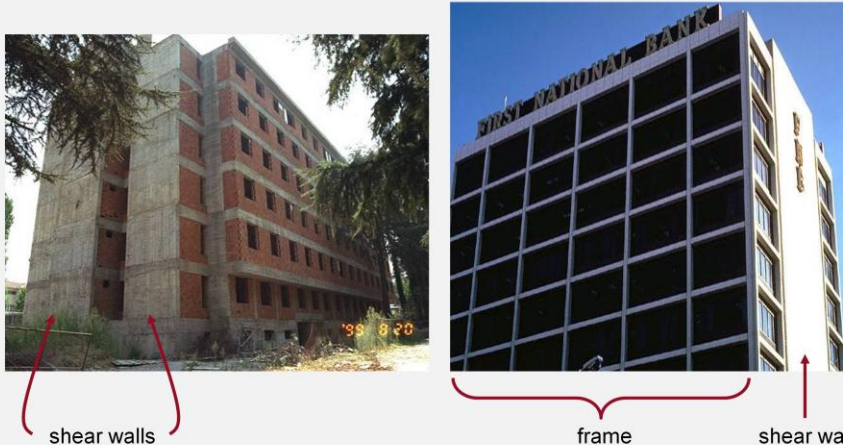
RC frame can be combined with shear walls for a dual system.

This slide shows the combination of shear wall with frame. We call the system a dual system. That means that the shear wall not only carries the force, but the framing and beams are also responsible for carrying earthquake loads. The picture on the right shows the external frame system as well as the shear wall on the right side. This is a type of redundant system, so that if the earthquake causes the shear wall to fail, then the framing system will be able to handle the earthquake forces. This is a very common type of commercial structural system and historically they perform well.

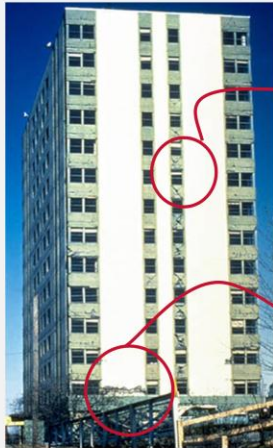
X-shaped cracks and failure of coupling girders or short spandrel girders

Failure of shear walls due to lack of adequate reinforcement at the edge of the shear walls.

This slide depicts historical failure modes for shear wall frame. Shown is a high rise building with shear walls that are visible as panels extending the length of the building from the second floor to the roof. The frame is between the shear walls and contains windows.

At the connection between the two big walls there was a failure of earthquake load transfer causing a very wide crack in the shape of an “X.” This type of cracking is very common. If an xbar or reinforcement is not there, then a crack will occur at that location.

At the base you can see there is a continuous crack along the width of the shear wall. This crack is the result of excessive forces being exerted downward along the shear wall and not properly transferred to the foundation. Without sufficient capacity to handle the loads, the force cannot be properly transferred to the foundation and a crack appears.

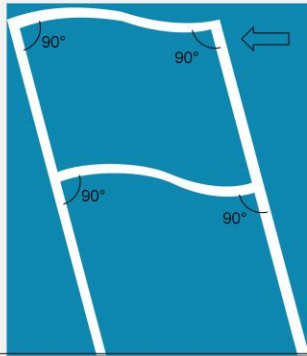
Example of beam flexure during earthquake

To illustrate, the figure on the right is being pushed in one lateral direction. The structure starts to deform and the lateral load resistance is taking place at all of the joints. If one or more joints fail, then the column and the beam will not be joined correctly and the loads will not be transferred. The seismic performance of this type of structure depends on the proper detailing of the beam/column connection to make sure flexural behavior of joints is maintained. For reinforced concrete structures, it is required that beams and columns have sufficient reinforcement around the joint to provide confinement and ductile behavior. For steel structures, the beam/column connections are critical, and sufficient welding and additional plates are required. Older buildings may not have sufficient ductility of proper welding requirements.

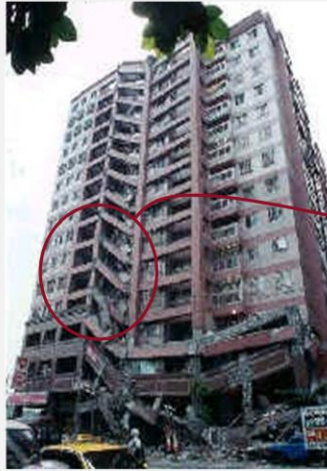
Collapse of new 15-story building
Taiwan 1999

Failure due to poor beam-to-column joint reinforcement

This is an excellent example of the failure of joints in a non-ductile reinforced concrete frame high rise. The joints in this building are responsible for the transfer of loads from the top to the bottom of the structure. If these joints or connections are not properly built, or do not have sufficient reinforcement, then they can fail as shown in the photos above for a building that collapsed in the 1999 Taiwan earthquake. This is a common building failure, especially in Taiwan where this type of building is popular for high rise structures. These types of buildings are classified as non-ductile, which causes the damageability of this type of building to be much higher than the ductile building construction that allows the building to respond to lateral earthquake forces in a less rigid manner.

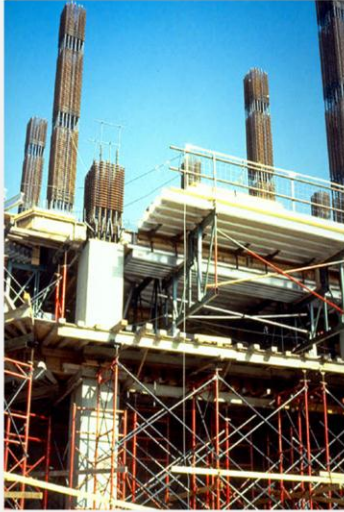
DUCTILE REINFORCED CONCRETE FRAME (ATC 12)

- Shown here is a reinforced concrete ductile moment-resistant space frame structure.
- Note the close spacing of the lateral reinforcement that has been provided in the columns to obtain adequate confinement.

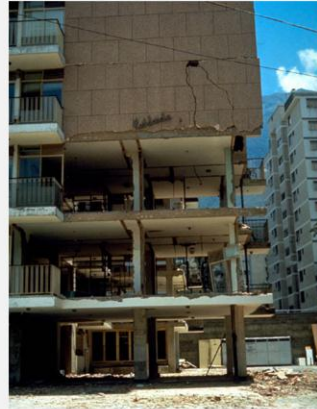
This 12 story RC building suffered considerable non-structural damage in the 1967 Venezuela earthquake. The tile walls and partitions of the lower stories shattered.

Another modifier that is not only applicable to concrete buildings but also to steel structures, are URM partitions. This is covered cladding, or partition walls, constructed with URM. If these elements are not properly connected to the structural frame, they can crack and detach from the structure, as shown in this example. This is a very old structural practice that is common in some areas of the world such as Taiwan, but it is not prevalent in the U.S.

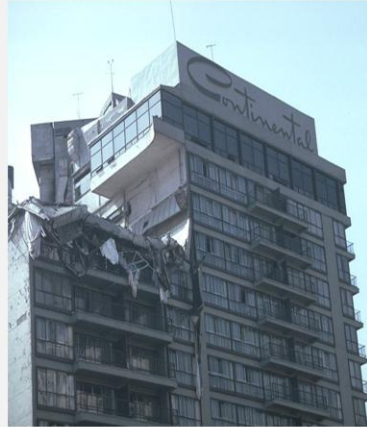
SECONDARY MODIFIER – POUNDING

- Definition/condition:
 - A condition where two adjacent buildings collide during an earthquake.
- Examples:
 - Adjacent commercial buildings with little space between them.
 - Most common for reinforced concrete or steel structures.
- Possible consequences:
 - Damage where the two buildings collide, of particular concern if floors are not at the same elevation.

A common modifier in urban commercial areas with buildings built very close to one another, is pounding; where one building is impacted by a neighboring structure that is moving at a different frequency or direction during an earthquake. When the structures are the same height, pounding between the structures should not be as much of an issue. If neighboring structures are different heights, they will both move with different modes of vibration and impact each other. At the point of impact you see significant damage and deformation to the building. This can happen to both steel and concrete buildings. According to newer building codes, there must be a sufficient gap between the two buildings, so this should not be as significant a damage issue for newer buildings.

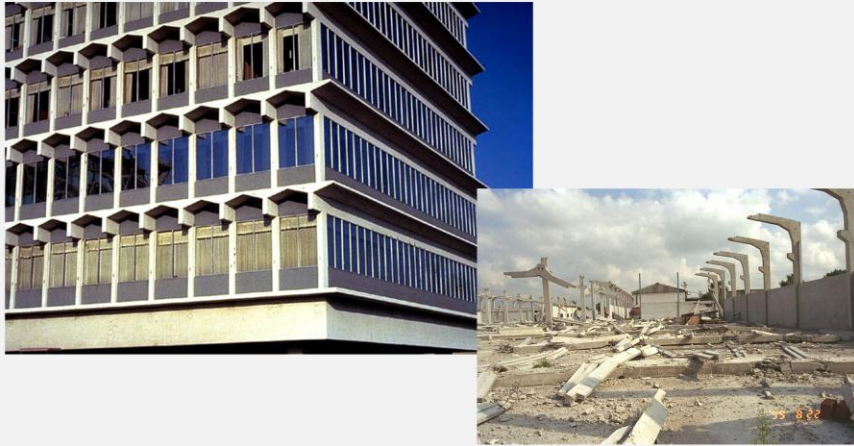
PRE-CAST CONCRETE (ATC 14)

- Earthquake forces are resisted by frames and walls.

However, if sufficient connections are not provided, the building will fall apart, as seen in the picture on the lower right. This photograph is from Turkey, and represents a very common type of failure of this kind of building in the area.

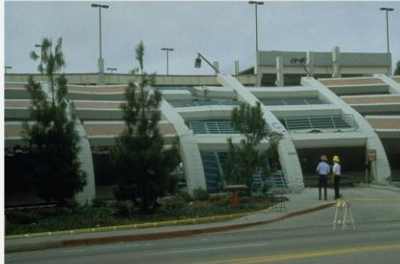
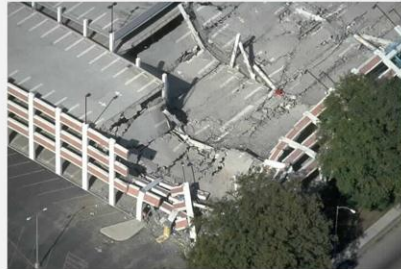
Three story pre-cast concrete parking structure

This is a parking garage after the Northridge earthquake in 1994. From the standpoint of life safety, these columns have actually done quite well - there was no one hurt in this building. Part of the roof came down and caused damage to some of the structure.

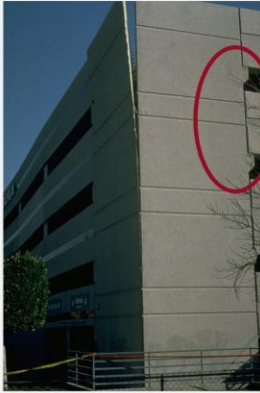
Close-up of damaged corbels. The reinforcement in the corbels is exposed, and significant shear cracking is apparent.

This is another example from the 1994 Northridge earthquake. These pre-cast pylons hit the top of the corbels. If there is sufficient impact due to the movement back and forth, they can cause cracks at the location where the pylons are sitting, which is actually the weakest point on this type of structure. A corbel is defined as an architectural member that projects from within a wall and supports a weight, especially one that is stepped upward and outward from a vertical surface.

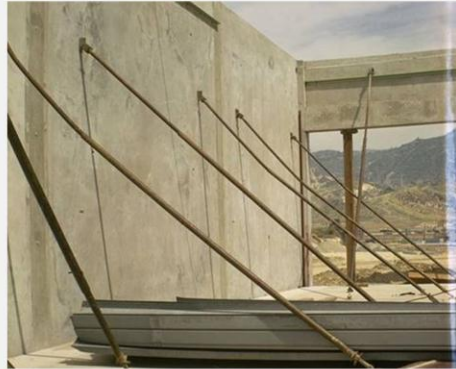
- These buildings have concrete walls pre-cast on the ground and then tilted vertically into place.
- Earthquake forces are resisted by pre-cast concrete walls.
- They often fail at the connections between walls, floor, and roof.

Another group of pre-cast concrete structures are tilt-ups. These buildings are typically single story structures. They may build another level on the interior of the building, but in terms of the construction, they are only one story.

The walls are built on site and then tilted upward to create the exterior of the building. The roofing system is then built. If the roofing system is not properly connected to the walls, these walls could fall apart.

The main cause of failure to tilt-up buildings is out-of-plane failure, due to insufficient connectivity between the roof and the walls.

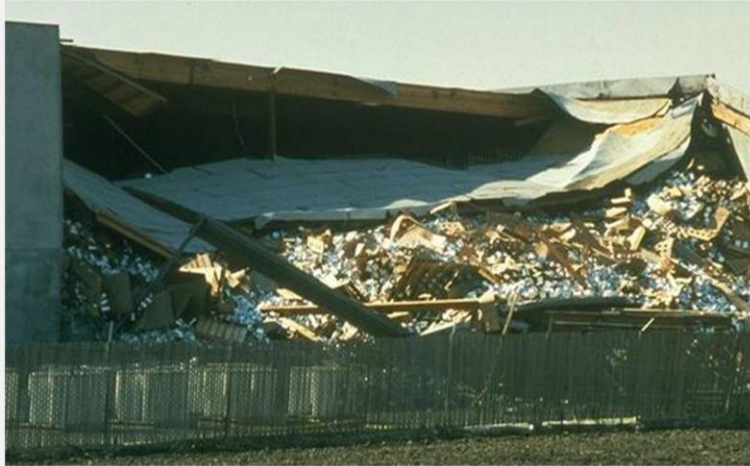
LEARNING FROM FAILURE – TILT-UP BUILDING

- 1989 Loma Prieta Earthquake, out of plane wall failure

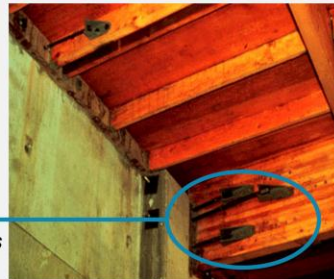
- Definition/condition:
 - Attachment of perimeter roof members to the exterior walls.
- Examples:
 - Typically applies to tilt-up and masonry wall construction.
- Possible consequences:
 - If inadequately attached, walls pull away from the roof structure.

Extra reinforcement can be added to strengthen connections

During the Northridge earthquake, RMS found that even though the roof is connected properly to the walls, there can be another type of failure. The picture at the top shows the connection of the purlin to the wall using a ledger. Even though you have a purlin connection, you have to have sufficient nailing from the deck to the ledge.

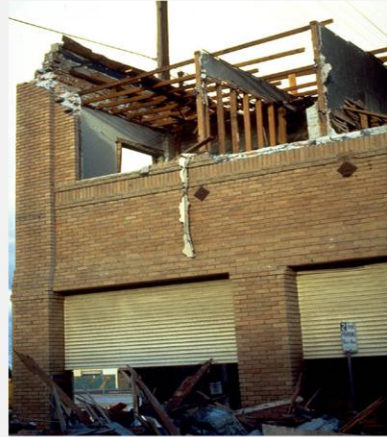
- Also applies to masonry buildings.
- Ties together the super-structure.
 - The upper parts of the brick walls fell down due to lack of proper connection with the roof.
- Significant Dates:
 - 1971 San Fernando Earthquake
 - 1994 Northridge Earthquake

Using purlin anchoring will reduce this type of failure by properly connecting the walls to the roof. The significant dates for seeing this are the 1971 San Fernando earthquake and the 1994 Northridge earthquake.

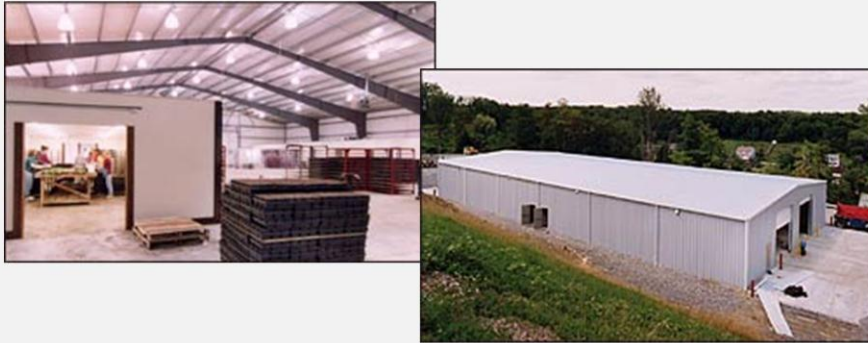
- Light metal structures are pre-engineered and prefabricated with transverse rigid steel frames.
- They are one story in height.
- The roof and walls consist of lightweight metal.

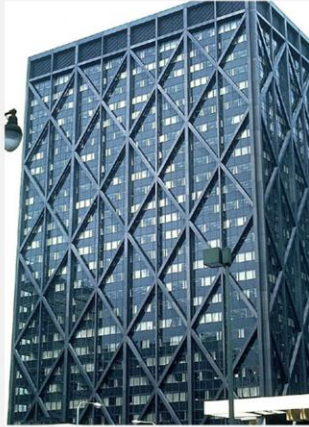
Shear bracing on the outside frame of the building down to the first floor.

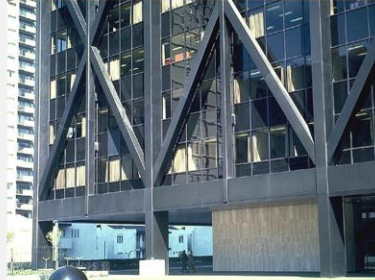
Below the first floor, horizontal shear force is transferred to a central core.

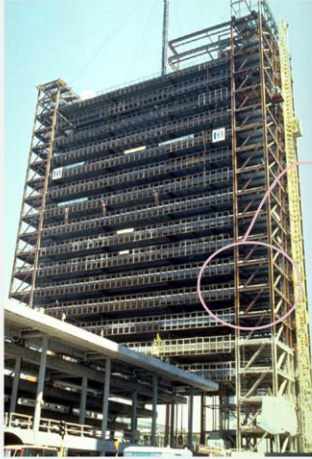
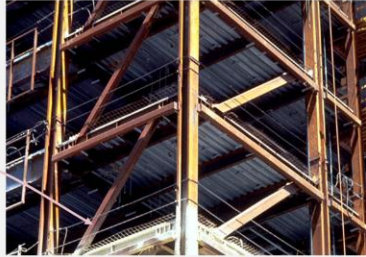
ECCENTRICALLY BRACED STEEL FRAME

- Research conducted over the past several years has clearly shown the advantages of using eccentric braces rather than “concentric” or “X” braces.
- Braces do not connect directly at joints.
- Better distributes peak loads.

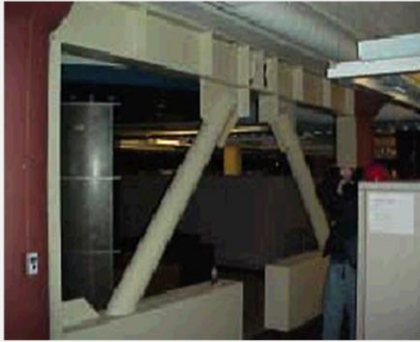
Eccentrically braced steel frame, Starbucks Headquarters, Seattle

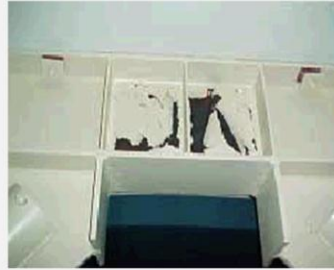
Yielding of an eccentrically braced frame, Seattle 2001

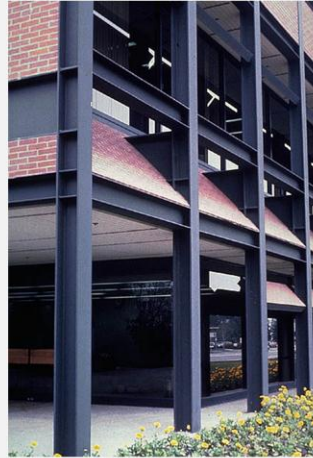
This six story frame consists of I-beams for horizontals and verticals, and uses all-welded construction.

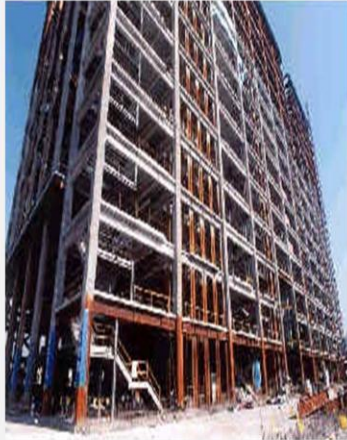
14-Story steel moment-resisting frame (MRF)
building under construction

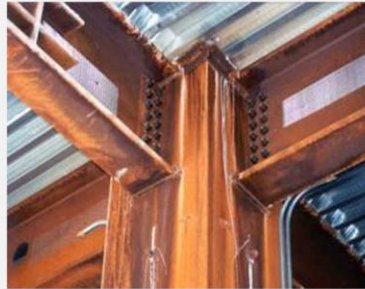
Typical moment frame connection
details

The steel frame connections can be provided by welding or by bolts.

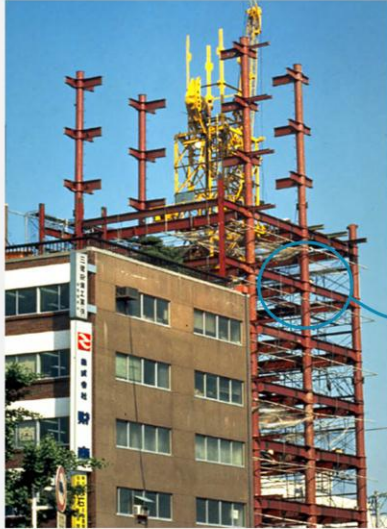
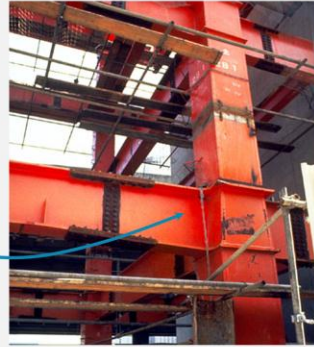
Erection of a steel-framed structure using prefabricated tree-column assemblies.

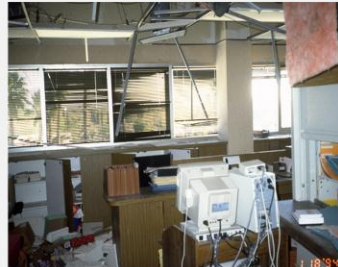
- Definition/condition:
 - Bracing of architectural finishes and utility systems that are not a part of the lateral load resisting system.
- Examples:
 - Piping, A/C units, ceilings, walls, etc.
- Possible consequences:
 - If inadequately braced, can result in extensive damage, including water leakage.

So far, all of the secondary modifiers we have discussed have been structural elements. However, non-structural elements, such as the bracing of architectural finishes, will experience much movement during an earthquake. If they are not properly connected to the structure, then we may see extensive damage to ceilings, walls, etc. Also, it may result in failure of pipelines or sprinkler systems, which will cause water damage to both contents and structures.

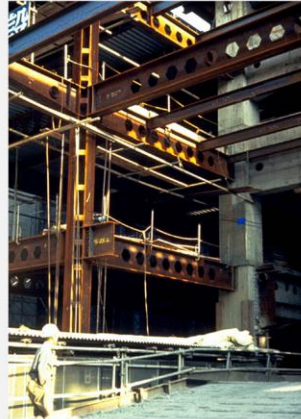
- Earthquake forces are resisted by steel beam-column flexure.
- Common in Japan.
- A light structural steel frame is built first then, to avoid the buckling of steel members, they are covered with confined reinforced concrete.

Composite structural steel and reinforced concrete earthquake-resistant building under construction in Japan.
