SERVICE INSTRUCTION	PT5661
	POWER SUPPLY 4008 109 70560 MB	Waveform monitor/vectorscope
Prepared by : Gbg

Scope

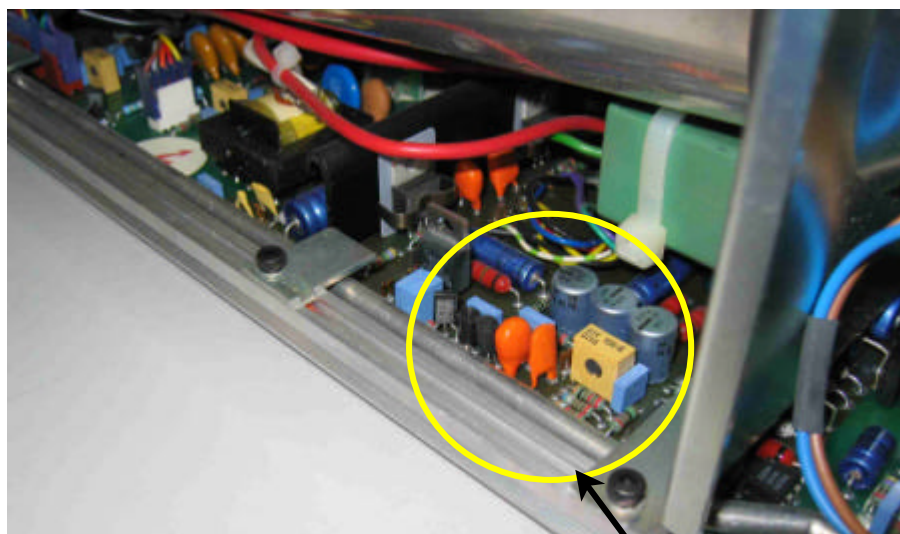
1. Overview of power supply seen from bottom side

Area to check
