Active health monitoring of an aircraft wing with embedded piezoelectric sensor/actuator network: I. Defect detection, localization and growth monitoring

Article in *Smart Materials and Structures* · June 2007

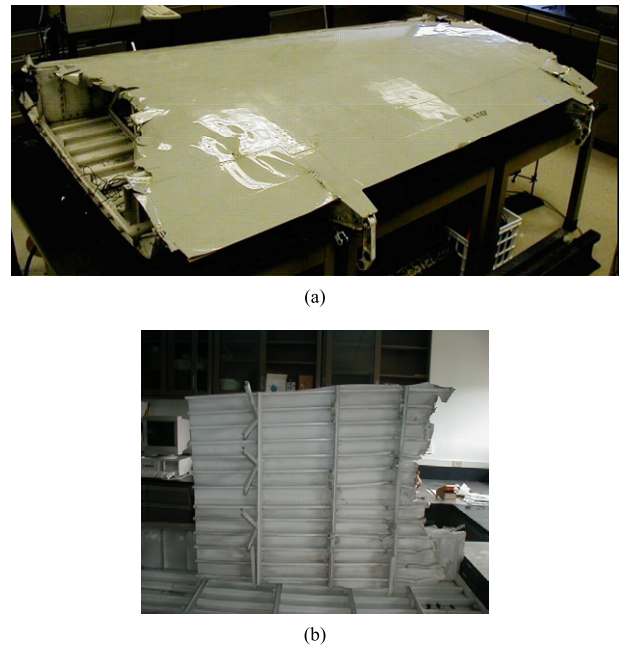
Figure 1. (a) E-2 surveillance aircraft wing section; (b) the disassembled top panel of the wing.

Figure 1(a) shows an E-2 surveillance airplane wing section that was acquired from the US Navy for this study. It is made of aluminium alloys and coated with paint. For the ease of sensor implementation and experimentation, the top skin of the wing section was disassembled with a plasma cutting tool. Figure 1(b) shows a picture of the disassembled top skin piece. Several samples of the top-skin panel were produced after the dissection, and the inner structures of the wing, such as the D-spars, ribs, and stiffeners, were accessible for the experimental studies.

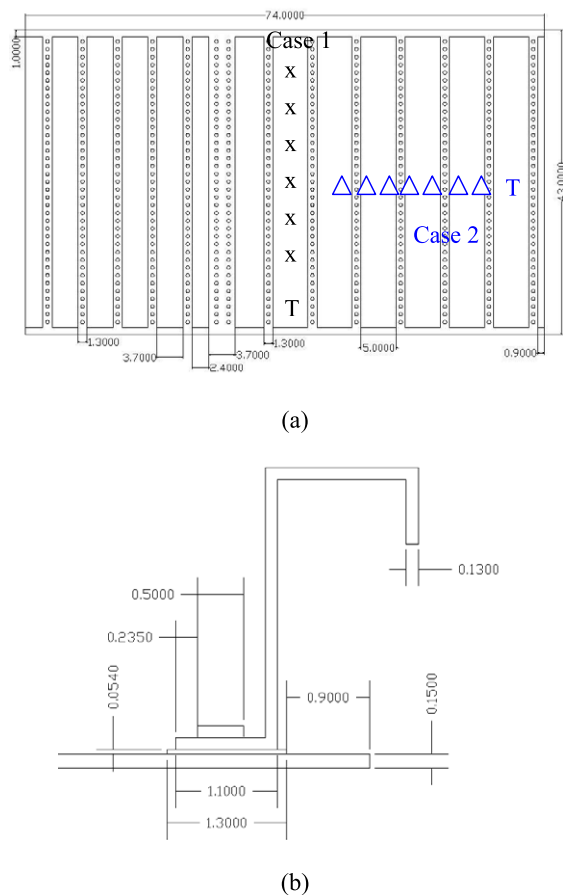
Figure 2. Wing skin structure: (a) sketch of the rivet row and angle beam transducer locations; (b) typical geometry of a stiffener riveted to the skin (all scales are in centimetres).

Figure 2(a) shows a schematic of a piece of the top wing panel and its rivet distribution (in hollow circles). Those rivets are used to fasten the wing panel to the inner structures, such as spars and ribs, but most of them are to strengthen the wing skin with L-shaped stiffeners. Figure 2(b) shows a detailed sketch of a stiffener riveted to the wing skin. As shown in

figure 2(b), the wing skin is a bit thicker under the stiffeners than where there is no stiffener. Thickness measurement was carried out with a micrometer. The average thicknesses of the wing skin with paint are about 1.08 and 1.51 mm, respectively, at different wing sections, and the additional thickness beneath the stiffener varies from 0.3 to 0.6 mm.

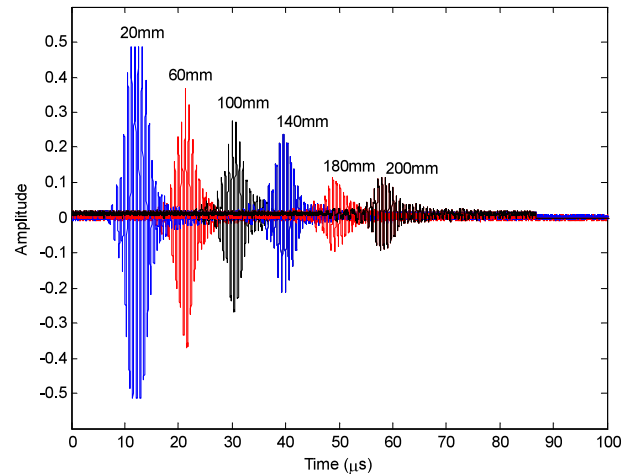
Figure 3. Guided wave signals between rivet rows show the wave attenuation with propagation distance.

The geometric complexities of the wing panel lead to complicated ultrasonic guided wave propagation characteristics. The conventional uniform-thickness plate model is not directly applicable here, since the thickness variation leads to variations in wave speed, mode shape, and mode conversion etc. The wing skin is also coated with at least two layers of paint on the outer surface and one on the inner surface, which attenuates the ultrasonic energy substantially. In addition, the wing panel is distributed with rivet rows in every 6.5 cm and the rivets are spaced less than 9 mm from each other. This introduces great energy scattering and blockage for waves across the rivet rows. We performed an initial wave propagation study on the wing panel with two angle beam transducers in a through-transmission mode. In the first case, the transducers were put in between two adjacent rivet rows and the receiver moved away from the transmitter (T), following the 'x' line in figure 2(a). Thus the wave propagates mostly parallel to the rivet rows. Figure 3 shows the sample 1.8 MHz S_0 mode Lamb wave signals collected when the receiver transducer was 20–200 mm away

from the transmitter. Wave amplitude reduction is quite noticeable with distance due to beam spreading, wave leakage to the paint, and attenuation. The average signal attenuation rate was around 0.044 dB mm^{-1} for the S_0 mode Lamb wave. In the second case, the transducers were put perpendicular to the rivet rows, with the receiver locations shown in figure 2(a) as 'Δ's. The 1.8 MHz S_0 mode Lamb wave propagated across the rivet rows and an average amplitude attenuation of 15 dB was observed for passing each row, of which about 9 dB was caused by rivet scattering, plate thickness variation, wave leakage to the stiffener bond joint, etc. The signal shape was also no longer a pure single burst like those in figure 3 but rather extended in the time domain with multi-path/scattering signals coming in (not shown here). From the above study, it was observed that the attenuation, wave leakage and scattering effects certainly restricted the inspection range of the guided waves. A practical effective range should be estimated or measured before implementing the guided wave actuator/sensor networks.

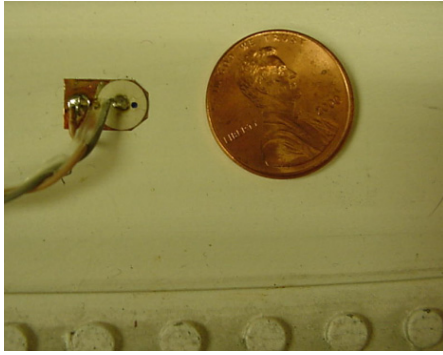
Figure 4. The overall size of the surface mounted PZT sensor/actuator.

Lead zirconate titanate (PZT) is a piezoelectric material with a high electromechanical coupling coefficient. It is widely used in acoustic and ultrasonic devices to generate and receive acoustic waves. The PZT disc transducers used in our experiment are made of PZT ceramics with silver electrodes on both sides of the discs. They were ordered from American Piezo Ceramics Inc (material model 850). When the transducer is electrically polarized in the thickness direction, several vibration modes can be excited by applying an ac voltage between the top and bottom electrode. A sample of the PZT disc transducer used in our experiment is shown in figure 4. The thickness and diameter of the ceramic are 10 mils (0.254 mm) and 1/4 in. (6.3 mm), respectively. Generally, two vibration modes can be excited in this thickness polarized disc: thickness mode and radial mode. The mode frequencies are controlled by the design parameters of the thickness and diameter together with the material properties. Radial resonance was used in this ultrasonic guided wave experiment.

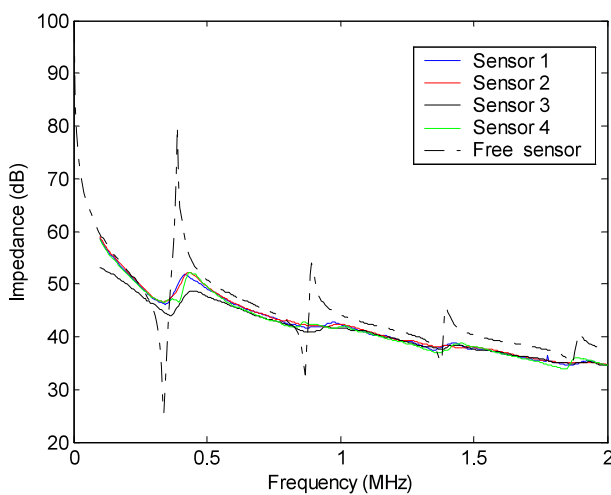
Figure 5. The impedance spectra of a free PZT disc and sample PZT discs when mounted on the wing panel.

To attach a PZT sensor to the wing structures, the surface of the wing section is cleaned first with alcohol, and a copper tape is attached to the cleaned surface. Then a PZT disc is glued on top of the copper tape with conductive epoxy. Finally, a lead wire is soldered or glued with conductive epoxy to the top surface of the sensor to serve as the signal wire and the copper tape is used as the electrical ground. To insulate the sensor and protect it from shock or vibration, the sensor assembly could be covered with epoxy, with only the signal and ground wires leading out. The electric mechanical impedances of the sensors were measured with an impedance analyser (HP 4192) to check their performance. The decibel scale impedance was obtained from the reading of an impedance analyser's Z_{Ω} with $Z_{dB} = 20 \log_{10}(|Z_{\Omega}|)$. In figure 5, the dashed curve shows the free vibration disc in air; and the solid curves show the PZT impedance after being bonded to the wing panel. The resonance frequency around 350 kHz shown in the free vibration curve corresponds to the resonance in the radial direction of the disc. The higher-order resonances are the corresponding harmonics. When the sensor is attached to the wing skin, the resonance phenomenon is not as significant as the free vibration condition. However, operation around

350 kHz still has good wave excitation efficiency. Furthermore, the sensor implementation uniformity and potential differences in the mechanical properties of the wing panel cause slight differences in the impedance spectra of these attached sensors.

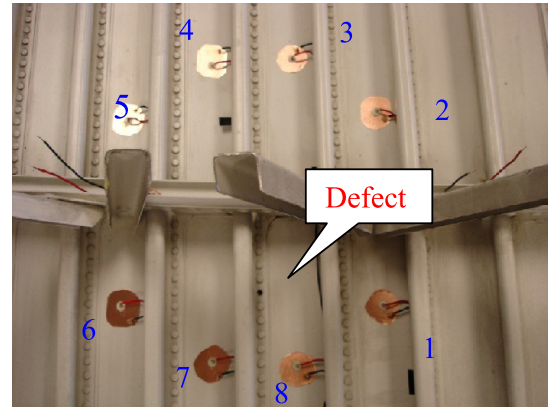
Figure 6. PZT sensor/actuator array attached at the inner surface of the wing panel for defect monitoring.

For demonstration purposes, a circular array configuration of the PZT transducer network was implemented on the wing panel for defect monitoring. Such a configuration should be useful for monitoring a well-defined region or a structural 'hot spot' where defects are most likely to occur. In our study, eight piezo-ceramic discs were attached to the aircraft wing surface in a circle about 10 inches in diameter. The discs are nearly equally spaced. Figure 6 shows the example array, with arabic numbers 1, 2, ..., 8 marked nearby to identify each PZT. A MATEC TB-1000 tone burst pulser/receiver card was used to generate and receive the ultrasonic signals. A 100 V peak-to-peak 350 kHz windowed sinusoidal signal (three to four cycles) was used to drive the PZT actuator. The PZT discs take turns generating ultrasonic signals while the rest of them are listening. For example, when disc 1 is sending a signal, sensors 2–8 are in the reception mode; then disc 2 is transmitting signals and sensors 1, 3–8 are listening, and so on. The waveforms of each actuator-sensor pairs are collected. Figure 7 shows an example waveform collected from actuator-sensor pairs 1 and 8 with and without a crack. Note that at 350 kHz, S_0 and A_0 mode Lamb waves could exist in the wing panel; besides, the scattering of the guided waves from the rivet rows also complicated the waveform, therefore it is difficult, if not impossible, to identify the wave modes from the raw signal. A physics-based statistical data processing algorithm is thus developed for real-time processing of the data so that the defect presence, growth, and location can be monitored effectively. Of course, for applying the PZT actuator/sensor network to a general structure, the single circular array configuration could be expanded to a network of arrays in hexagons, for example, so that a large structural area could be monitored.

In this experiment, the wing panel shown in figure 6 was used as a specimen to monitor cracks that were initiated from the

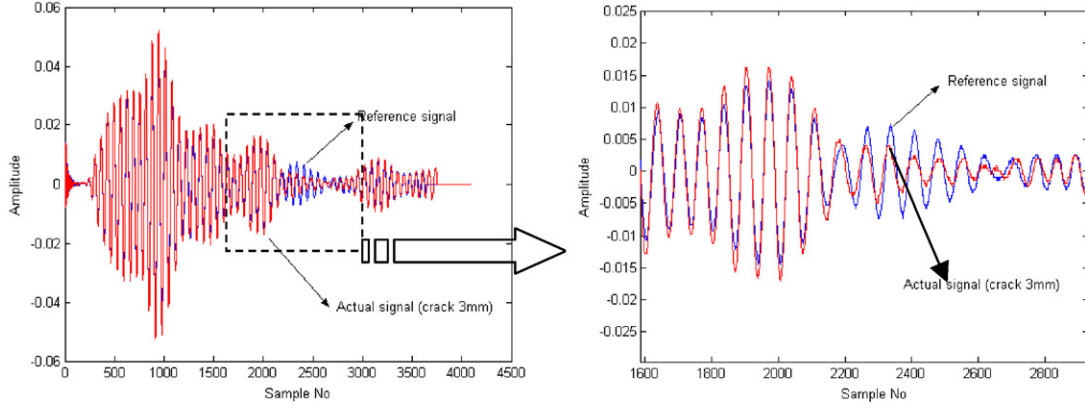
Figure 7. Sample waveforms of the sensor pair (1, 8). One curve is for reference (normal condition) and the other is from the rivet hole with a 3 mm crack. The figure on the right is the zoom-in of the dashed window.

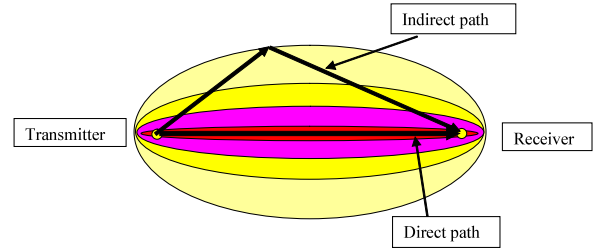
Figure 8. Illustration of the elliptical distribution function of the RAPID algorithm.

spatial distribution function of S_{ij} , with its contour in the shape of a set of ellipses. Figure 8 shows the geometric interpretation of this distribution function. In the formula,

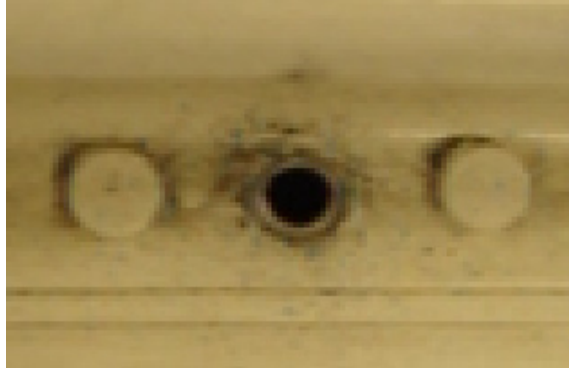
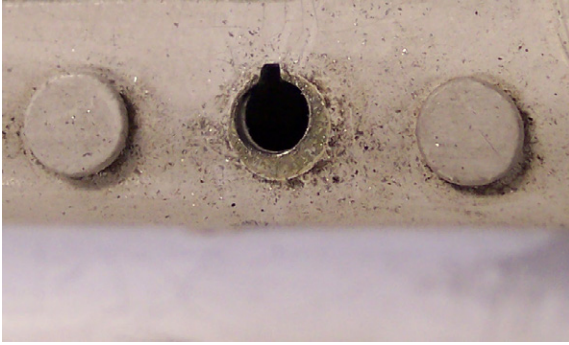
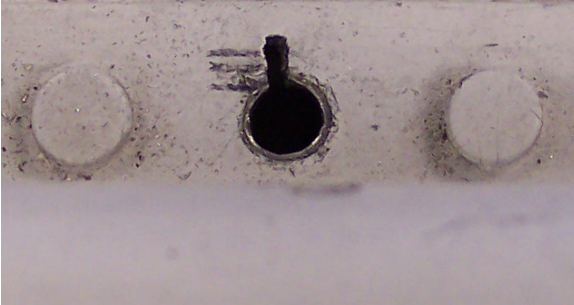
Figure 9. Photos of an artificial saw-cut defect introduced in a rivet hole: (a) rivet drilled off; (b) 1 mm crack; (c) 3 mm crack.

rivet holes. Four conditions were studied, i.e. (a) the normal, defect-free condition; (b) a rivet was driven out of the wing panel and then put back in to simulate a loose rivet; (c) a 1 mm notch was machined in the loose-rivet hole to simulate a small crack; and (d) the rivet crack was increased to 3 mm. Figure 9 shows the three defect pictures. As mentioned in section 3, a MATEC tone-burst pulser/receiver card was used to generate and collect pair-wise PZT sensor signals. The baseline ultrasonic guided wave data for the normal condition were collected first, and the data for each defect condition were collected afterwards.

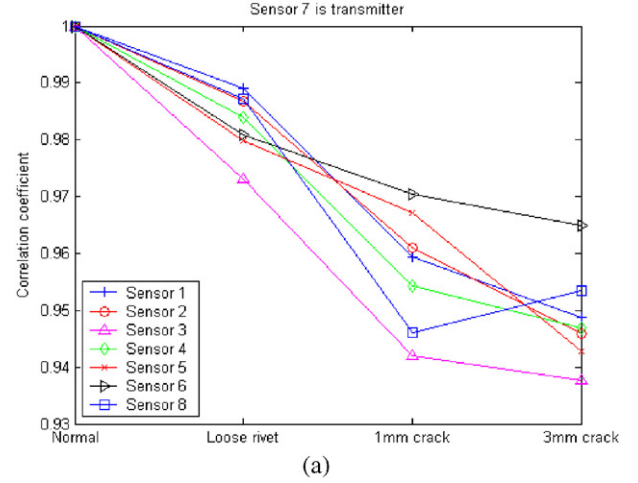
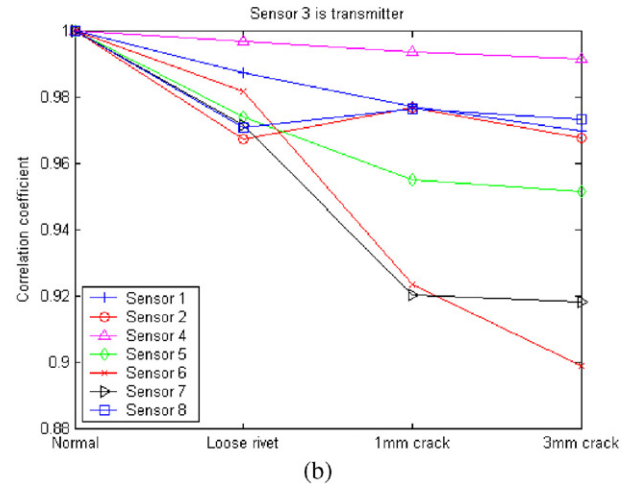
Figure 10. Correlation coefficients of the collected signals with reference signals for defect detection and growth monitoring: (a) sensor 7 is the transmitter, and all the others are receivers; (b) sensor 3 is the transmitter, and all the others are receivers.

The correlation analysis and RAPID algorithm described in section 4 was used to detect the defect, track its growth, and localize its position. The correlation coefficients of different stages of the defects, namely a normal, loose-rivet, 1 mm-crack, and 3 mm-crack are calculated for different pairs of sensors. Figure 10(a) shows the sample correlation coefficient plots versus failure stages when sensor 7 was used as the transmitter while the others were receivers. The correlation coefficient values for all the receivers are plotted using different symbols. Since the defect location is very close to sensor 7, all the receivers picked up the defect signature.

The correlation coefficients decreased in value with an increase in the defect severity level. So the defect growth could be monitored with careful calibration. Of course, not all of the sensor pairs showed the same amount of decrease in correlation coefficient value with respect to the crack growth. In this case, sensor 3 shows the largest decrease in the correlation coefficient, since the defect is in the direct path of sensors 7 and 3. Similarly, Figure 10(b) shows the correlation coefficients' change plots with respect to defect growth when sensor 3 was used as the transmitter. We can see that sensors 6 and 7 have the largest decrease in correlation coefficient value while sensor 4 shows almost no change. This also indicates that correlation analysis cannot only monitor the defect growth but also be used to estimate the defect location.

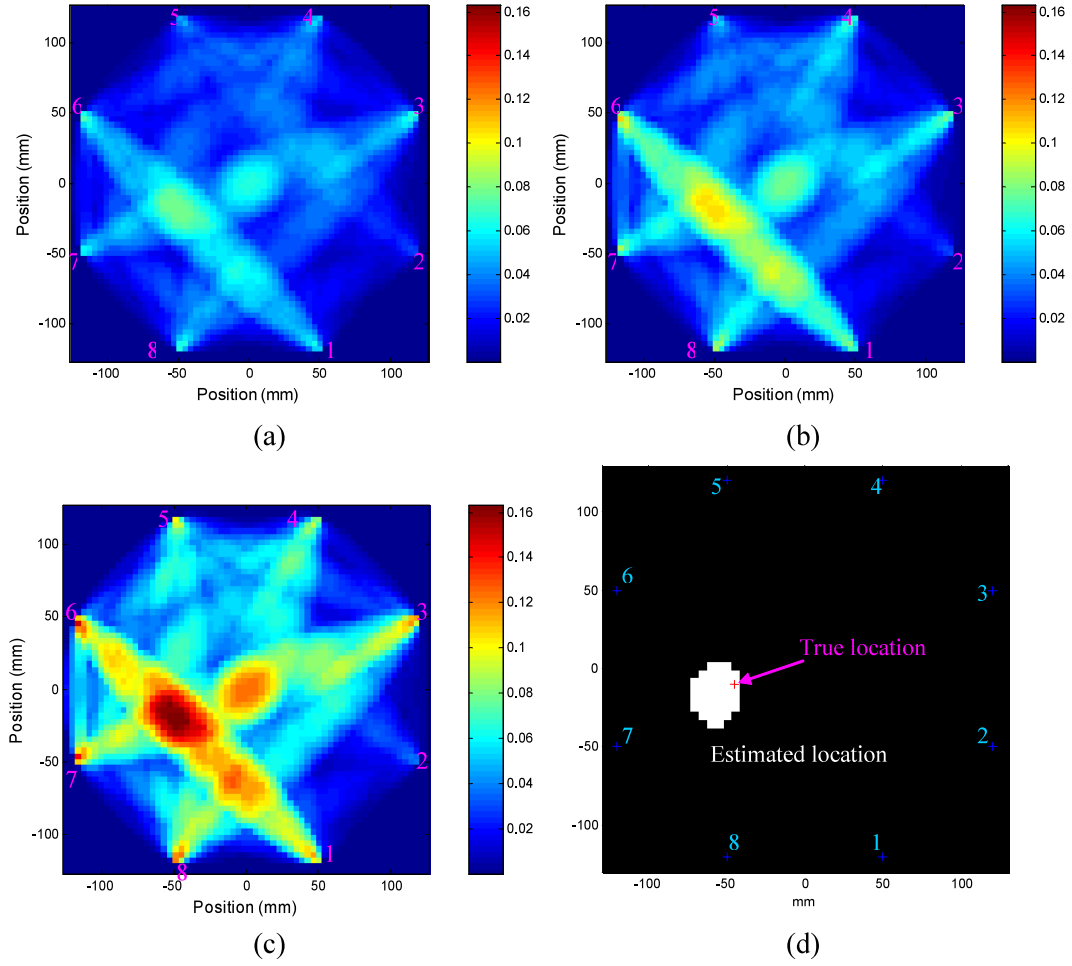
Figure 11. Defect location estimation with RAPID. The defect distribution probability map shows the location of the defect and its progression: (a) loose rivet; (b) 1 mm crack in the rivet hole; (c) 3 mm crack in the rivet hole; (d) the estimated defect location by setting a threshold to the probability density map.

The RAPID algorithm developed in section 4 was then used to determine the defect location. The probabilistic distribution maps for each stage of the defect, i.e. loose-rivet, 1 mm rivet crack, and 3 mm rivet crack, were reconstructed on the basis of equations (4)–(6) and plotted in MATLAB®, as shown in figures 11(a)–(c). In each image, the higher the probability density value is, the higher the chance that the defect is located there. We could also see that the overall

probability value increases with an increase in the defect severity level, as indicated from the image colour progression in figures 11(a)–(c). With a proper threshold value set to the defect probability density map regarding the defect, the estimated defect location, which is shown in figure 11(d), is found to agree quite well with the actual defect location. It can be seen that the RAPID algorithm works effectively with the PZT actuator/sensor network for small defect detection and localization. It also showed better sensitivity compared with conventional filtered back-projection computer tomography in another study [23].

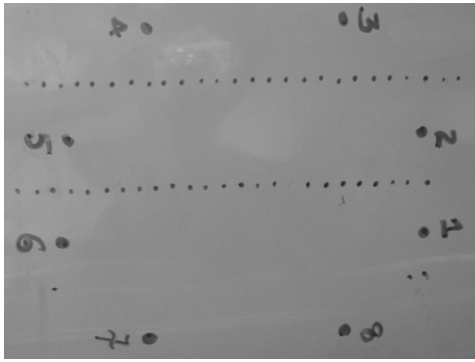
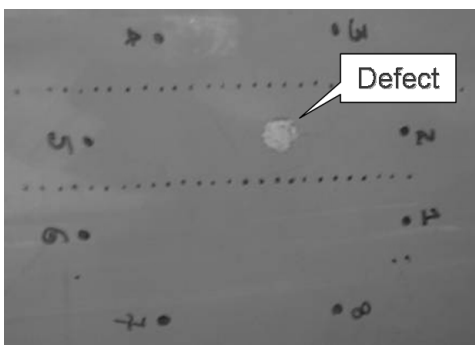
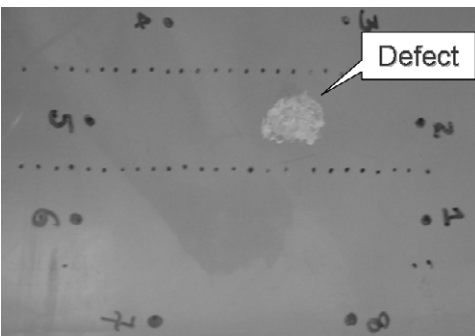
Figure 12. Simulated corrosion defects: (a) reference state; (b) small corrosion; (c) large corrosion.

As another case study, simulated corrosion defects were introduced by grinding the paint and some metal off at the outer wing skin. Three stages of corrosion on the wing were studied: the reference normal state, a small simulated corrosion area, and a large corrosion area. Pictures taken from the top surface of the wing of these three states are shown in figure 12. The corresponding sensor positions at the inner surface are also marked on the outer surface of the wing skin. The signal difference coefficients (SDC) of these corrosion states are shown in figure 13, where the x and y axes denote the transmitter and receiver PZTs and the z axis is the SDC of the combination transmitter–receiver pair. The progression of structural damage is indicated with a general increase of the SDC feature. In addition, the geometric distribution of the damage is also indicated with the difference in SDCs for different sensor pairs. With the RAPID algorithm, the corruptions were mapped as the dark red area, as shown in figure 14. A circle is marked on the map as the true size and location. An accurate estimation of the corrosion location can be seen when compared with the true location. The size of the corrosion could also be estimated, though not exactly, with proper calibration.

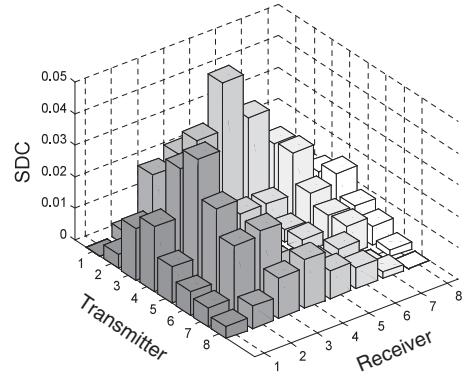
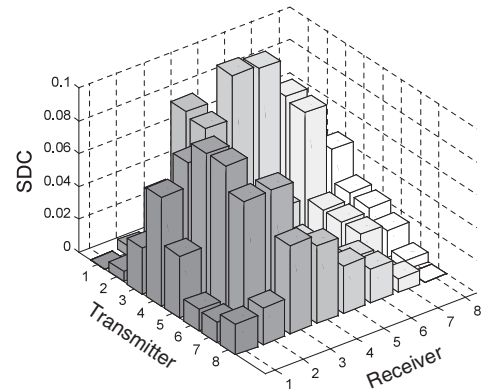
Figure 13. Signal difference coefficients for small and large simulated corrosion on the wing panel.

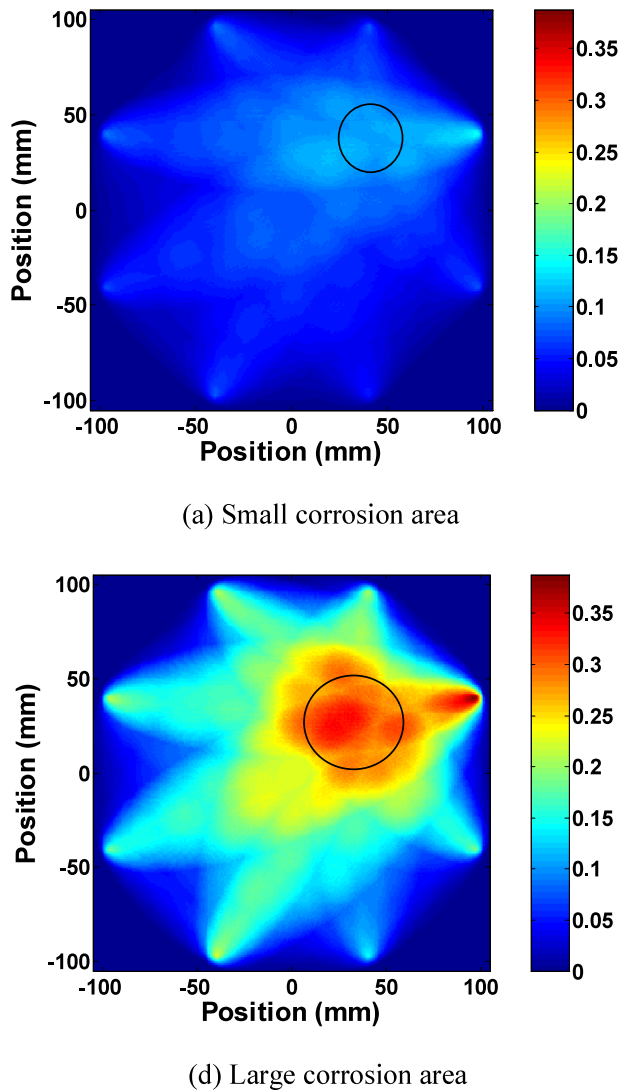
Figure 14. Reconstruction image of the corrosion damage distribution.
