MTE544 Lab 1

Group 29

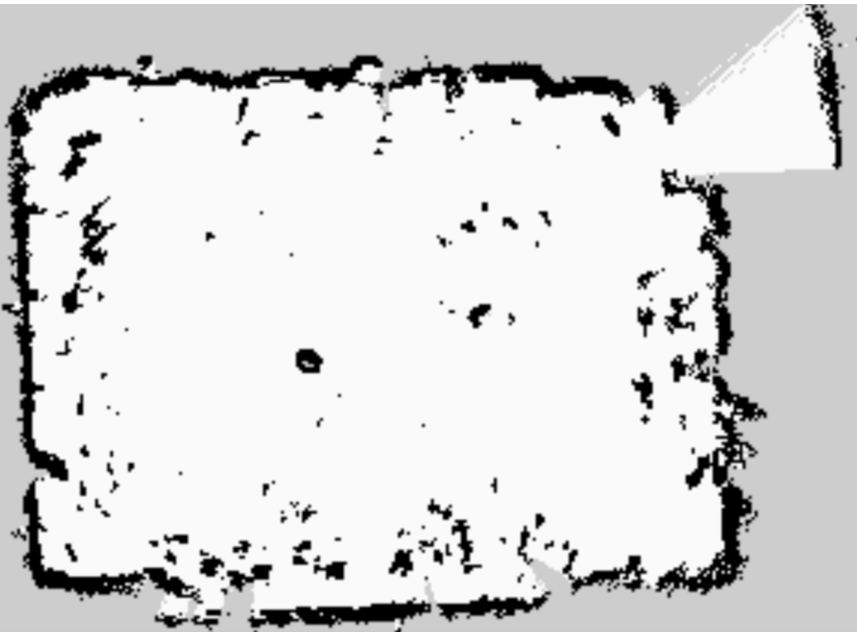
Figure 1: Map of the room

The map acquired during Part 8 of Lab 1 can be seen in Figure 1. Based on analysis of the map the solid black barrier surrounding the map is the wall, whereas the smaller isolated black parts are obstacles that the LiDAR detected. Also it appears the door was open while the robot was mapping the top right corner of the room.

The laser scan at the start of each trajectory (t_0) can be seen in **Figure 2**. Based on the angle increment, each LiDAR measurement contained 360 different values. Not all values were plotted due to the measurements being out of range. From the plot, it is evident that the laser scan at a single timestamp does not capture the level of detail of the room compared to the map acquired via the SLAM package for a longer period of time (**Figure 1**).

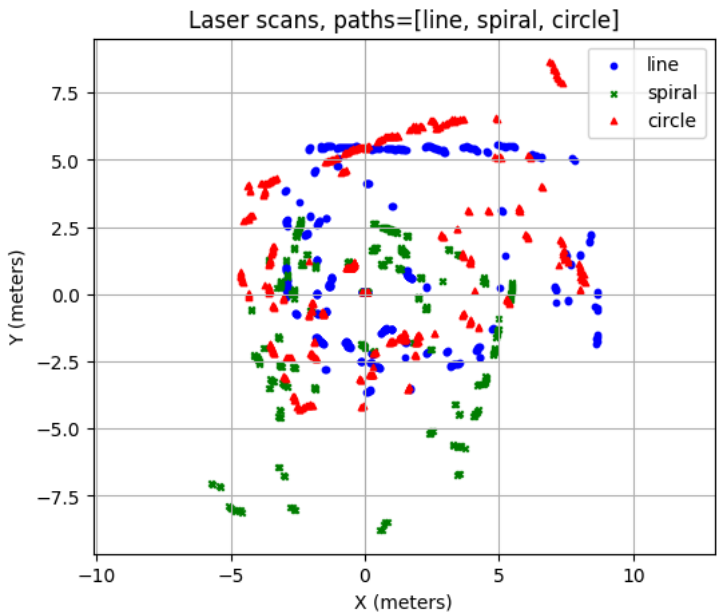
Figure 2: LiDAR data (t_0 , cleaned) for various paths (line, spiral, circle)

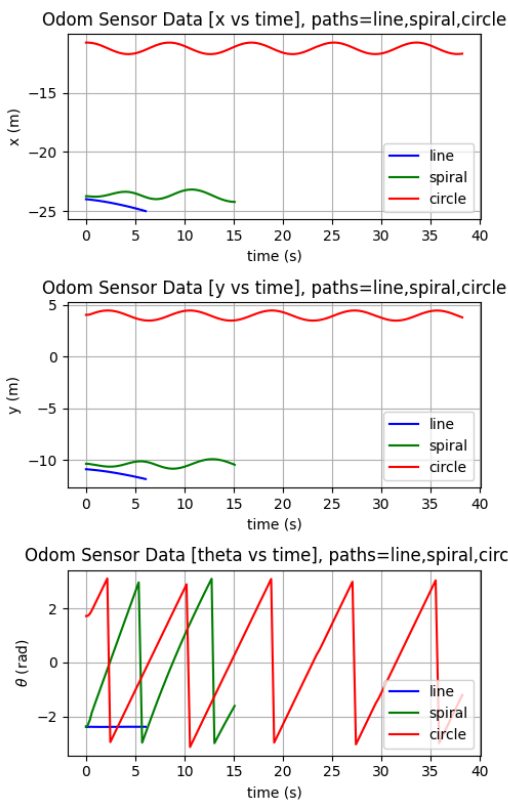
Figure 3: Odometry Data with Respect to Time

Based on the trajectory plot (**Figure 4**), we can see that the robot's path is in the shape of a circle. This is confirmed in **Figure 3** as the x & y positions are following sinusoidal paths with respect to time. Furthermore in **Figure 5**, the circle has a relatively constant angular velocity after the initial spike, which implies a circular shape.

Based on the trajectory plot (**Figure 4**), we can see that the robot's path is in the shape of a spiral. This is also confirmed in **Figure 3** as the x & y positions follow a sinusoidal shape with an increasing amplitude over time. Angular velocity is also non-zero during the path which implies a circular shape. The angular velocity is decreasing over time after the initial spike, as shown in **Figure 5**, and is also somewhat evident from the decreasing slope of the angular position vs time plot in **Figure 3**. This implies that the radius of the circle is increasing faster than the linear velocity, this relationship can be seen in equation (1).

Based on the trajectory plot in (**Figure 4**), we can see that the robot's path is in the shape of a line. We can see the line is increasing over time because in **Figure 3** the x & y positions are increasing in a non-linear manner with respect to time, implying that the robot is accelerating. It is also known that the line is straight because the angular velocity in **Figure 5** is constant at zero.

Looking at the amount of noise in the odometry data (**Figure 3**) versus the IMU data (**Figure 5**), it is evident that the IMU data has much more high frequency noise than the odometry data (especially the linear acceleration values). Additionally, the sawtooth shape of the angular position (yaw angle) vs time from the odometry data suggests that there is an implicit range of the function used to calculate the yaw angle, which appears to be from $[-2\pi, 2\pi]$.

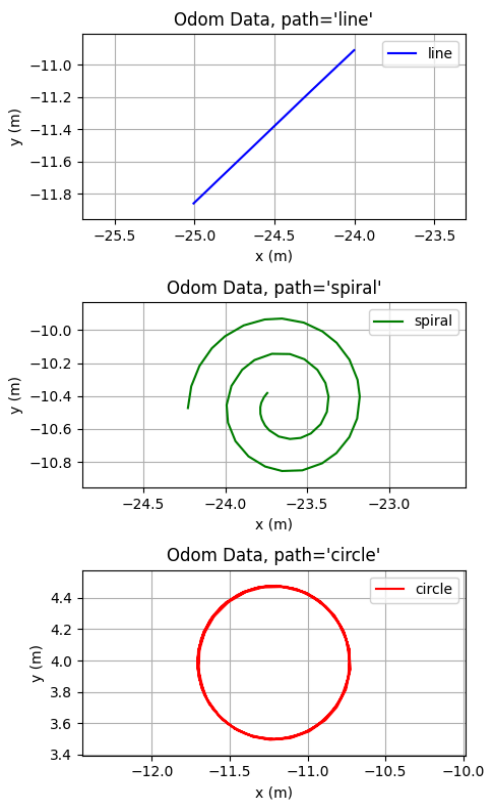
Figure 4: Path Plotting with Odometry Data

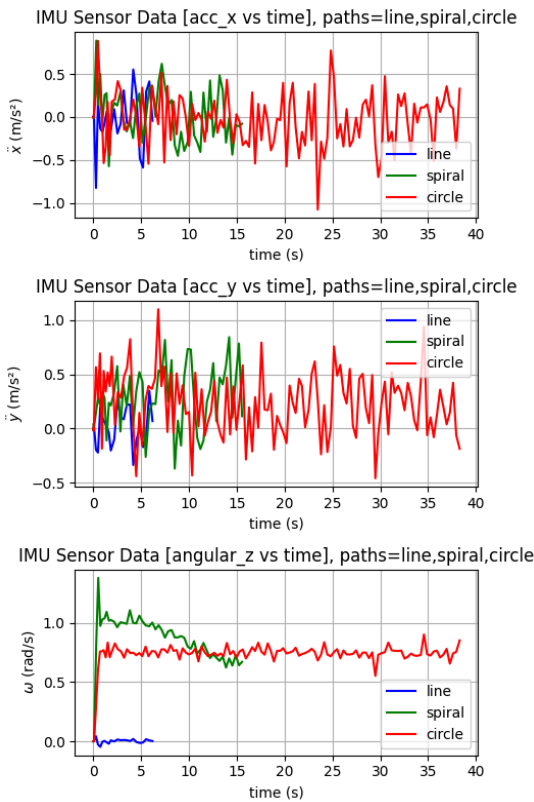
Figure 5: IMU Data
