# Diagnosis and management of teeth with vertical root fractures

Alex J. Moule\*

Bill Kahler†

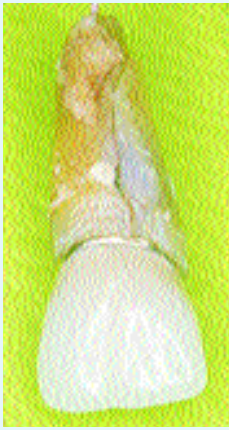
**Fig. 1.** - Upper central incisor showing complete crown-down vertical root fracture.

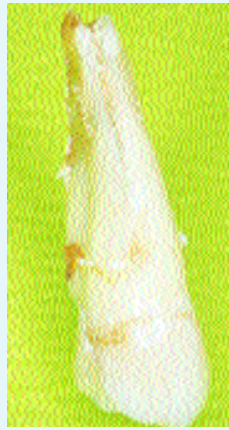
**Fig. 2.** - Maxillary second premolar shows an incomplete bucco-lingual vertical root fracture which has been initiated in the apex. Note the V-shaped resorptive defect which has occurred apically.

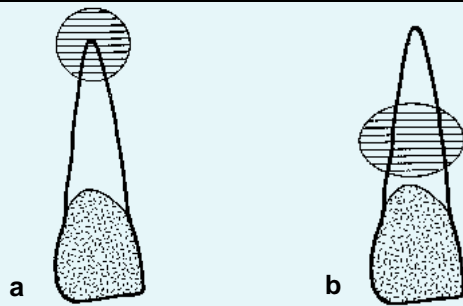
**Fig. 3.** - Diagrammatic representation of the position of soft tissue swelling (a) in a tooth with a periapical abscess, and (b) in a tooth with a vertical root fracture.

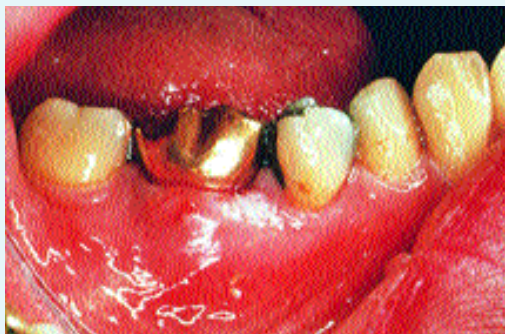
**Fig. 4.** - A broad-based swelling over the mesio-buccal root of this mandibular first molar is typical of that associated with a vertical root fracture.

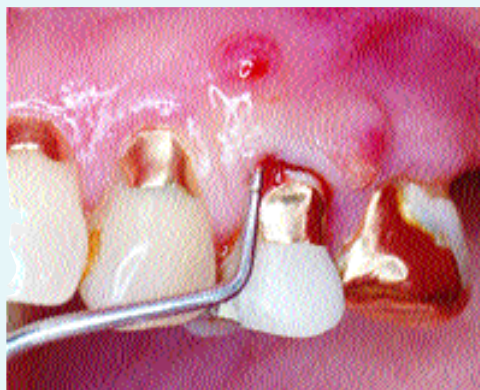
**Fig. 5.** - Double or multiple sinus tracts are a feature of vertically fractured teeth.

Some swelling of soft tissues is usually present. The swelling is usually broad-based, and mid-root in position. Palpation will often show swelling and tenderness over the root itself, but little swelling in the periapical region (Fig. 3, 4). When a sinus tract is present, it may be situated in or close to attached gingiva rather than in the apical region. Double or multiple sinus tracts are common.<sup>1</sup> Where multiple sinus tracts are present one or more of these tracts may be located some distance from the involved tooth. The insertion of a gutta percha point into each sinus tract can assist with diagnosis. An example of a vertically root fractured tooth exhibiting multiple sinus tracts is shown in Fig. 5.

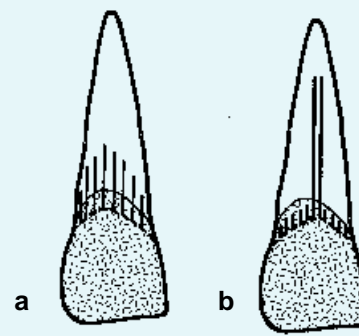
**Fig. 6.** - Diagrammatic representation of a probing pattern seen in (a) periodontal disease and (b) vertical root fracture. A deep narrow pocket in one position around the circumference of the tooth and the presence of otherwise normal attachment is a feature of vertically fractured teeth. When similar pocketing occurs in two points around the circumference of the tooth, a vertical root fracture is inevitably present.

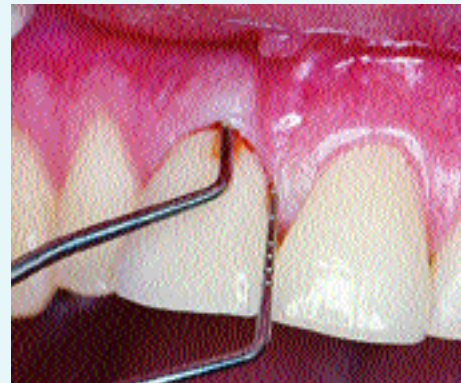
**Fig. 7.** - Maxillary central incisor tooth exhibiting a deep narrow pocket on the labial surface of the tooth with normal attachment in the interproximal area. The presence of a bucco-lingual vertical root fracture was confirmed by surgery.

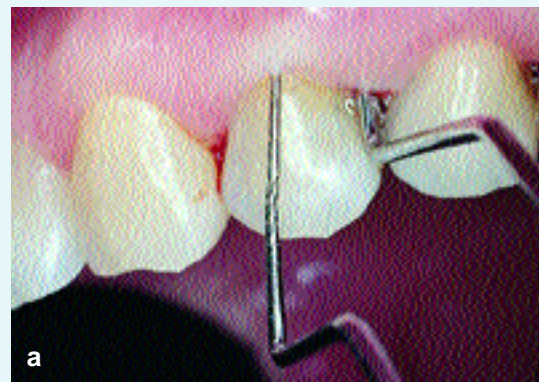
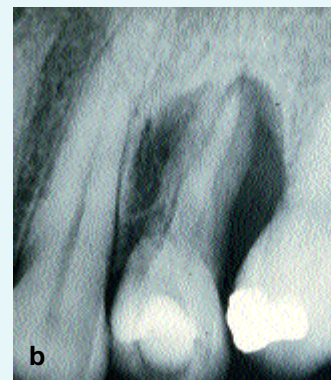
**Fig. 8.** - (a) Maxillary right first premolar with a mesio-distal fracture. Deep probing is evident mesially and distally but attachment is normal on the buccal and lingual aspect. (b) Radiograph of same tooth. Note the extensive bone loss mesially and distally but little evidence of bone loss apically.

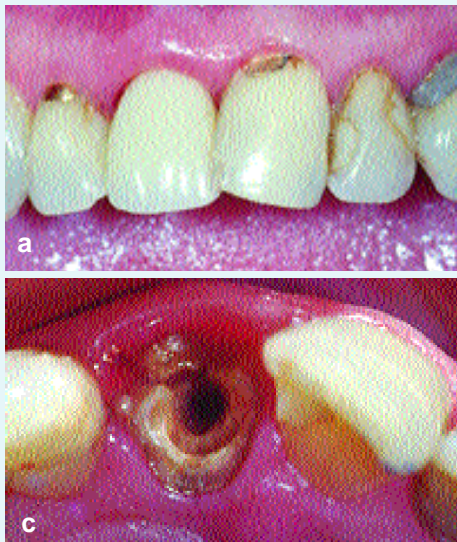
**Fig. 9.** – (a) Clinical presentation of a patient with discomfort associated with the maxillary right central incisor which was crowned. The patient has experienced a low grade discomfort, and an itchy feeling associated with this tooth for some months. (b) Periapical radiograph shows the tooth to be restored with a post retained crown. No evidence of root filling is present although the lamina dura at the apex appears intact. There is slight widening of the periodontal ligament space in the mid-root region. (c) Clinical photograph six months after Fig. 9a. The post crown is dislodged and a root fracture is evident on the labial surface. (d) Dislodged crown from Fig. 9a. Dislodgement of an apparently well-fitting post or post crown is a sign that the root may be fractured.

A common presenting feature is the dislodgement of a post or post crown. A root fracture should be suspected if an apparently well-fitting post or post core becomes dislodged. A typical case is illustrated in Fig. 9. The presence of a vertical root fracture should be strongly suspected in teeth where there has been a history of repeated dislodgement of a post or post crown. Because of problems with diagnosis, it is not uncommon for teeth with vertical root fractures to have been treated repeatedly by surgery before the presence of a fracture is suspected. When surgery fails for no obvious reasons, a vertical fracture should be considered a possibility before the periapical area is re-entered surgically.

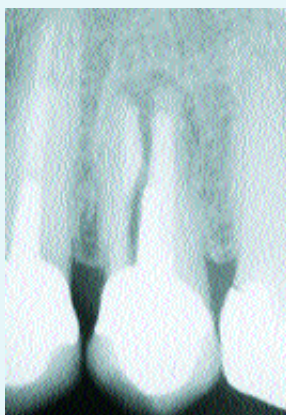
**Fig. 10.** – Separation of the fragments is clearly visible in this vertically fractured maxillary left first premolar.

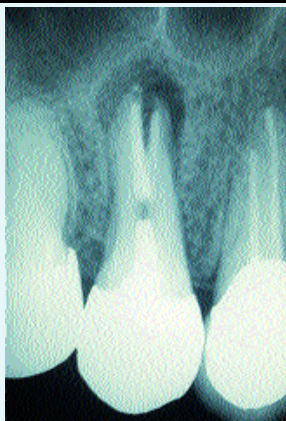
**Fig. 11.** – Vertically fractured mandibular lateral incisor showing wide separation of the fragments. The distal fragment is completely separate from the tooth and has moved distally to be in contact with the canine. Granulation tissue separates the gutta percha fill from both fragments.

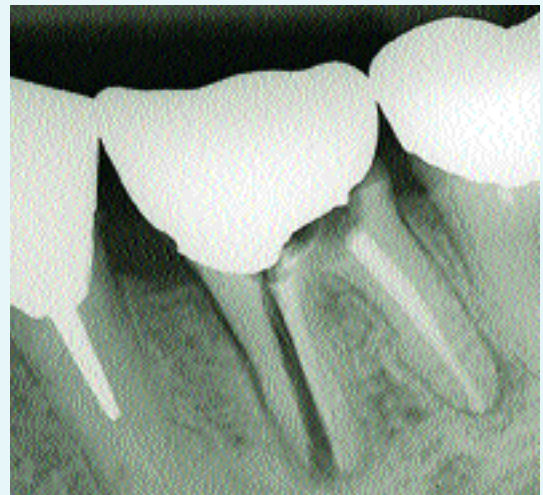
**Fig. 13.** – Separation of the fragments in the mesial root of this mandibular right molar can be clearly seen. The mesial fragment has remained attached to the large restoration.

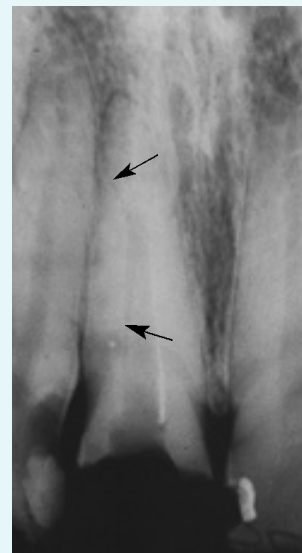
**Fig. 14.** – A fracture line (arrows) can be seen running parallel to the root canal and then exiting distally in the apical third in this maxillary left central incisor tooth.

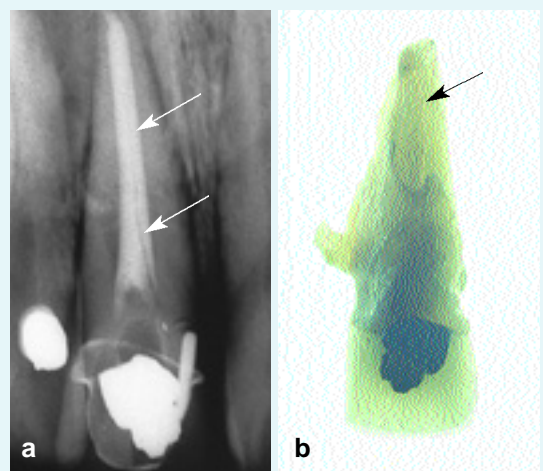
**Fig. 15.** – (a) A vertical fracture (arrows) radiographically superimposed over the root filling is present in this maxillary left central incisor tooth. (b) Clinical photograph of a tooth from Fig. 15a showing the fracture (arrow). Note the amount of fibrous tissue which is attached to this tooth once it has been extracted. This is a feature of teeth that are vertically root fractured.

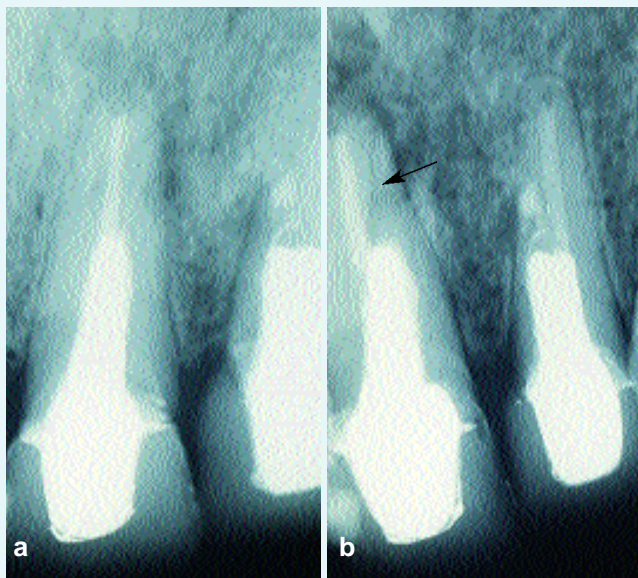
**Fig. 16.** – Two periapical radiographs taken at the same consultation showing the effects of angulation changes on the visibility of the root fracture on the right maxillary central incisor tooth. (a) The fracture is difficult to see. (b) The fracture is easy to see (arrow) where the X ray beam passes down in the plane of the fracture.

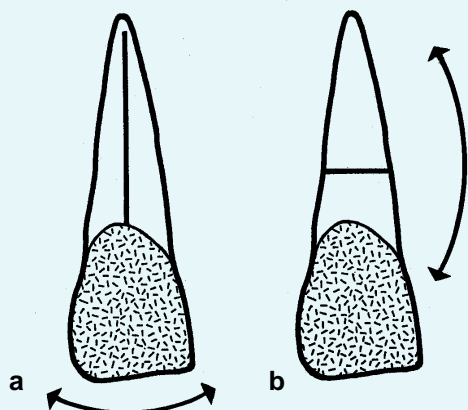
**Fig. 17.** – Diagrammatic representation of the changes in horizontal angulation of the X-ray beam that are necessary to detect a vertical root fracture (a). For better visualization of a transverse root fracture, the angulation is changed vertically rather than horizontally (b).

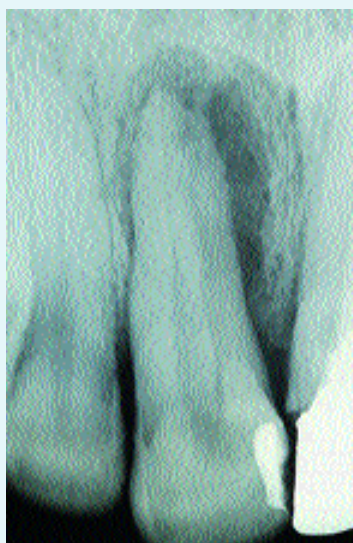
**Fig. 18.** – Periapical radiograph of maxillary right central incisor with a deep palatal groove, the radiographic picture of which mimics a vertical root fracture.

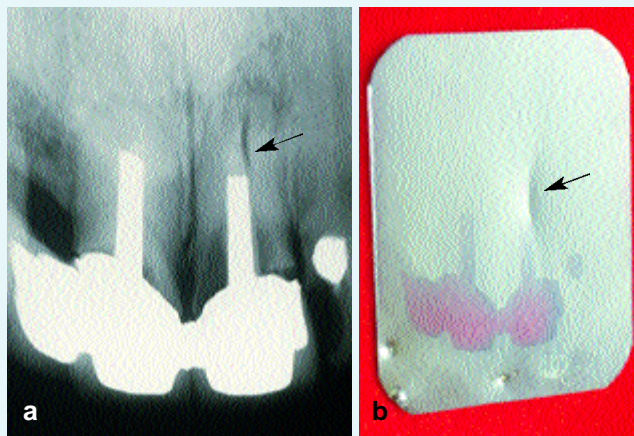
**Fig. 19.** – (a) Periapical radiograph of a failed anterior bridge. A dark line extending from the bottom of the post in the maxillary right central incisor to the apex (arrow) gives the appearance of a vertical root fracture being present. (b) Clinical photograph of the radiograph showing a mark (arrow) responsible for the radiographic image. In interpreting radiographic lines on radiographs consideration must be given for the presence of artefacts and scratches.

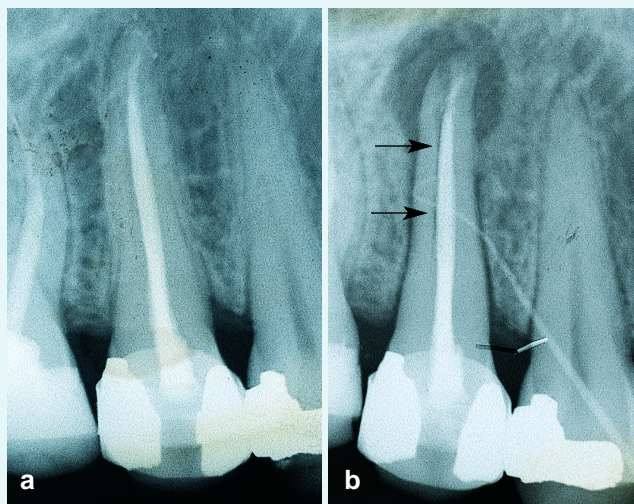
**Fig. 20.** – Periapical radiographs of a root filled premolar tooth. (a) At one year recall, there is no evidence of any radiographic changes which are suggestive of a problem. (b) Two years later there is widening of the periodontal ligament space and the appearance of a large periapical lesion. The fracture is seen as a space (arrows) which has developed on the distal side of the root filling due to slight separation of the fragments.

Minor separation of fragments can result in the radiographic appearance of a vertical space adjacent to the root filling material in an otherwise well-obtimated canal. Vertical root fractures should be suspected if the root filling appears well condensed but is in close contact with only one wall of the root canal.

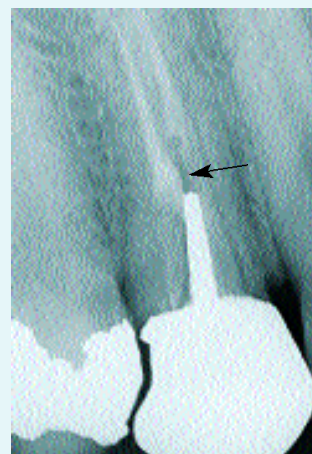
**Fig. 21.** – Maxillary right first premolar restored with a post/crown restoration. A space is present between the post and the root which is covered with a layer of cement. The space can be traced past the post beyond where the fracture line is clearly shown (arrow).

In general, posts are constructed so that they fit the canal. When a post is present in a vertically root fractured tooth, slight separation of the fractured fragments can result in the appearance of a space between the edge of a root canal, which may be coated with cement, and the post itself.

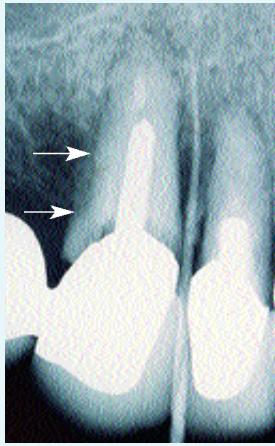
**Fig. 22.** – Wide separation of the fragments has occurred in this vertically fractured maxillary right canine which is fractured mesio-distally. Double images of the distal root surface (arrows) are caused by overlapping of the fragments.

When separation of fragments occurs in a direction other than parallel to the X-ray beam, overlapping of fragments may result in double images of the external root surface. While this effect is sometimes seen in normal teeth, for example, in the mesial concavity of maxillary premolar teeth, step-like double images on the external outline of a

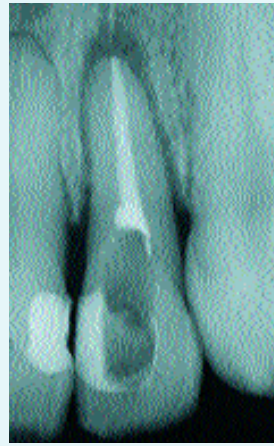
**Fig. 26.** – Periapical radiograph of maxillary left lateral incisor showing widening of the periodontal ligament space around the whole of the root. This is a classic sign that a root fracture is present.

Wide enlargement of the periodontal ligament around the whole length of the root is an indication that the tooth is vertically fractured. The radiographic appearance of bone loss is quite different from that seen in a periapical lesion where apical bone loss can occur but without destruction of the lamina dura along the root surface. When the fracture is in a bucco-lingual direction and involves the apical portion, there is loss of bone on the buccal and lingual surfaces of the tooth. Radiographically, the tooth root can be seen more clearly (or appears more 'in focus') than adjacent teeth. Widening of the periodontal ligament space around the whole length of the root is a classic sign that a vertical root fracture is present.

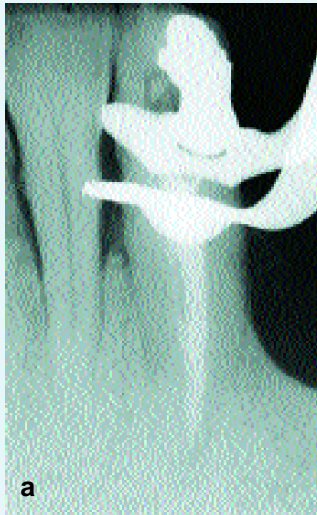
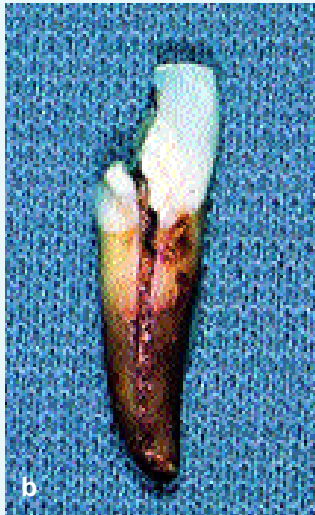
**Fig. 23.** – (a) Periapical radiograph of a recently root filled maxillary right canine showing a well condensed root filling with an irregular outline. (b) Extracted tooth showing vertically fractured root.

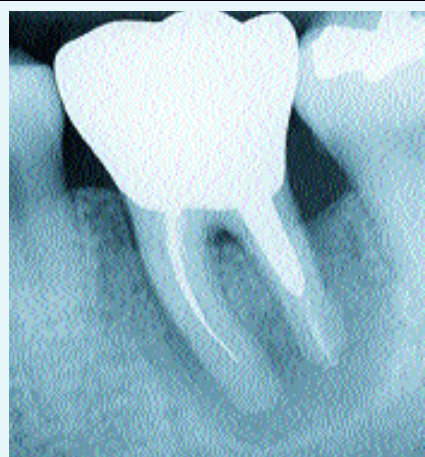
**Fig. 27.** – Periapical radiograph of mandibular left first molar showing a wide diffuse radiolucent 'halo' around both roots. The tooth was fractured mesio-distally. Radiolucent halos of this type are a classic sign that a vertical root fracture is present.

When the plane of fracture is at right angles to the X-ray beam, the pattern of bone loss appears wider and more diffuse than that seen in bucco-lingual fractures. Pitts and Natkin<sup>1</sup> have described this appearance as a 'halo-like' radiolucency running around the whole of the tooth. While the width of the diffuse bone loss may vary, a radiolucent halo which runs around the whole of the root surface is a classic sign of a vertical root fracture.

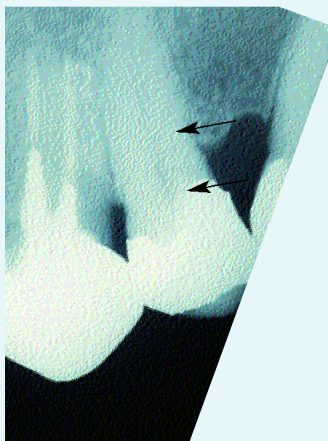
**Fig. 24.** – Periapical radiograph of a root filled maxillary right first molar which suffered a vertical root fracture. A thin film of cement (arrows) is evident in the buccal root extending from the root filling to the root surface.

Where a vertical root fracture is present prior to root filling, or occurs during the root filling procedure, extrusion of cement or root filling material can occur into the fracture site or apically. When the plane of the fracture is predominantly in a bucco-lingual direction, the excess cement material can be seen as a more intensely radiopaque line superimposed over the root filling.<sup>1</sup> In some instances, this can give the appearance of a second canal or an irregularly obturated root canal. Where the plane of the fracture is mesio-distal, the cement excess can sometimes be seen as a thin film extending proximally from the root canal filling to the root surface. Where separation of the fracture occurs during root filling, extension of root filling material through the apex can result in a tangle of accessory points at the apex ('apical spaghetti').

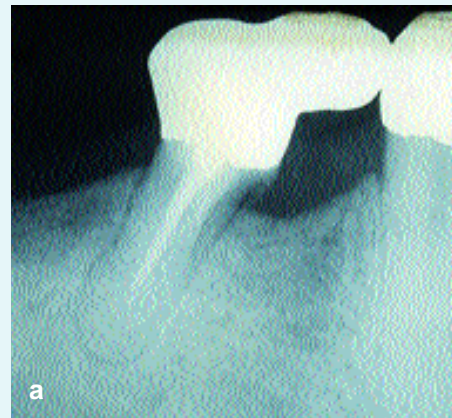
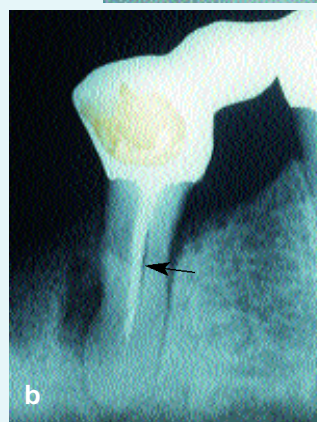
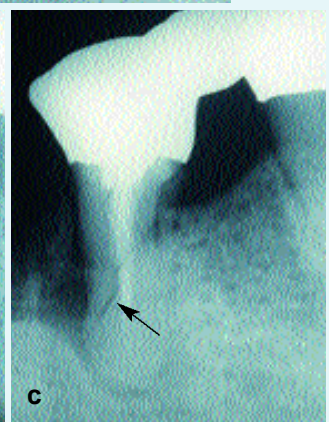
**Fig. 28.** – (a) Periapical radiograph of hemisected lower molar showing good bone adaptation to the distal surface. (b) A step-like bone defect has developed on the distal in association with a vertical fracture in the root. (c) A periapical radiograph taken at a slightly different angle reveals that the step-like bone defect finishes at the level of the fracture.

When the fracture runs obliquely across the root, or where the fracture does not extend into the apical portion, a characteristic step-like bone defect develops.<sup>1,31</sup> The width of the bone loss can vary. However, the depth of the step is governed by the apical extent of the fracture. The appearance of a step-like bone defect on a particular tooth is subject to the angulation of the X-ray beam. Additional radiographic examination with the X-ray beam angled 15 degrees to the mesial or distal may provide a better view of the defect. It must be remembered that step-like bone defects can mimic simple endodontic lesions resulting from other causes, for example, post perforations and vertical grooves. Similar defects can also be associated with non-vital teeth that have not been root filled but such defects will include the apex. Step-like bone defects are only a sign that a fracture may be present. The presence of the fracture needs to be confirmed by other means. Pitts and Natkin<sup>1</sup> have suggested that the possibility of a fracture is increased if the pocket extends to the mid-root level rather than to the apex, as this eliminates apical pathology from consideration.

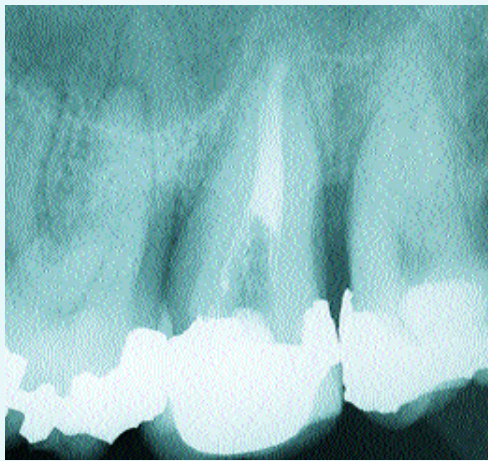
**Fig. 29.** – Isolated horizontal bone loss occurring in association with a single isolated tooth, in an otherwise periodontally stable mouth, is an indication that a vertical root fracture is present.

It is unusual for one tooth in a dentition to be severely involved with periodontal disease without involvement of other teeth. When only an isolated tooth shows bilateral horizontal bone loss the presence of a mesio-distal root fracture should be expected, particularly in the presence of apparently successful endodontic therapy, and where the overall periodontal situation is stable. Occasionally, the same radiographic appearance can be seen where there is a foreign body wedged in the periodontium.

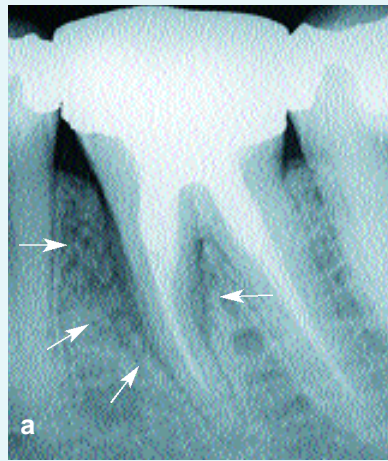
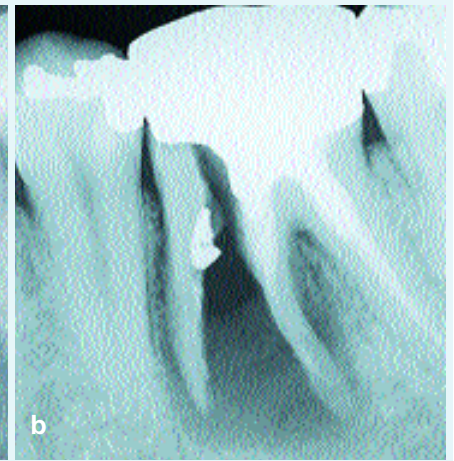
**Fig. 32.** – (a) Mandibular right first molar which has been root filled and restored with a large amalgam restoration. Note the diffuse V-shaped bone loss (arrows) around the mesial root which is a classic sign that a root fracture is present. (b) Periapical radiograph taken four months later clearly shows a major fracture with wide separation of fragments.

Where the buccal roots of maxillary molars or the roots of lower molars are vertically fractured, the characteristic radiographic image of bone loss is a diffuse V-shaped radiolucency, widest at the crestal bone, narrowing towards the apex.<sup>1</sup> The shape and diffuse radiographic evidence of the bone loss is due to the fact that much of the bone lost is lingual to the buccal plate of bone, which to some extent masks its presence. Diffuse bone loss of this type, when confined to a single root or a single tooth in the mouth, is almost pathognomonic of a vertical root fracture.

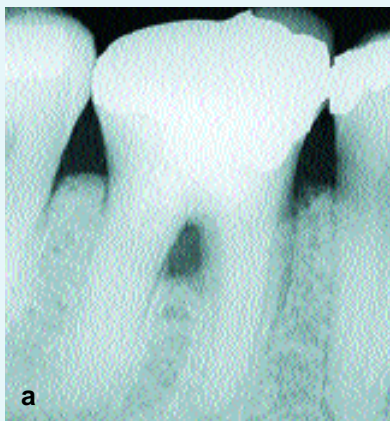
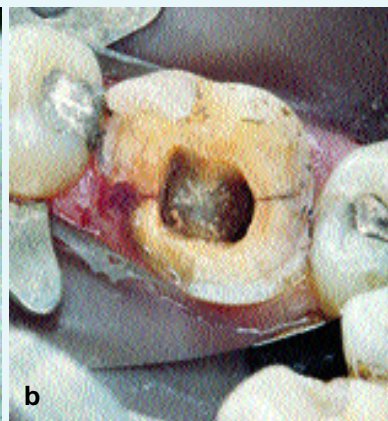
**Fig. 30.** – (a) Periapical radiograph of mandibular right first molar tooth showing unexplained bone loss in the bifurcation region. The lamina dura is intact apically and there is normal attachment buccally and lingually. (b) Clinical photograph of the tooth showing the mesio-distal fracture running across the pulp chamber. A vertical fracture should be suspected if there is unexplained bone loss in the bifurcation region of the molar teeth.

Bone loss in the bifurcation region of molars can occur in patients without overt periodontal disease in situations where there is ingress of bacteria through defects in the bifurcation, for example, perforations and other defects in the pulpal floor. Bifurcation bone loss is also seen in lower molars with non-vital pulps but this is usually in association with periapical bone loss. Where bifurcation bone

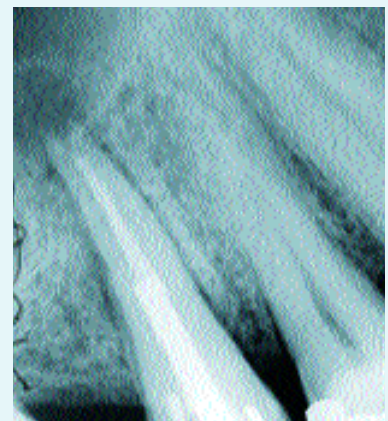
**Fig. 33.** – Vertically fractured second premolar tooth showing a V-shaped resorptive defect at the apex. The periodontal ligament space is widened around the whole root.

One of the presenting signs of a vertical root fracture is resorption along the fracture line.<sup>1,15</sup> This resorption may occur apically where it causes a V-shaped notch in the apical region, or longitudinally along the whole length of the fracture, giving the appearance of an irregular long resorptive defect running along the gutta percha root filling. Disintegration of root canal sealer, silver points and gutta percha in association with extensive resorption of the root has been reported as being a feature of vertically root fractured teeth.<sup>15</sup>

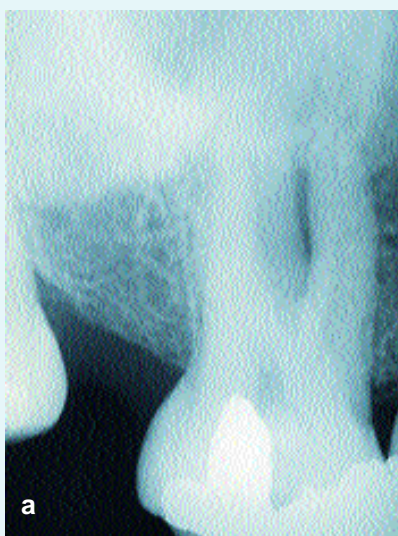
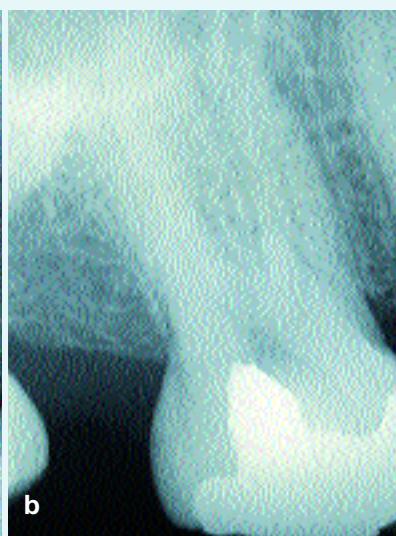
**Fig. 31.** – (a) Periapical radiograph of vertically fractured maxillary left first molar shows bone loss in the bifurcation region of this molar. (b) In a straight on view of the same tooth, the lesion in the bifurcation is masked by the palatal root. There is widening of the periodontal ligament space around the mesio-buccal root. The lamina dura appears to be intact around the tooth. This tooth was fractured mesio-distally.

loss occurs for no apparent reason, and without any obvious sign of apical pathosis, the presence of a vertical fracture through the bifurcation needs to be considered. In mandibular teeth, bifurcation bone loss is usually fairly easy to see. In maxillary molar teeth, however, it is usually masked by the position of the palatal root. An oblique angle on the radiograph is necessary to bring the bone loss into view.

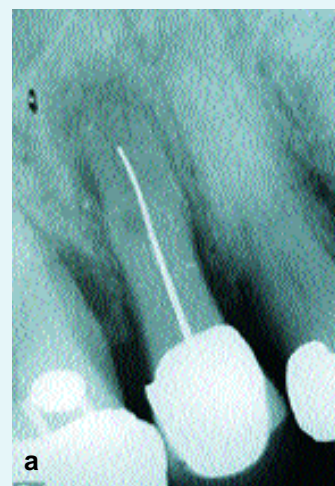
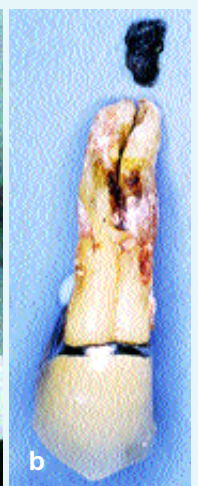
**Fig. 34.** – Dislodgement of a retrofilling material is a sign that a root fracture may be present. This premolar was treated surgically and a retrofilling material was placed at the apex. (a) A periapical radiograph taken prior to extraction shows the retrofilling material is no longer in place. (b) This patient returned with the amalgam restoration which had been dislodged through the soft tissues. The existence of a vertical root fracture is clearly evident.

Dislodgement of retrograde filling material in association with vertical root fractures has been described previously.<sup>1,32,33</sup> Dislodgement of retrograde root fillings can occur due to inadequate retention.<sup>33</sup> However, for the retrograde root filling to be displaced, some force usually has to be applied to move it away from the root apex. Should a retrograde root filling become dislodged, a likely cause is a vertical root fracture. In some cases the dislodged retrograde root filling material can be expelled through soft tissues.<sup>32</sup>

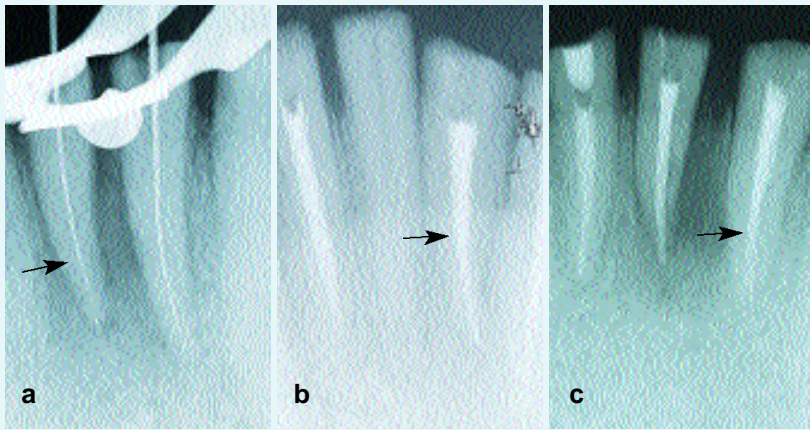
**Fig. 35.** – A vertical fracture should be suspected if there is breakdown of bony architecture which occurs subsequent to the complete resolution of an endodontic lesion. (a) At the time of initial endodontic treatment the mandibular left central incisor (arrows) is associated with a periapical lesion. (b) On review there has been complete healing. (c) Six years later a lesion has developed. This tooth is obviously vertically fractured. Note the resorption along the fracture line.

Endodontic failure can occur many years after the tooth is root filled for a large number of reasons.<sup>34</sup> Coronal leakage<sup>35</sup> is considered to be one major cause of long-term failure of endodontic procedures. However, when the endodontic status of a tooth

deteriorates rapidly after a long time without symptoms, or where radiolucencies reappear after healing has previously taken place, a vertical root fracture should be considered as a cause and further investigations of the tooth should be undertaken with this possibility in mind.

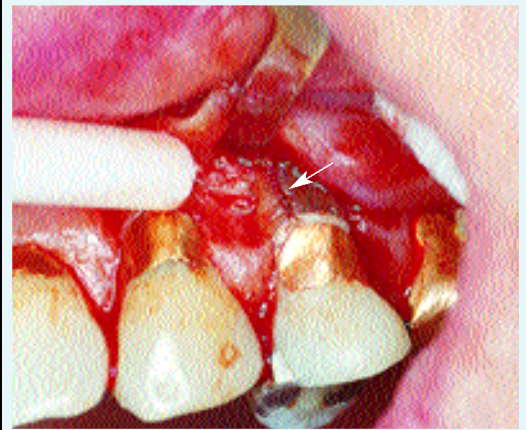
**Fig. 39.** – Where it is important to determine the type and extent of the fracture, a full thickness periodontal flap is recommended. Often a single vertical incision one tooth distal or mesial to the suspect tooth is all that is required to expose sufficient root surface to visualize the fracture (arrow).

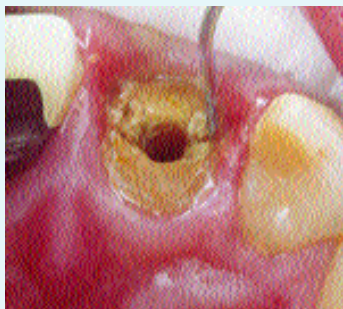
**Fig. 36.** – The presence of a vertical root fracture is clearly visible on the root face. The post crown has been dislodged.

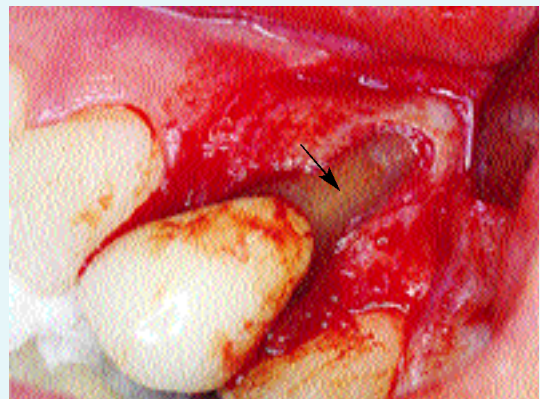
**Fig. 40.** – Loss of bone and deposition of soft tissue adjacent to the tooth root is usually found in the presence of a root fracture. On this occasion, the fracture can be seen as a linear yellowish line in the mid-root region, running vertically from crown to apex (arrow).

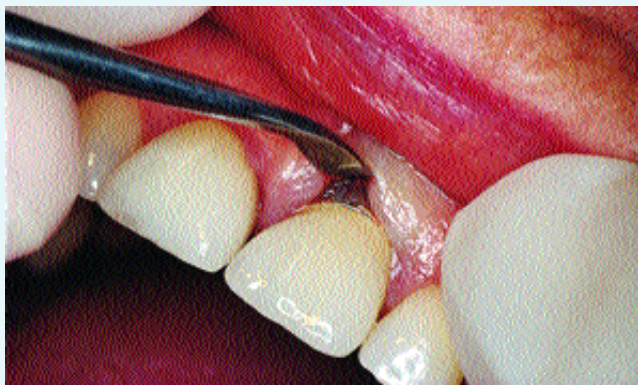
**Fig. 37.** – Gentle reflection of soft tissues under local anaesthesia is often all that is required to confirm the presence of a vertical root fracture.

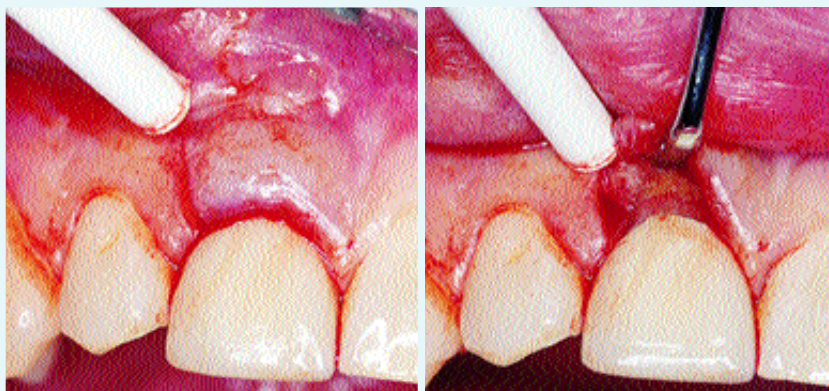
**Fig. 38.** – A triangular 'miniflap' involving a single vertical incision (a) in the attached gingiva on the side of the tooth away from the probing defect or suspected fracture is a relatively atraumatic way of exposing the coronal root surface and (b) of confirming the presence of a suspected vertical root fracture.

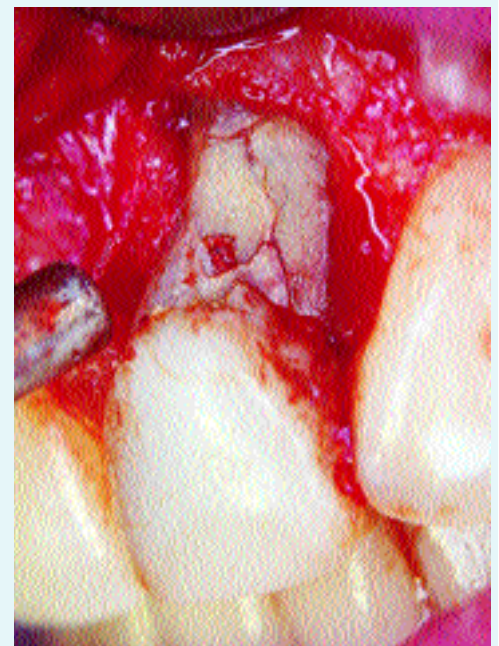
**Fig. 41.** – Reflection of a full thickness flap reveals the full extent and complexity of the root fracture in this central incisor tooth. Flap reflection is recommended to confirm the presence of a vertical root fracture.

is not stained, or where separation of fragments has not occurred. It is proposed by these authors that, where possible, a small flap should be raised routinely to confirm the presence of a fracture, rather than just to suspect that one is present (Fig. 41).
