LiDAR Quality Assessment Report

AK_BrooksCamp_2012

Brooks Camp, AK Ortho/Lidar

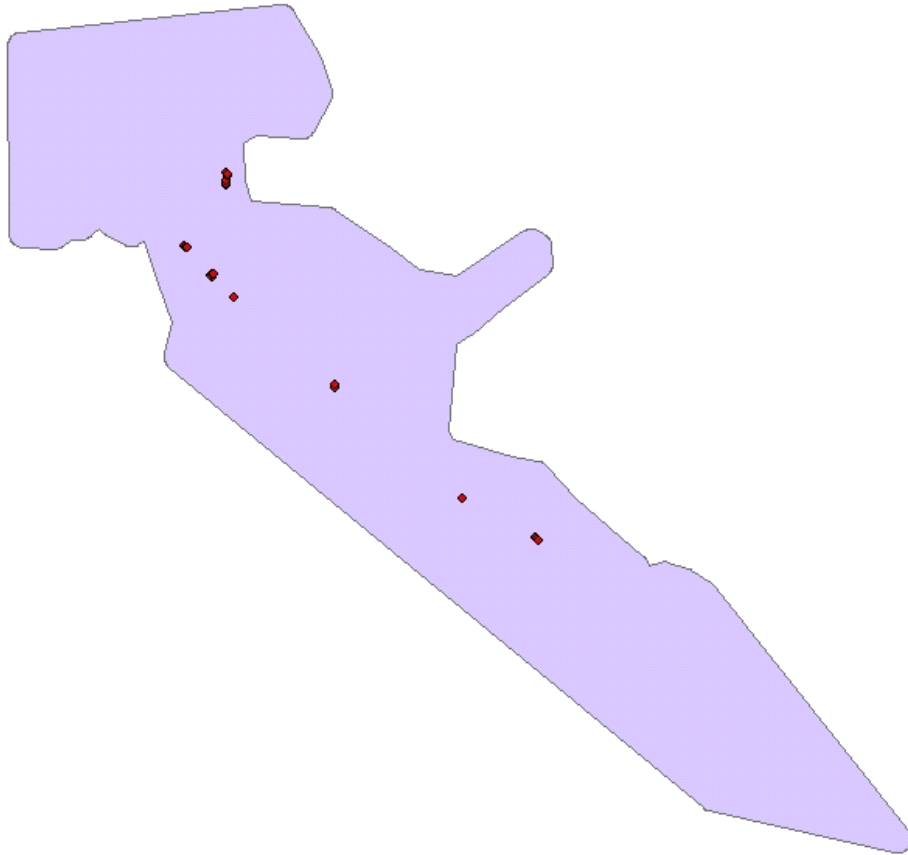
**Brooks Camp AK Ortho/Lidar Task
checkpoint layout**

Further examination of the checkpoint distribution shows limited areas of open, flat terrain. This may also explain the "clumping" of the checkpoints. Looking at imagery and lidar, as well as creating buffers around breaklines, it is the opinion of the NGTOC that there were additional open, flat, terrain areas where independent checkpoints could have been collected, increasing the distribution of the checkpoints.

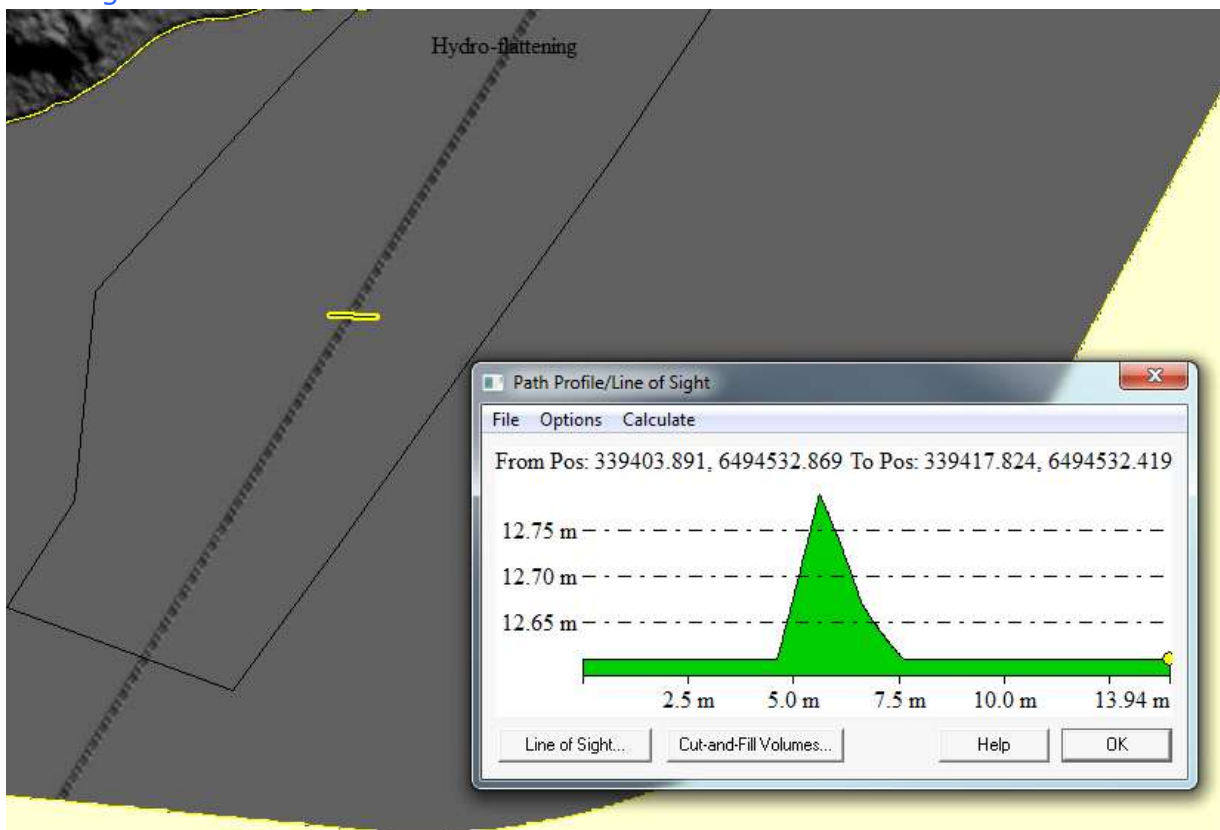
10/15/2012: This water feature at the boundary should be flat, however there is an artifact that is causing a ridge in the surface. This should be corrected. All instances of this occurrence are georeferenced in the delivered shapefile.

12/11/2012: All hydro-flattening and breakline issues have been corrected. The breaklines are accepted.

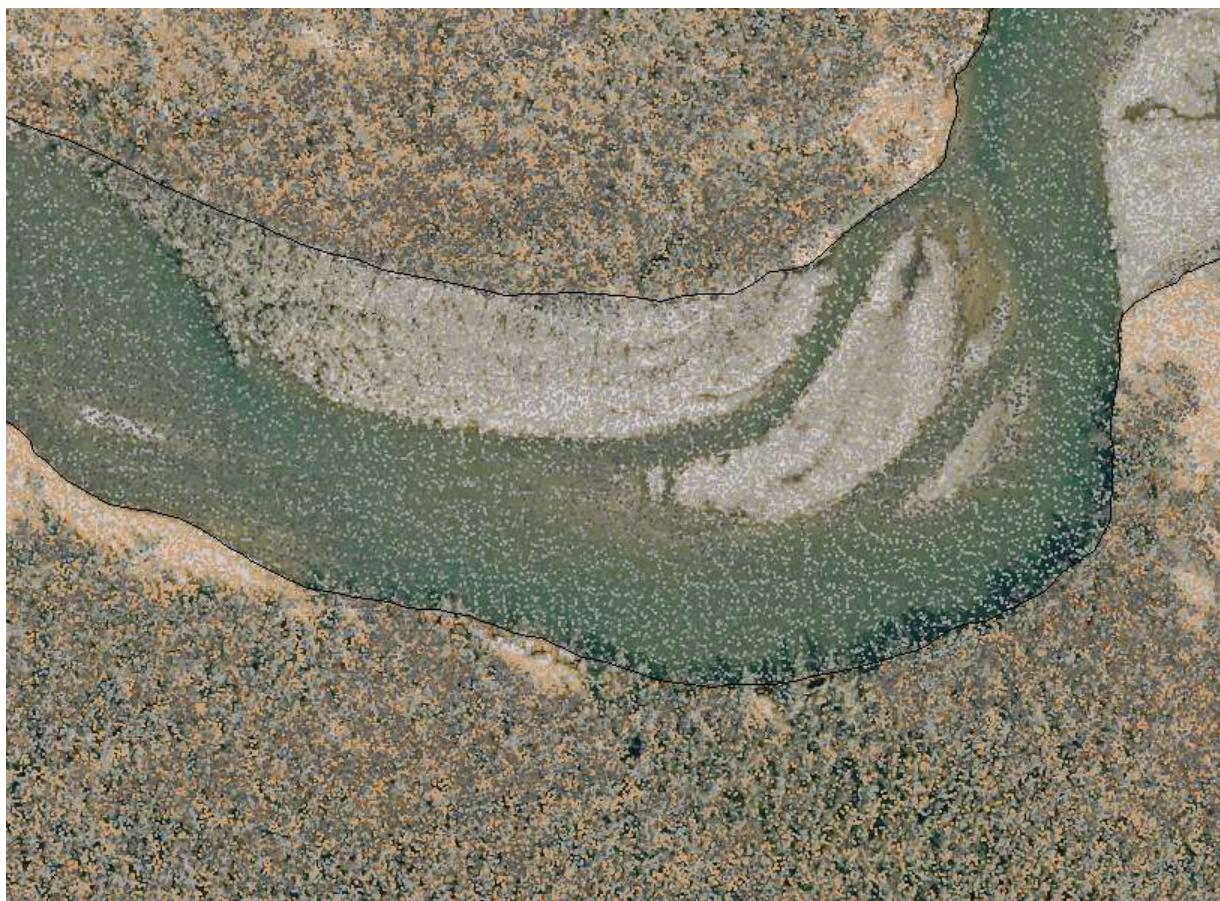
10/15/2012: The breakline is covering bare earth. Additionally, there is an island that is not shown when hydro-flattening occurs because there is not a breakline around it. This island should show in the DEM, and the breakline should be closer to the shoreline.

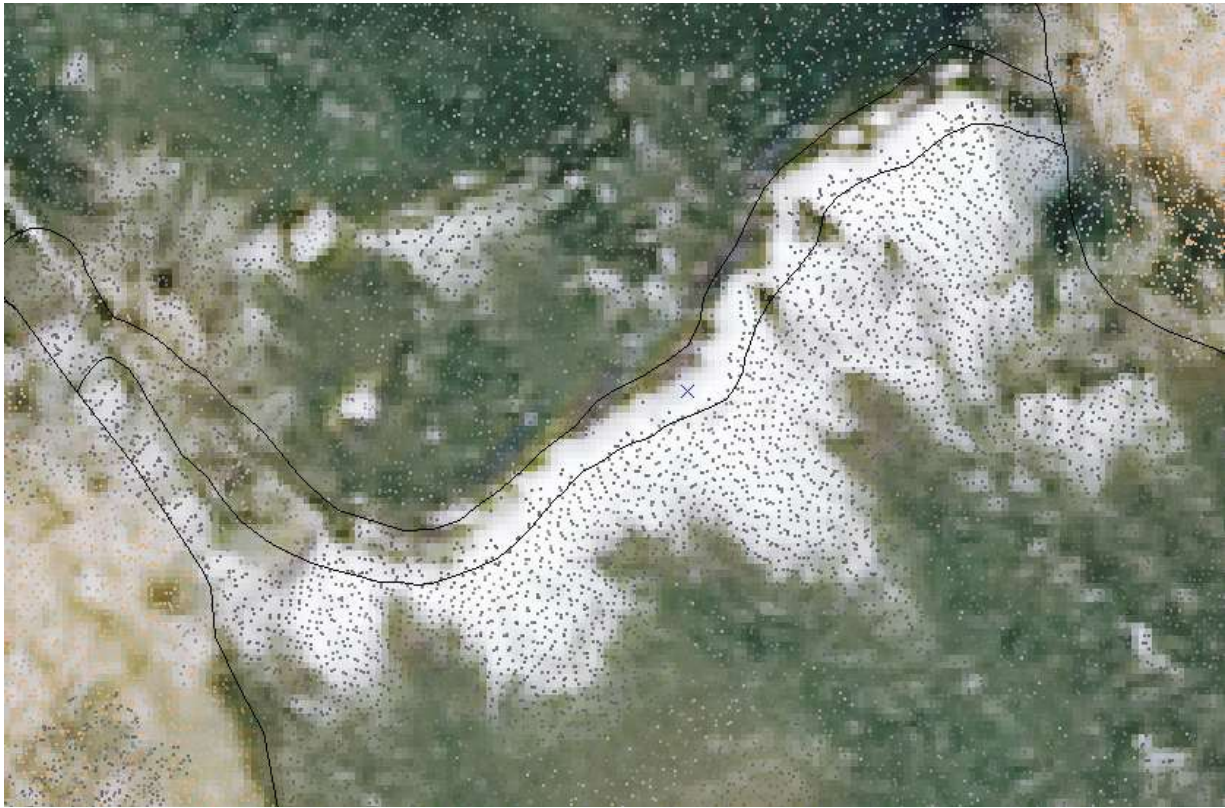
10/15/2012: This breakline appears to be randomly placed. Breaklines should be continuous across surface.

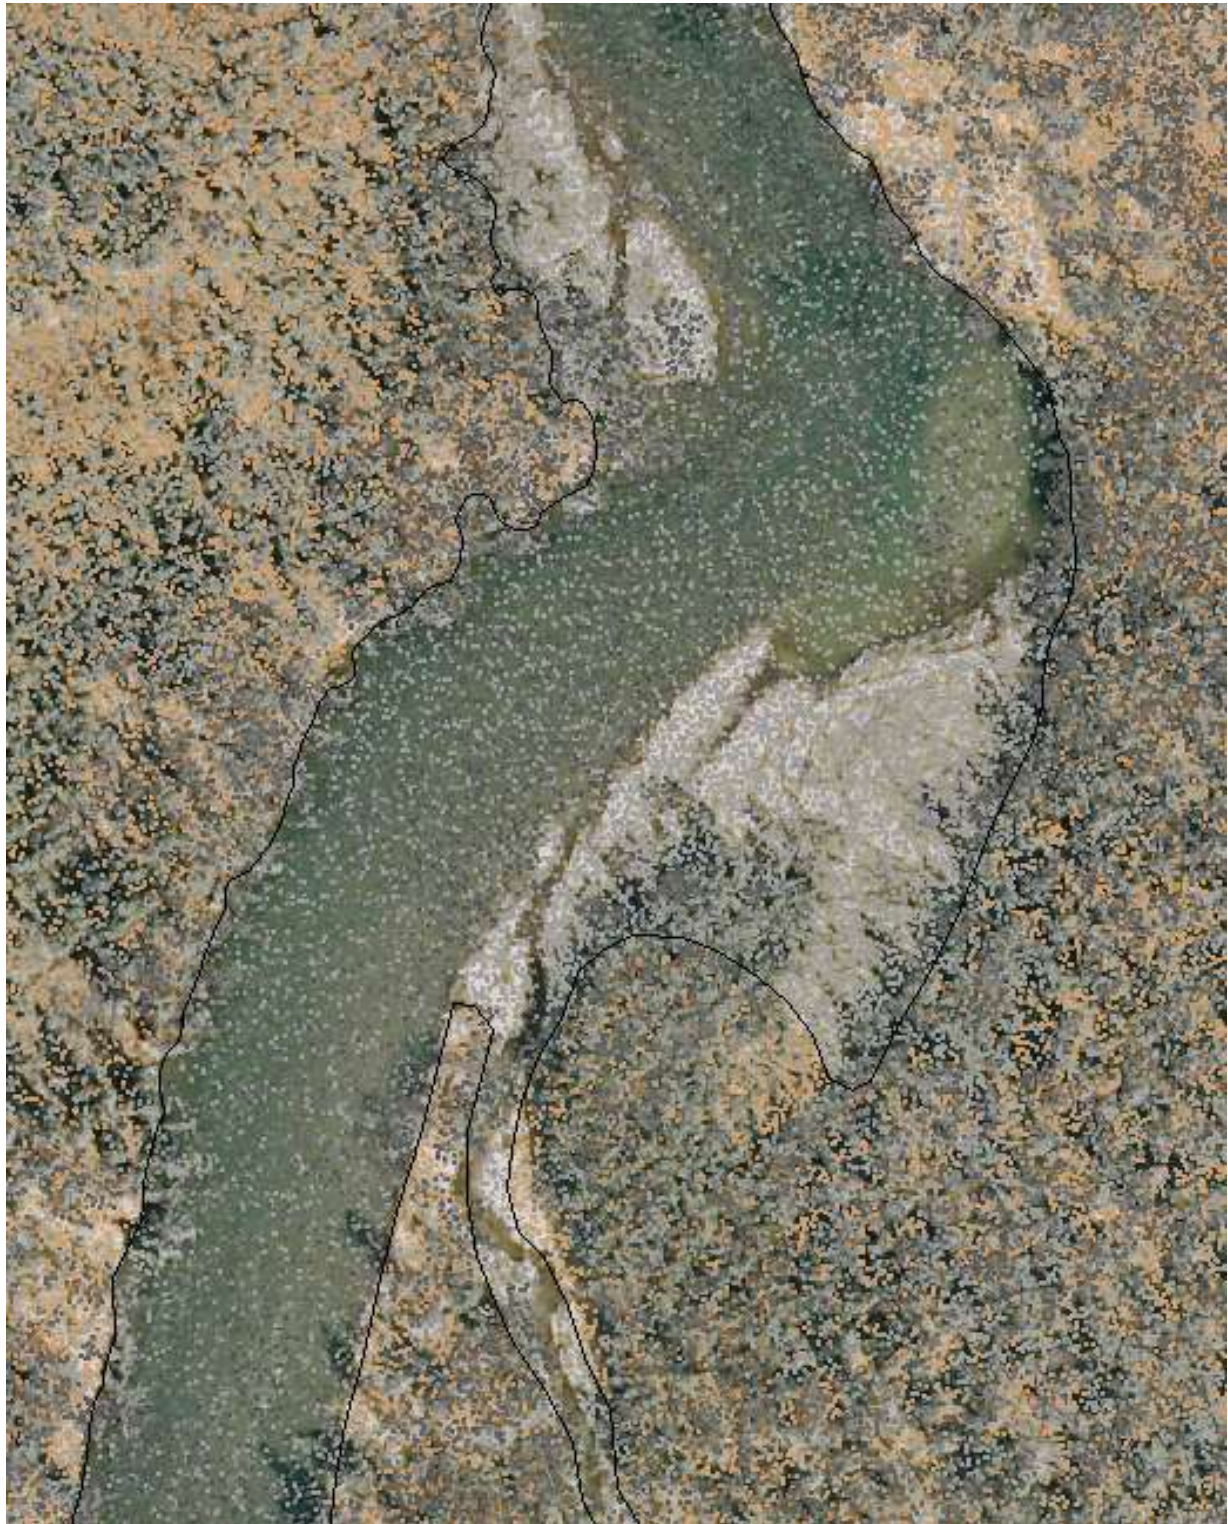
10/15/2012: This breakline is covering bare earth. The breakline should be set closer to the actual shoreline to preserve bare earth surface.
