# UAF Light Detection and Ranging (LiDAR) and Ortho-Imagery Data Project Report Revilla Corridor

Tetra Tech was contracted by the University of Alaska Fairbanks (UAF) to provide LiDAR and ortho-imagery data for the Road to Resources in Alaska Program. Tetra Tech collected LIDAR data and aerial imagery during the fall of 2013 and the spring/summer of 2014. Included within this document are the various reports required by the contract.

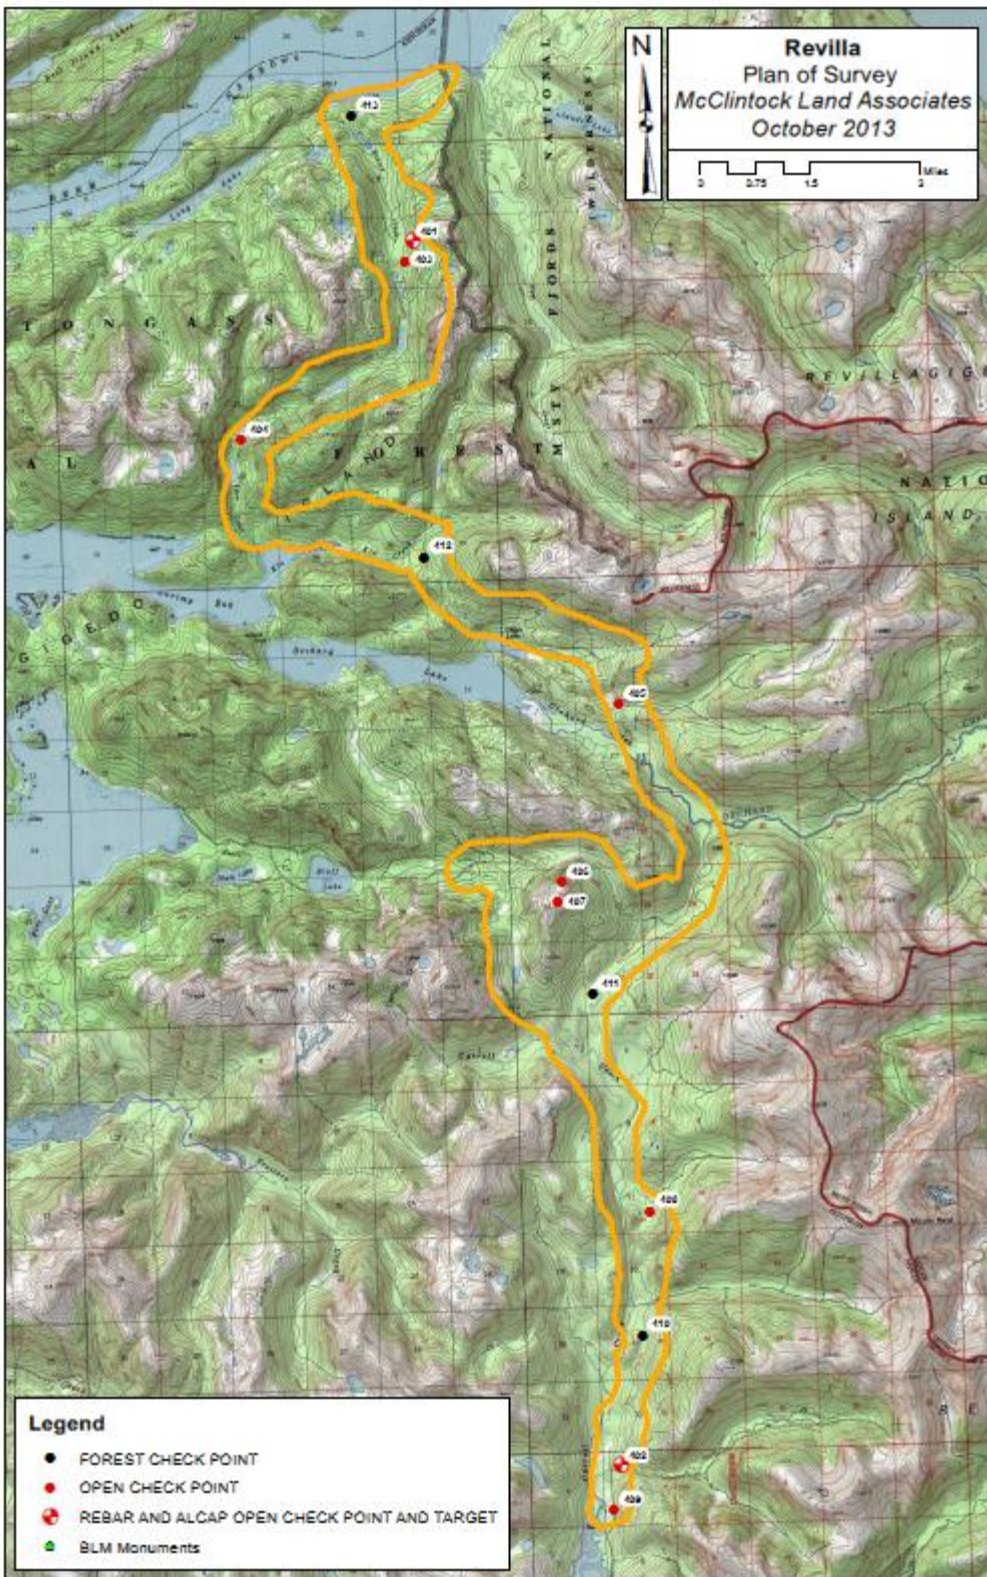
The Revilla area contains 3 calibration points and 10 independent check points as shown in the diagram below.
