# Block 4 – Imaging

## Part 1: Infrared Thermography

34553: Applied Photovoltaics

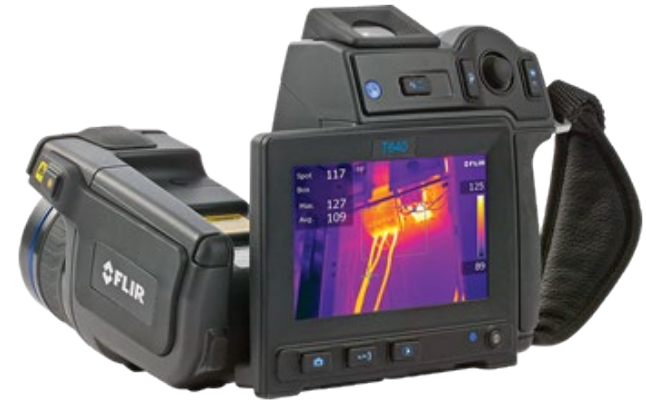
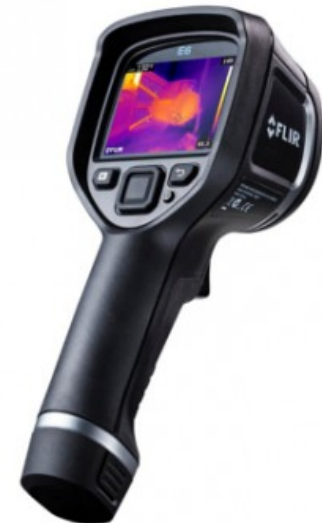
# Infrared Thermography - Principles

- **IEC/TS 60904 -12** “Infrared Thermography of Photovoltaic Modules” (under development)
- **IEC/TS 62446-3** “Photovoltaic modules and plants – Outdoor infrared thermography”
- **Steady state:** Sun illumination or  $I_{SC}/I_{MPP}$  in lab conditions.
- **Camera Position:** 90 to 60 degrees from the panel (glass)
- **Sun Irradiance:** 700-600 W/m<sup>2</sup> minimum
- **Emissivity:** 0.85 (glass)

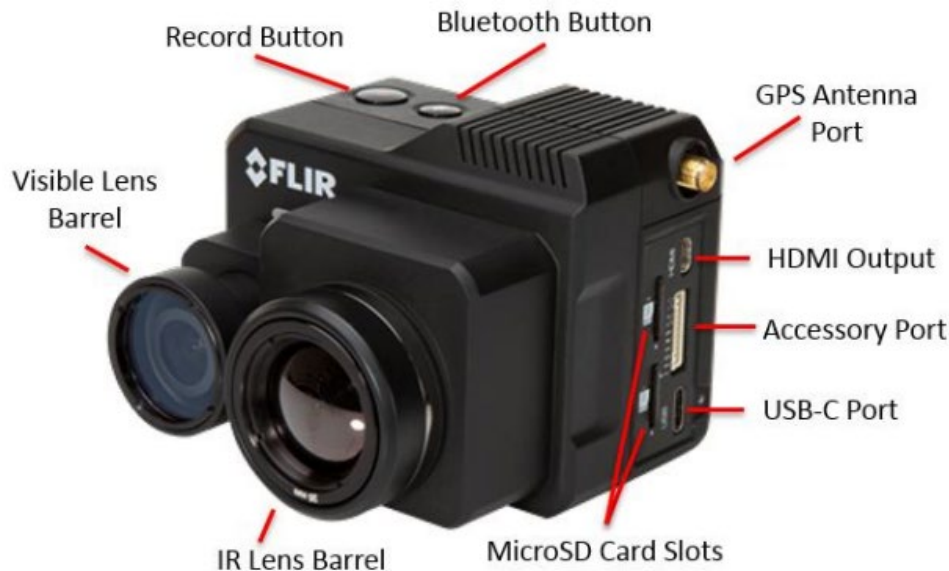
# Camera – FLIR Duo Pro R

Overview	Duo Pro R 640	Duo Pro R 336
Thermal Imager	Uncooled VOx Microbolometer	
Spectral Band	7.5 – 13.5 $\mu\text{m}$	
Thermal Sensitivity	< 50 mK	
Thermal Sensor Resolution Options	640 x 512	336 x 256
Thermal Lens Options	13 mm: 45° x 37°	9 mm: 35° x 27°
	19 mm: 32° x 26°	13 mm: 25° x 19°
	25 mm: 25° x 20°	19 mm: 17° x 13°
Thermal Frame Rate	30 Hz	
Visible Sensor Resolution	4000 x 3000	
Visible Camera FOV's	56° x 45°	56° x 45°
Radiometry		
Measurement Accuracy	+/- 5 C or 5% of readings in the -25°C to +135°C range +/- 20 C or 20% of readings in the -40°C to +550°C range	
Physical Attributes		
Size	85 x 81.3 x 68.5 mm 85 x 86.5 x 68.5 mm (640/25 mm lens only)	
Weight	325 g 375 g (640-25 mm only)	325 g
Image Processing & Display Controls		
Imaging Modes	IR-only, Vis-only, Picture-in-Picture (IR in Vis)	
MSX Image Enhancement?	Yes	
Multiple Color Palettes?	Yes – Adjustable in App and via PWM	
IMU Sensor		
GPS?	Yes (GPS, GLONASS)
