Effect of Bluff Erosion and Shoreline Change in Great Lake Michigan

Geographic Information System and Technology

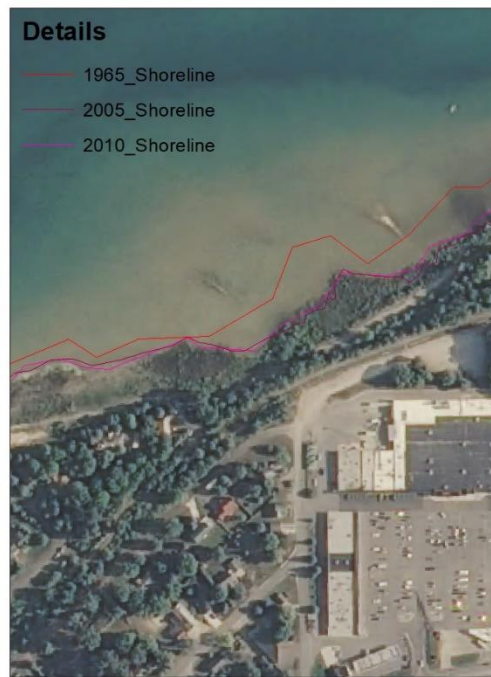
Figure 3.2 Ariel View of South Eastern part of Little Traverse Bay in 2010

The figures 3.1 - 3.3 shows the changes in shoreline over the years especially in the parts where human intervention is high. Throughout the years the normal shoreline has been persistently recreated for the human purpose. This has totally changed the regular shoreline which ought to be safeguarded. . It is probably not years of drainage that accounts for this shoreline erosion; rather the shoreline has been changed dependent on human needs.

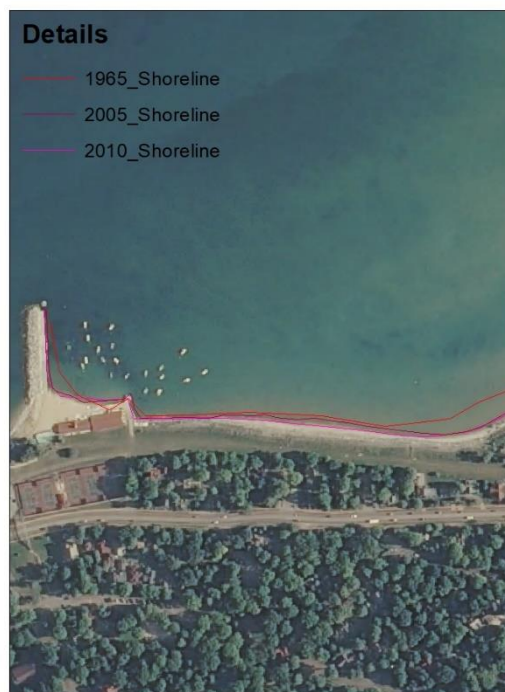
Figure 3.3 Ariel View of South part of Little Traverse Bay in 2010

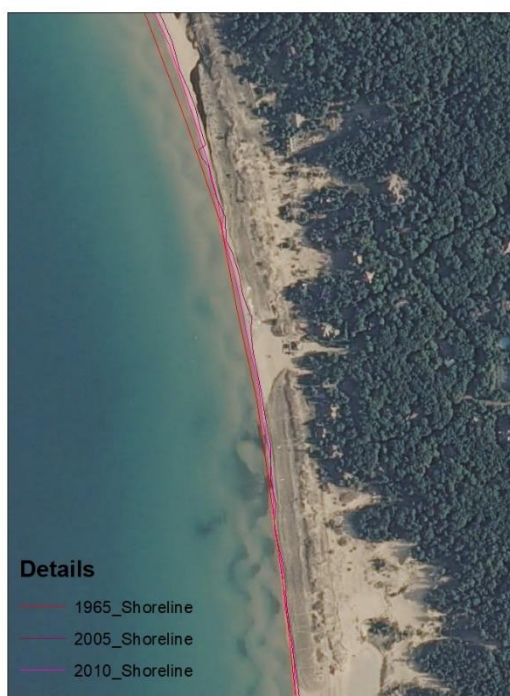
Figure 3.7 Ariel View of Eastern part of Little Traverse Bay in 2010

Figure 3.6 – 3.8 images shows the shoreline where human intervention is very less over the years. As a result, there is no much change in Shoreline. The dune vegetation remains the same over the years. Urbanization on those areas is nearly zero. The natural shoreline is preserved over the years.

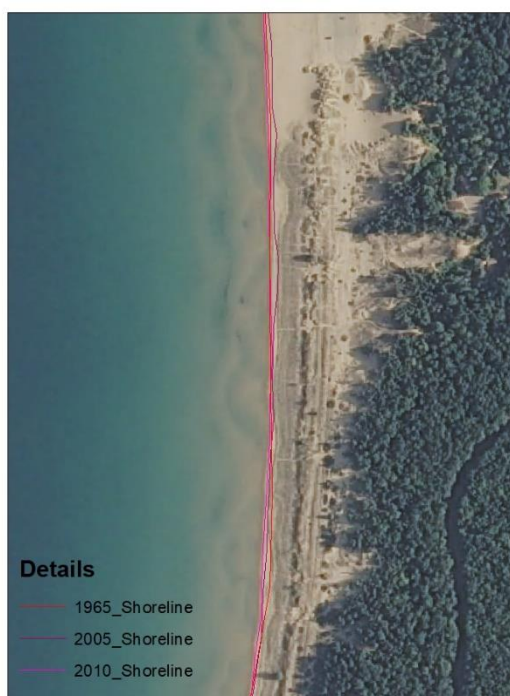
Figure 3.8 Ariel View of Eastern part of Little Traverse Bay in 2010

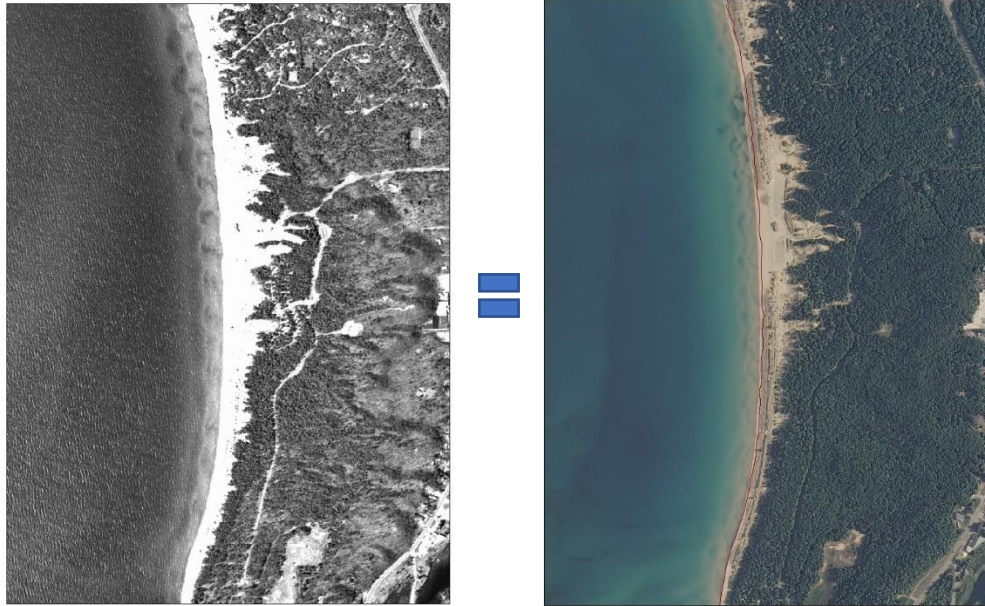
Figure 3.9 Ariel view of Eastern part of Little Traverse Bay in 1965 and 2010

Figure 3.9 shows the shoreline in that area in 1965 and 2010. There is no change in the vegetation along the shore. The average shift is around 10 – 15 meters over the years.
